**GEOTECHNICAL ENGINEERING REPORT
ALBANY WATERFRONT REDEVELOPMENT
ALBANY, OREGON**

PREPARED FOR
**WALKER MACY &
THE CITY OF ALBANY**

GEOTECHNICS PROJECT No. 19-008-1

DECEMBER 22, 2020

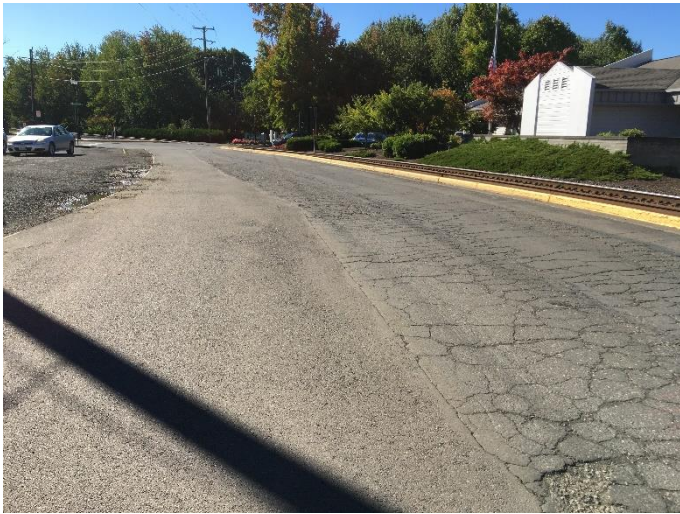
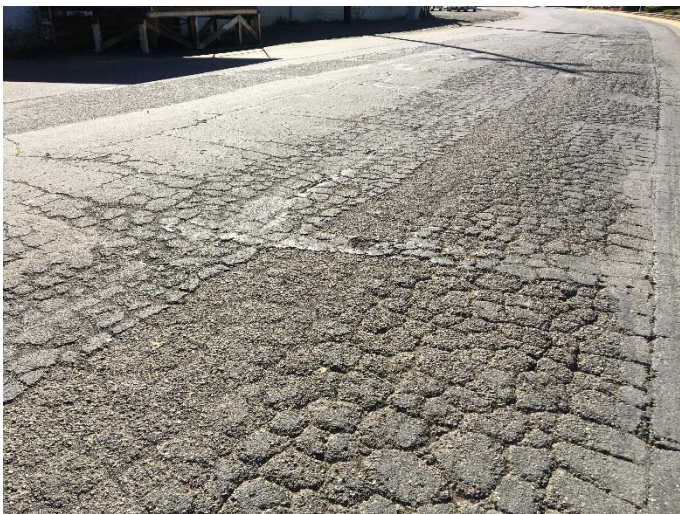
Station	Distress Level					Overall
	Fatigue Cracking	Longitudinal Cracking	Transverse Cracking	Potholes	Raveling	
6+80 to 9+70	H	H	M	M	H	H
9+70 to 16+00	L	M	M	L	L-M	L-M
16+00 to 27+00	L-M	M	L-M	L	L-M	L-M
27+00 to 41+50	L-M	L-M	L	L	M	L-M
41+50 to 53+00	L-M	M	M	L	L	L-M

Pavement condition is a function of pavement profile, past traffic, subgrade soils, drainage conditions, and age. It is not surprising that the poorest pavement condition coincides with the thinnest pavement (see boring B-11). Subgrade soils are generally low quality, requiring a relatively thick pavement section for a moderate traffic level. We are unaware of the pavement age and it is probably highly variable along the alignment. In general however, pavement distress appears excessive for its apparent age, and this suggests under-design. It is likely that the design did not properly account for traffic volumes along this alignment.

In considering a grind-inlay option, we consider condition and thickness of current paving materials. The first zone in the above table disqualifies for grind-inlay based on pavement condition and section thickness. The next three zones disqualify based on inadequate thickness of high-quality, angular base rock. East of Sta. 41+50 could be considered for a grind-inlay option, provided enough of the distressed AC is removed and desired grades allow for the design thickness required (see *Pavements* section).

- The recommended asphalt pavement section is 7 inches AC over 12 inches of aggregate base. We recommend a geotextile separator, placed below the aggregate base. Grind/inlay may be used for an eastern segment of the Water Avenue alignment. Concrete pavers can be used on the west end. For paved pathways, a lighter pavement section will be appropriate, and concrete surfacing can be used provided our subgrade support recommendations are followed.

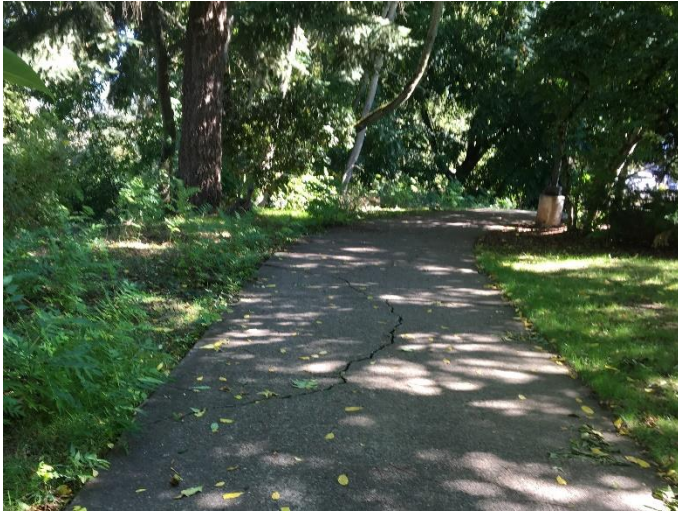
Between Washington & Ferry
cracks to 3/4" width

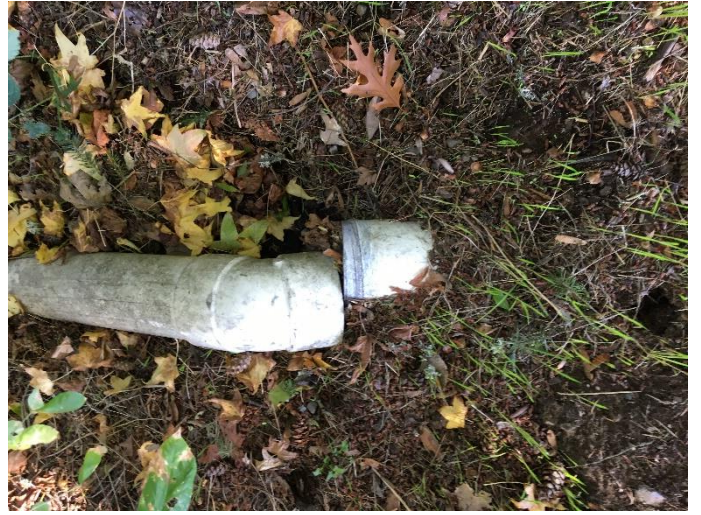
End of Ferry Street,
drain pipe offset

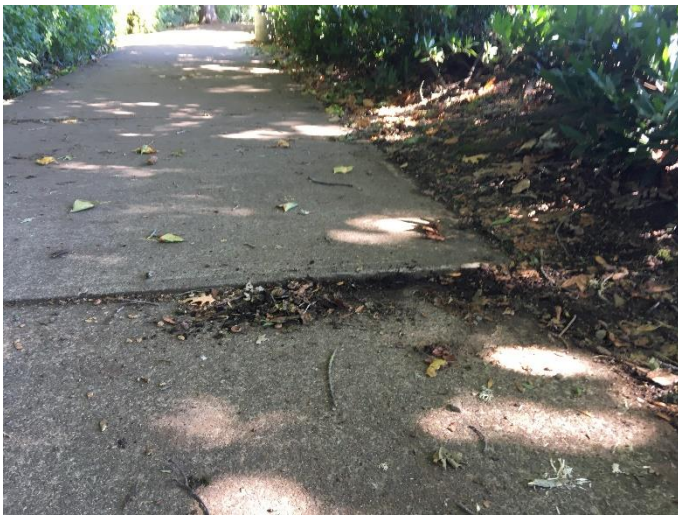
Between Ferry & Broadalbin,
slab panel tilt towards slope

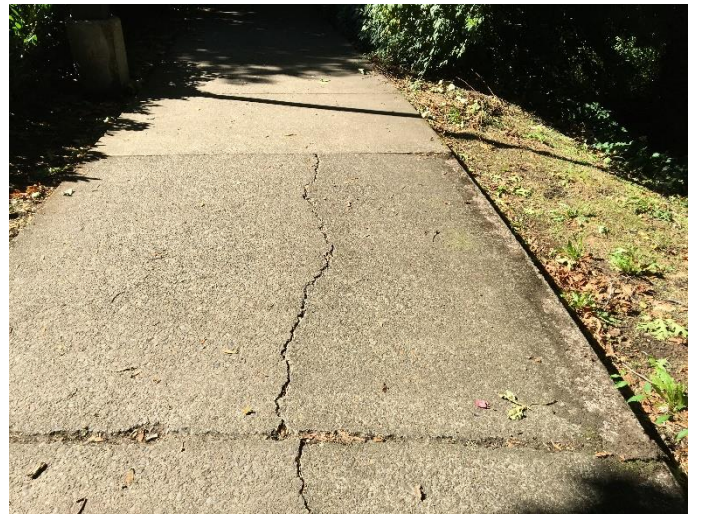
Between Ferry & Broadalbin,
parallel crack & slab tilt

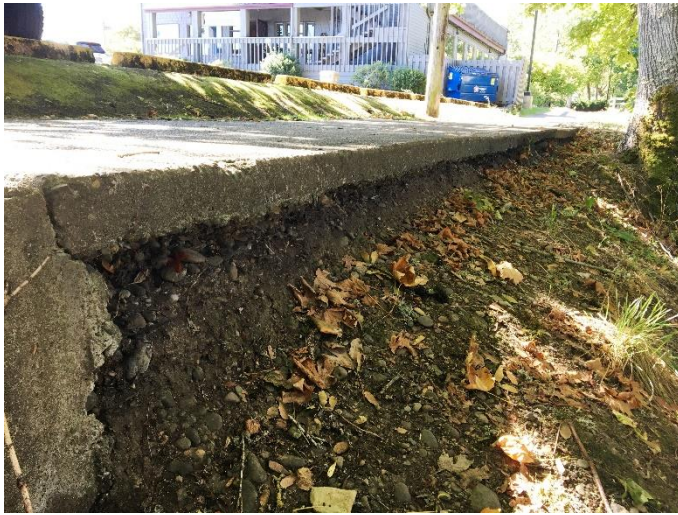
Between Broadalbin & Ellsworth,
trail undermining, 9" lateral

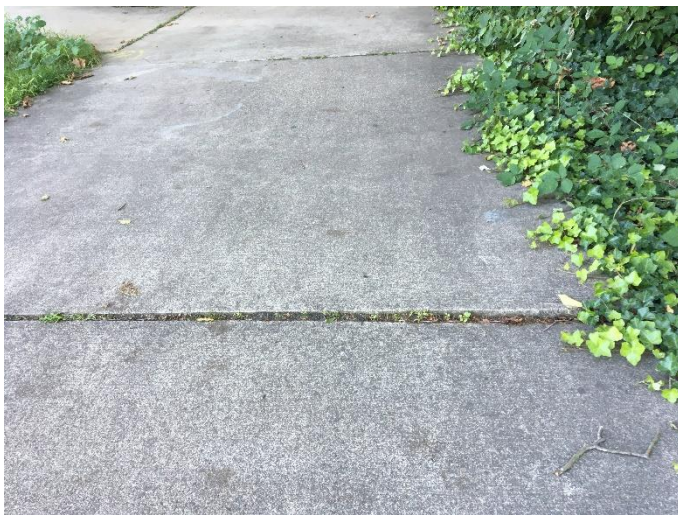
Between Ellsworth & Lyon,
slab tilt towards slope

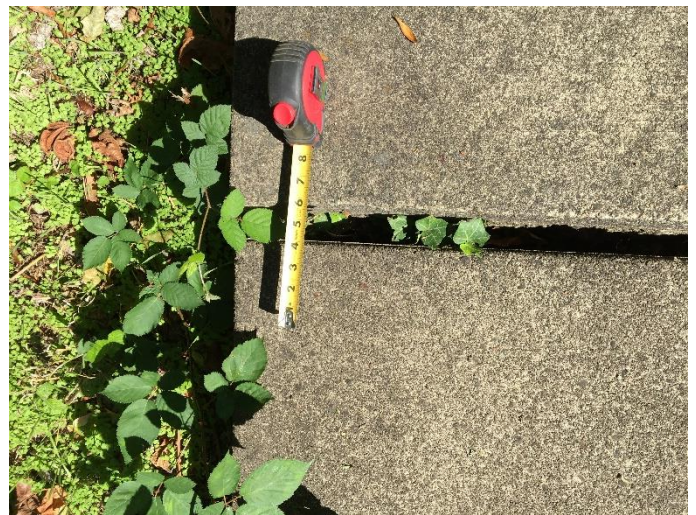
Between Ellsworth & Lyon,
slab panel lateral offset

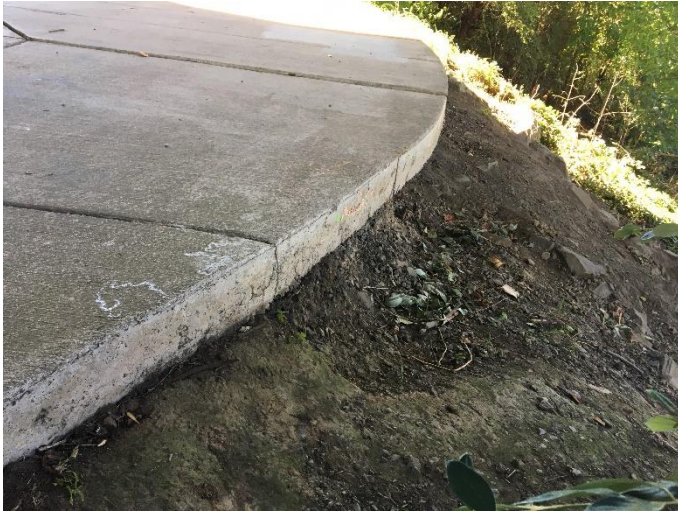
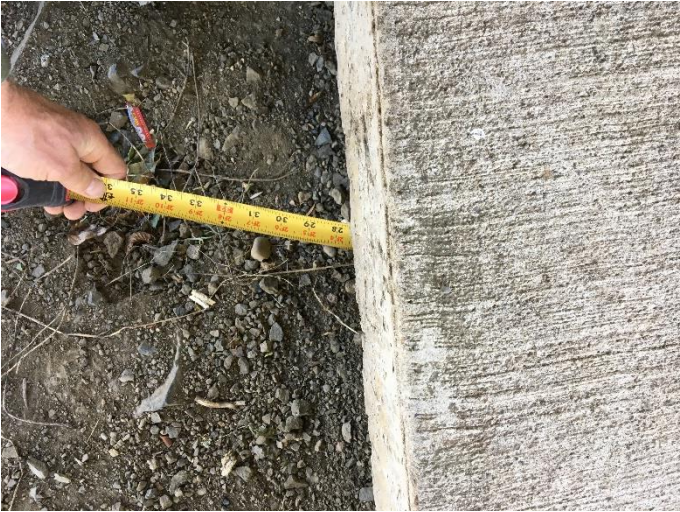
End of Lyon Street,
overlook undermining, 28" lateral

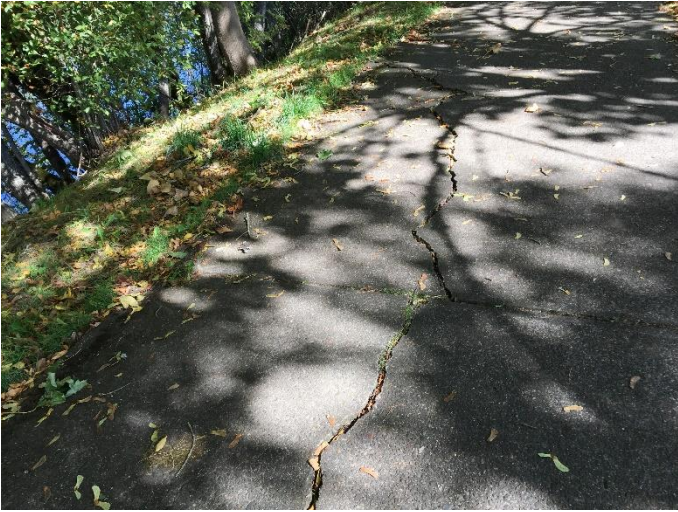
Between Lyon & Baker,
cracks to 1" width

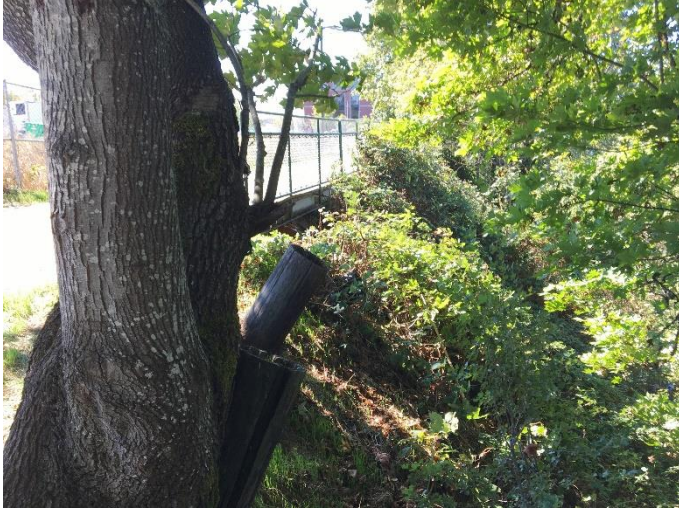
Between Jackson & Jefferson,
tilting posts, pile-supported trail

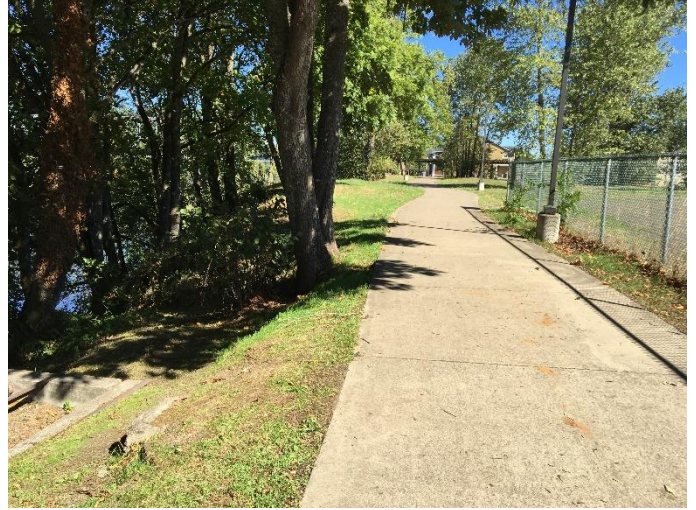
Between Jefferson & Thurston,
good condition

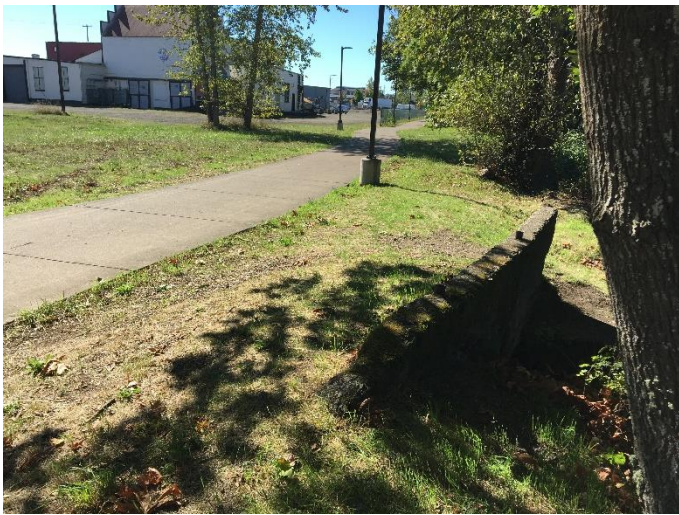
Between Thurston & Lafayette,
good condition

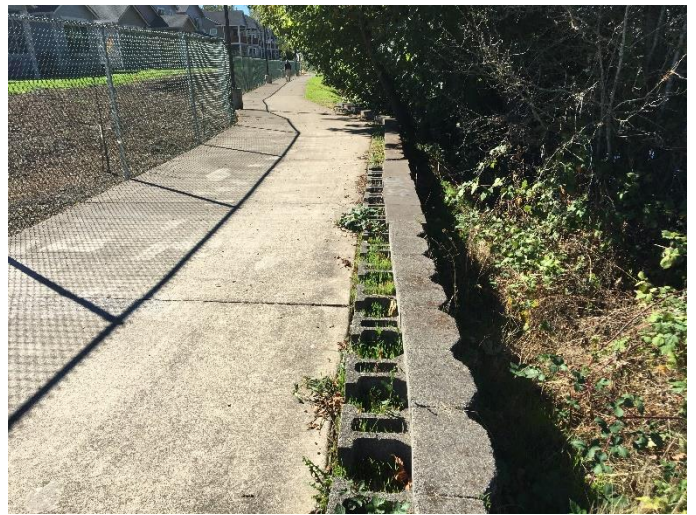
Between Madison & Hill,
modular-block retaining wall, good trail condition
