Albany Water System

City of Albany

G&E Engineering Systems Inc.

*G&E Report 32.34.01, Revision 0
January 30, 2006*

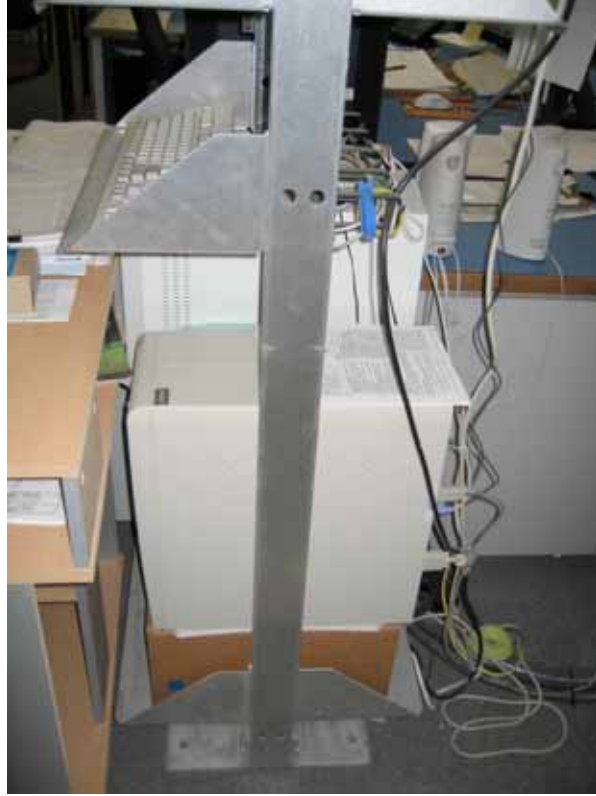
Figure 5-2. Unanchored Equipment Rack

The water quality lab has several pieces of counter top equipment (unanchored) prone to sliding / falling under strong ground shaking. There are unanchored equipment racks with control equipment / computers (Figure 5-2).

There are several unanchored / unrestrained or poorly restrained electrical / measuring cabinets, as for example Figure 5-2. All these should be suitably anchored by adding anchor bolts into the concrete floor below (do not anchor into URM walls).

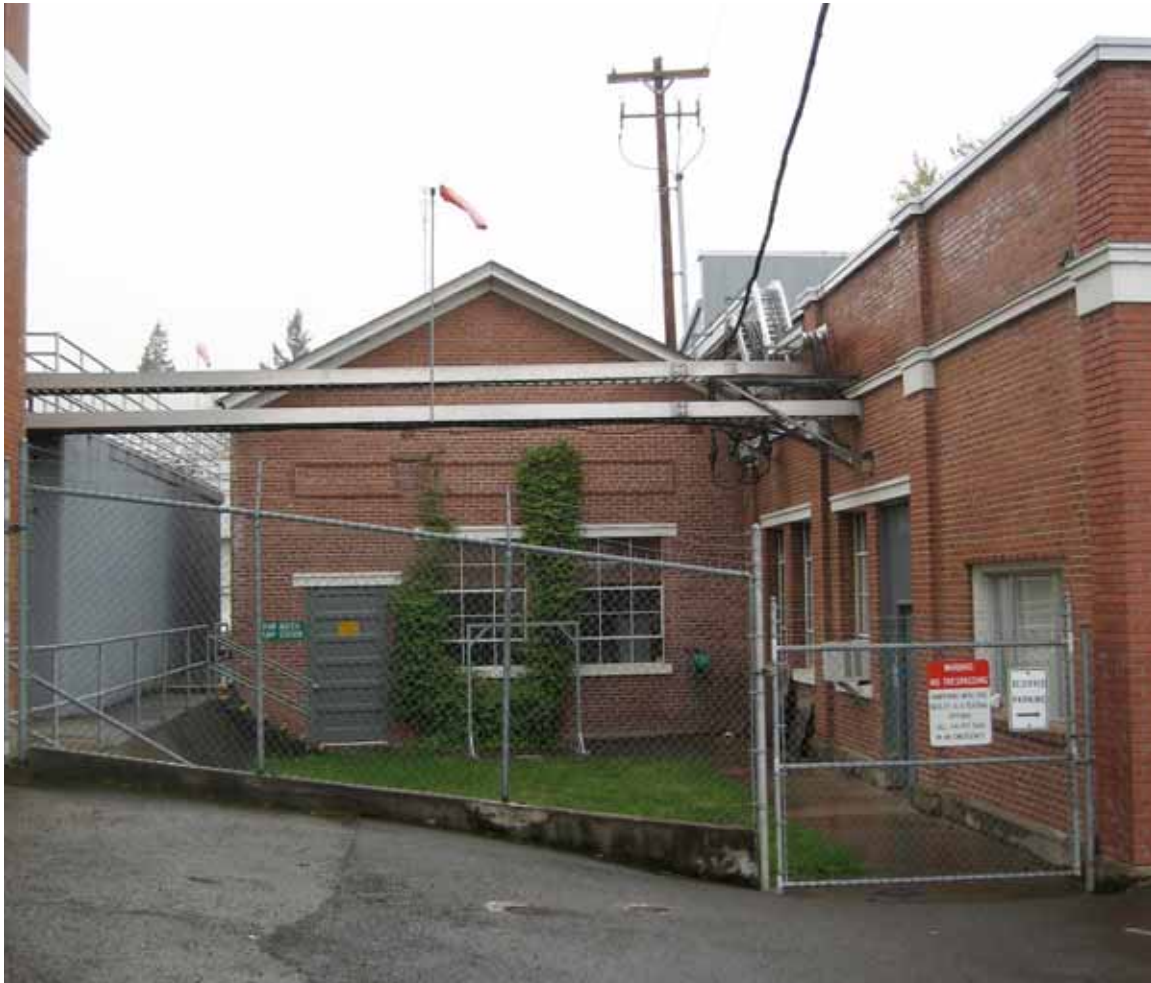
Figure 5-4. Raw Water Pump Station, East Elevation

Raw Water Pump Station building. This is a single story URM building (Figure 5-4), with concrete wet well. The recommended seismic upgrades include improving the in-plane and out-of-plane capacity of existing brick walls; modify diaphragms; and improve diaphragm connections. As this building is a historic brick structure, the upgrades would be done to preserve the roof-and-feel of the exterior facades. Interior walls are generally accessible. Possibly, the upgrade would include a new interior steel braced frame structure with suitable connections to the brick structure; with an enhanced diaphragm; shotcrete walls might be used at interior locations.

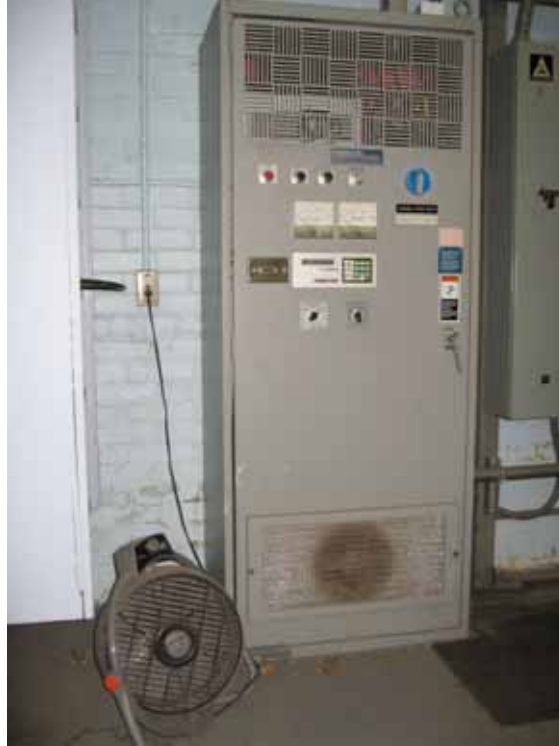
The pump controls in floor standing racks are unanchored³ (Figure 5-5).

Figure 5-5. Control Cabinet for Pumps (Unanchored)

³ During the site walkdown, the anchorage / restraint of all floor standing cabinets was reviewed. In some cases, ongoing operations prevented removal of bottom panels to confirm anchorage. Given the date of installation and site review, this report lists cabinets as unanchored if proper anchorage could not be confirmed in the field.

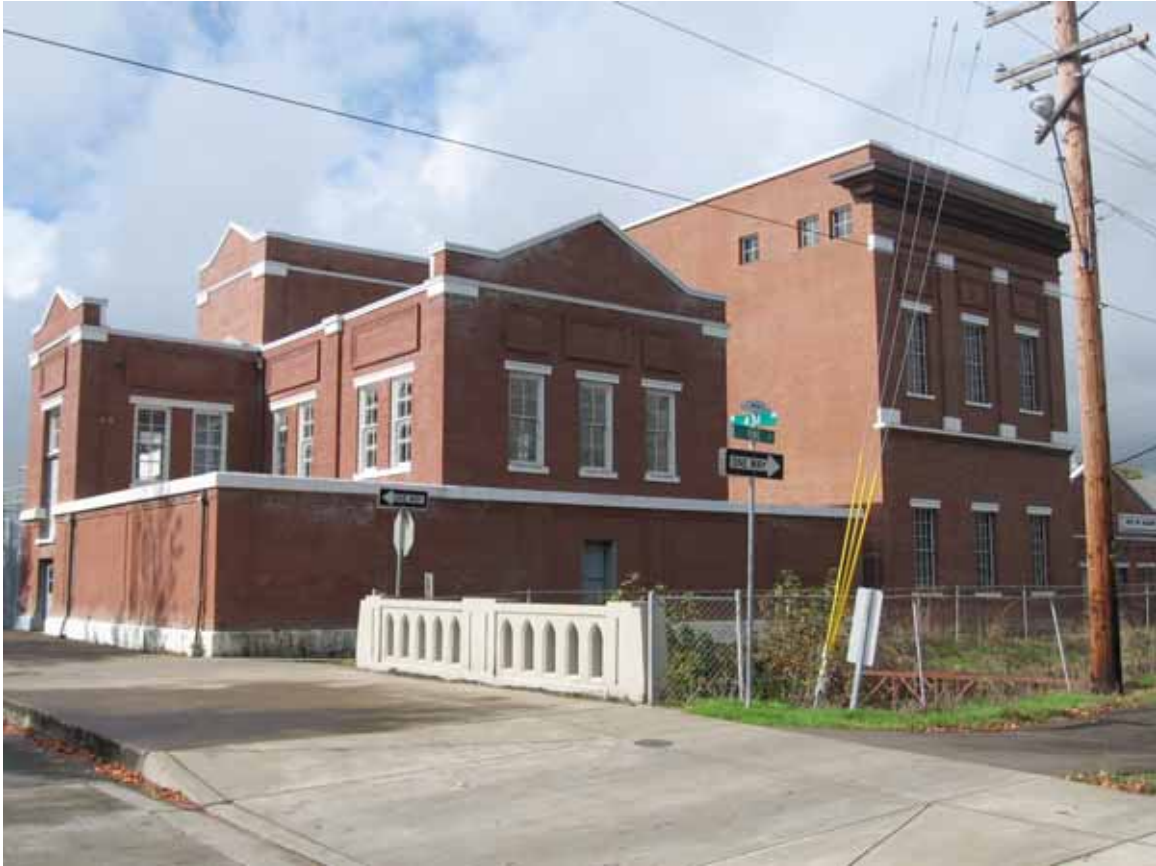
Figure 5-6. Old Filter Building (Left Side) and Soda Ash Building (Right Side)

Soda Ash building. The building is a URM structure, two stories tall (Figure 5-6). The exterior walls are perforated by numerous windows. There are no interior walls. This building is normally unoccupied and currently has little function in terms of maintaining critical plan operations, but does provide storage space for spare parts (Figure 5-7) and the like. Interior storage racks are unanchored. CH2M-Hill recommended a full upgrade, but the lack of occupancy / key function suggests a lower priority and lower cost-effectiveness. Average occupancy is less than 0.05 people on a 24 hour basis. Structural upgrades would include improving the in-plane and out-of-plane capacity of existing brick walls; modify diaphragms; and improving the diaphragm connections. As this building is a historic brick structure, the upgrades would be done to preserve the roof-and-feel of the exterior facades. Interior walls are easily accessible. Possibly, the upgrade would include a new interior steel braced frame structure with suitable connections to the brick structure; with an enhanced diaphragm; shotcrete walls might be used at interior locations.

Old Filter building. This building is normally unoccupied (Figure 5-6). At its lower levels, there are small reinforced concrete basins that can serve as part of system operation to provide flows after earthquakes. CH2M-Hill recommended a full upgrade, but the lack of occupancy suggests a moderate priority and cost-effectiveness. Seismic upgrades would include improving the in-plane and out-of-plane capacity of the existing brick walls; modify straight sheathing wood roof diaphragm; and improving the diaphragm connections. As this building is a historic brick structure, the upgrades would be done to preserve the roof-and-feel of the exterior facades. Interior walls are easily accessible. Possibly, the upgrade would include a new interior steel braced frame structure with suitable connections to the brick structure; with an enhanced diaphragm; shotcrete walls might be used at interior locations.

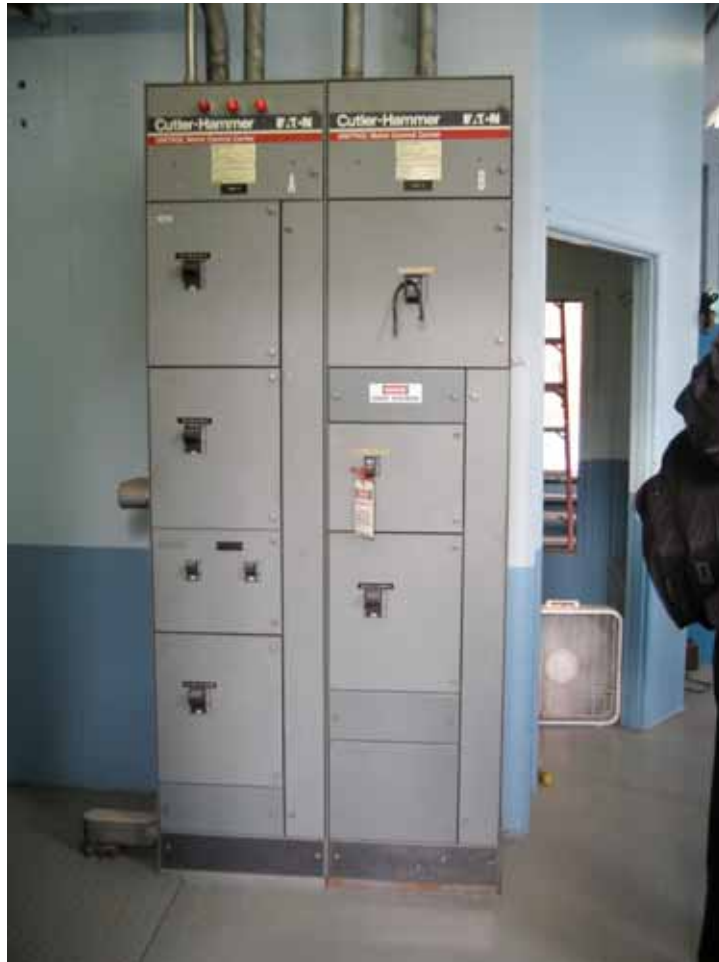
Figure 5-8. Restrained Control Cabinet

There are three floor standing motor control centers, one of which is restrained and the other two should be anchored / restrained (one of which shown in Figure 5-8).

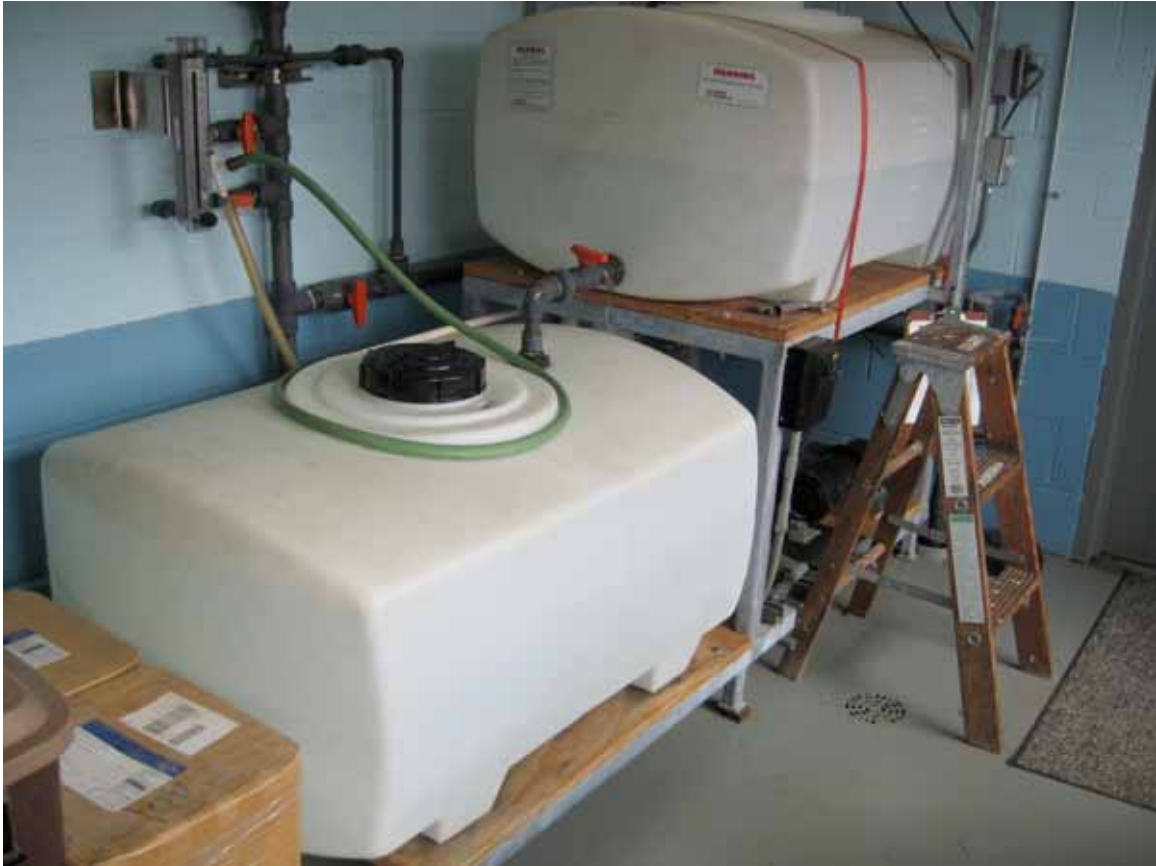
Figure 5-10 shows two poorly restrained plastic chemical tanks. The steel rack legs are supported on wood shims and left unrestrained on the floor below. A floor-standing motor control cabinet is unrestrained.

Figure 5-10. Poorly Restrained Chemical Tanks

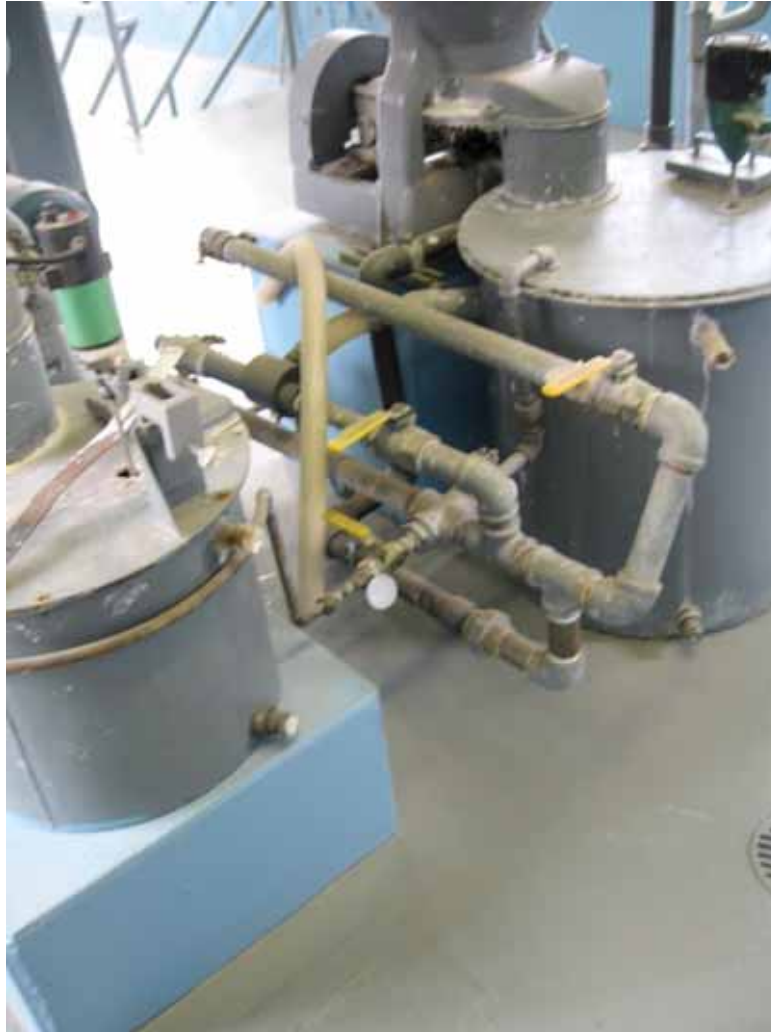
Figure 5-12. Unrestrained Tanks within Chemical Building

The function of this building is critical to plant operations after an earthquake. Planned upgrades would include improvement of connections; and improved anchorage of the alum tank and other chemical tanks within the building.

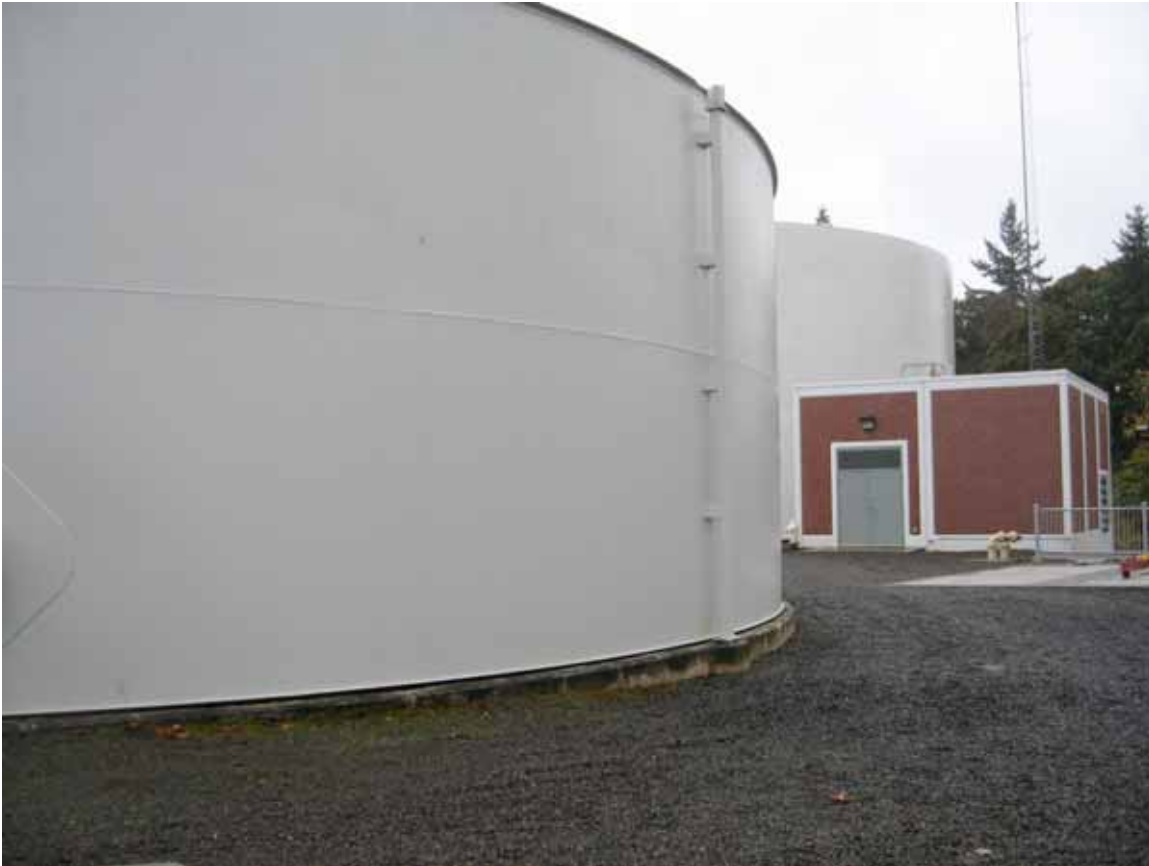
Figure 5-15. Accelerator 2 (Left Side) and Maple Reservoir (Right Side)

Accelerator #2 is a welded steel tank, Figure 5-15, built 1978. It is founded on a concrete ring beam, with the lowest course anchored using a steel channel embedded into the ring beam. Tank wall thickness is assumed to be 0.25 inches over the entire height. The existing tank shell performance should be adequate at $PGA = 0.3g$ (see Table 5-3 for results from analysis). There are interior tube settlers and launders; these appear to have satisfactory capacity to take seismic sloshing loads, and should not be significantly damaged barring tank wall uplift. Rocking of the interior baffles is possible.

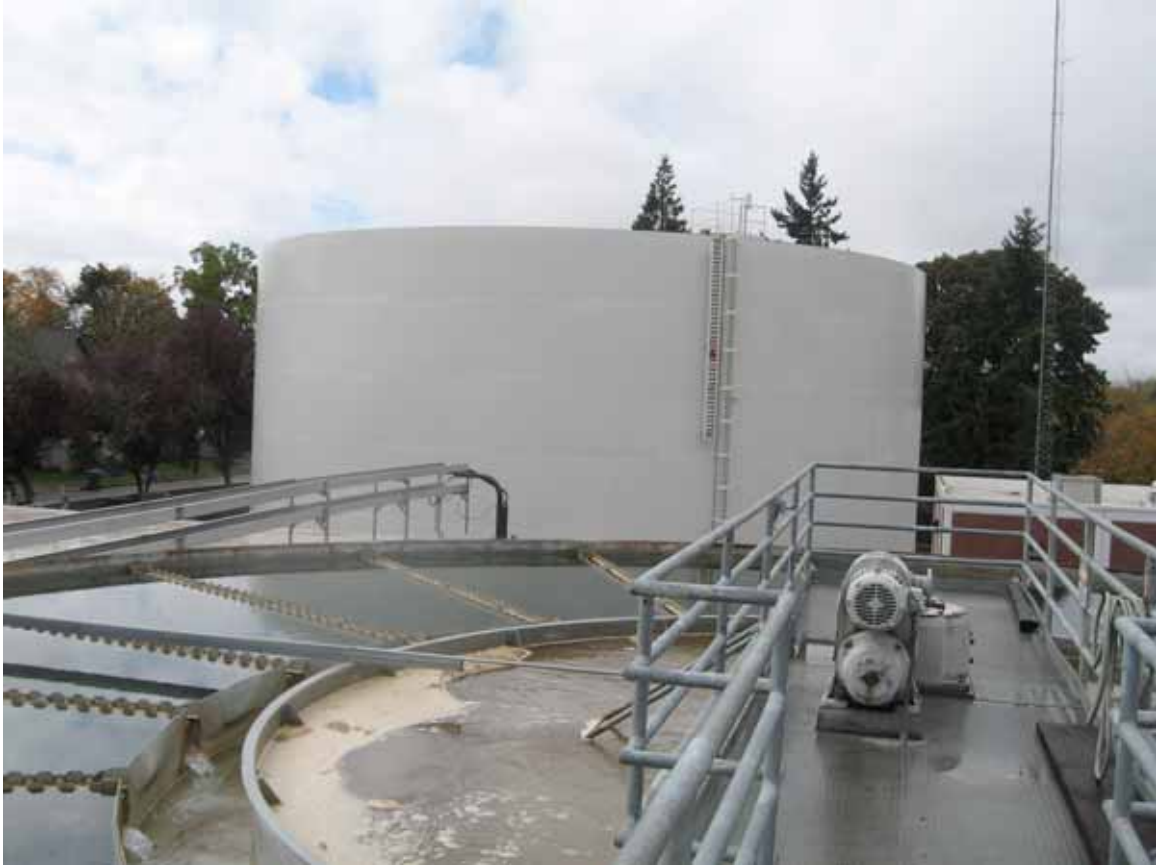
Figure 5-17. Maple Reservoir (Background), Accelerator 2 (Foreground)

Maple Reservoir is a welded steel tank resting unanchored to a concrete ring wall foundation (Figure 5-17). Its three entry/exist pipes are all susceptible to damage due to tank uplift at $PGA = 0.3g$ or so.

Based on these findings, we recommend that flexible connectors be provided for all side entry inlet-outlet pipes or under-tank drain pipes that be impacted by tank wall uplift on the order of 4 to 12 inches. As part of the upgrade design effort, wall thicknesses and materials should be verified either by obtaining the original fabrication drawings, or using a steel wall thickness gage tester; if the walls are much thinner than assumed (i.e., as might be possible if the tank was built using a higher grade of steel), then the conclusions about tank wall buckling might change.
