Vine Street Water Treatment Plant

Seismic Assessment and Retrofit Strategy Report

Albany, Oregon

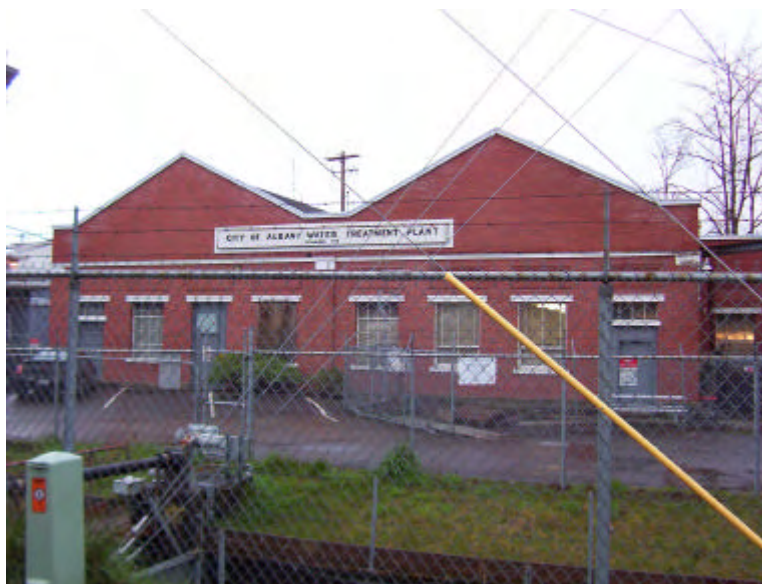
Figure 4.1-1: Control Building east elevation (entrance)

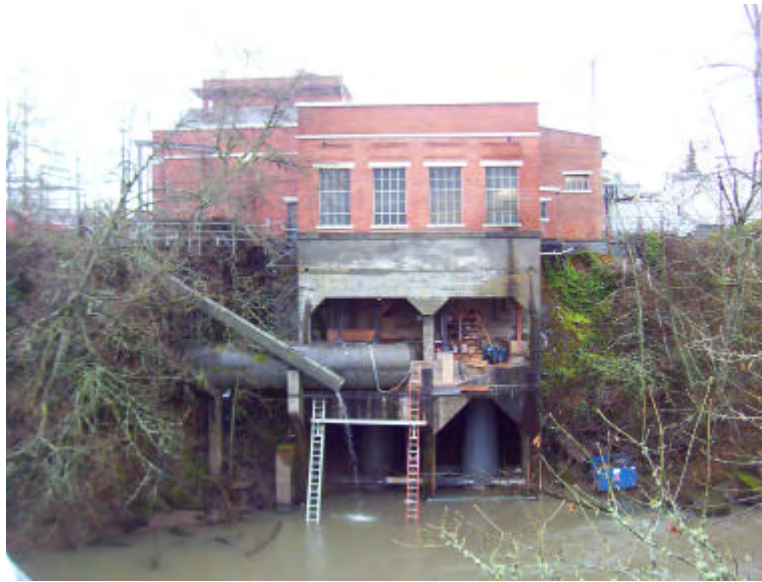
Figure 4.1-2: Control Building north elevation (north wing)

The north wing of the structure overhangs the river below; the lateral system for this wing consists of shearwalls, and concrete beams and columns that may function as frames under low lateral loading but were likely not designed or detailed for such loading. Additionally, this portion of the building is supported by relatively flexible elements (frames), compared to the slab-on-grade and foundation system of the rest of the building. The difference in stiffness between the two support structures would tend to result in high torsional forces in the wing under east-west loading, and could tend to separate the wing from the rest of the building under north-south loading. Lateral forces in this wing could be high due to the large mass of the generators supported by the wing's structural slab.

1. Proposed retrofits include:
2. Upgrade foundation system
3. Upgrade existing beam/column system with shearwalls.
4. Upgrade roofs

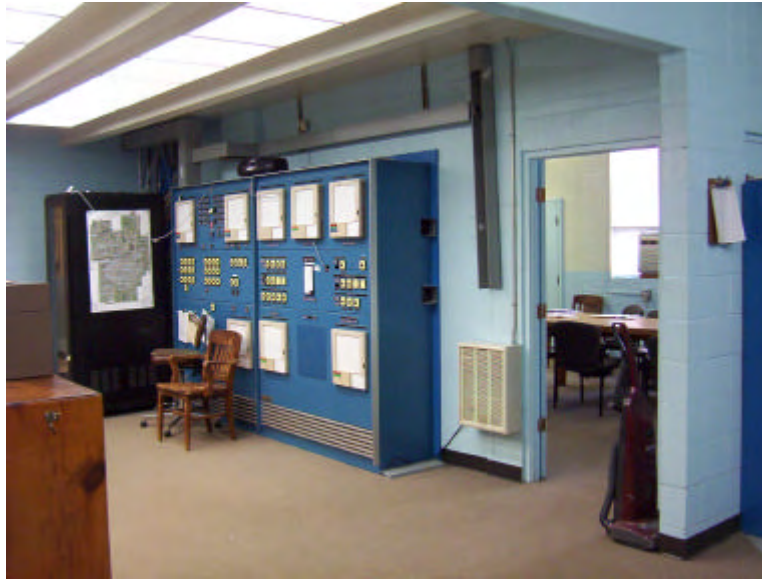
Figure 4.1-3: Interior of conditioned office space

As regards the interior conditioned office space, the ceiling of the office appears to be primarily architectural and does not constitute a horizontal diaphragm to transfer out-of-plane CMU wall loads or inertial loads generated by the ceiling itself. There is likely no shear transfer between the ceiling and the walls, as the ceiling framing extends over the tops of the walls.

Given the various mixture of framing types and elevation differences across the conditioned office space “ceiling,” it is not possible to retrofit the ceiling to function as a diaphragm. As such, out-of-plane wall anchorage of existing CMU walls would not be achieved, nor would in-plane load transfer from the ceiling to the walls. The existing ceiling construction precludes lateral load transfer within the diaphragm.

There are likely two retrofit alternates for the office space. The first alternate is to demolish the entire space, and build a new conditioned space within the envelope of the brick control building. This space could be entirely wood framed, or constructed of CMU walls with a horizontal diaphragm of wood or concrete construction. This space would be structurally independent of the control building and would not transmit any load to it. Pricing for this option is incorporated into the total retrofit cost. A second alternative is to remove the existing office ceiling and replace it, and retrofit the walls; were this retrofit pursued, seismic isolation gaps between the CMU walls and adjacent brick walls should be constructed. It is likely that this would cost approximately the same as a complete replacement.

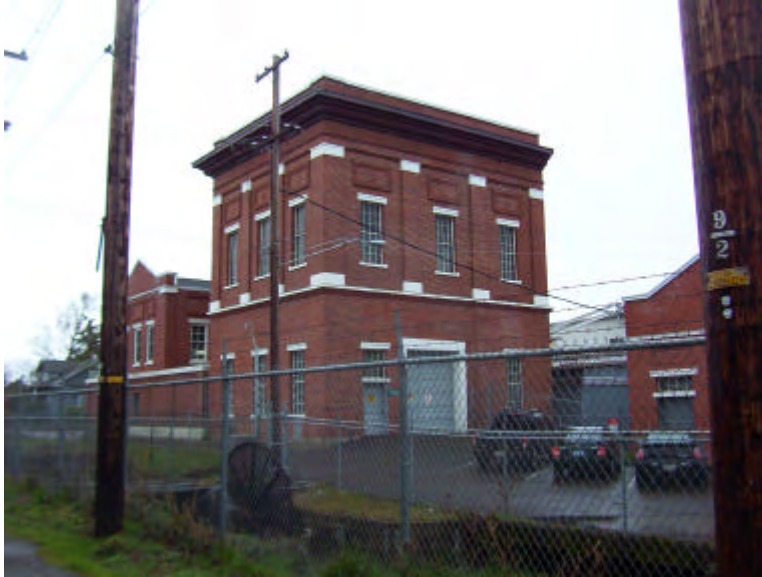
Figure 4.2 -1: Soda Ash building, north elevation

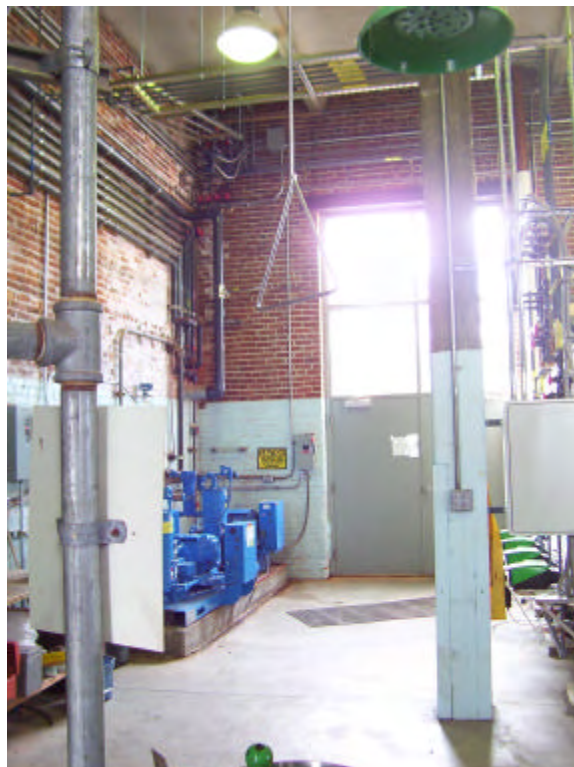
Figure 4.2 -2: Soda Ash first floor interior, looking west

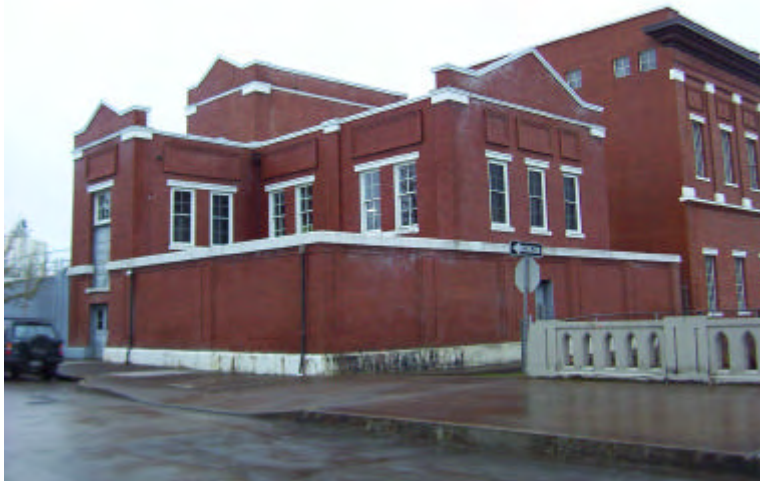
Figure 4.3-1: Old Filter Building looking northwest; note projection of central core above wings. Soda Ash building in background

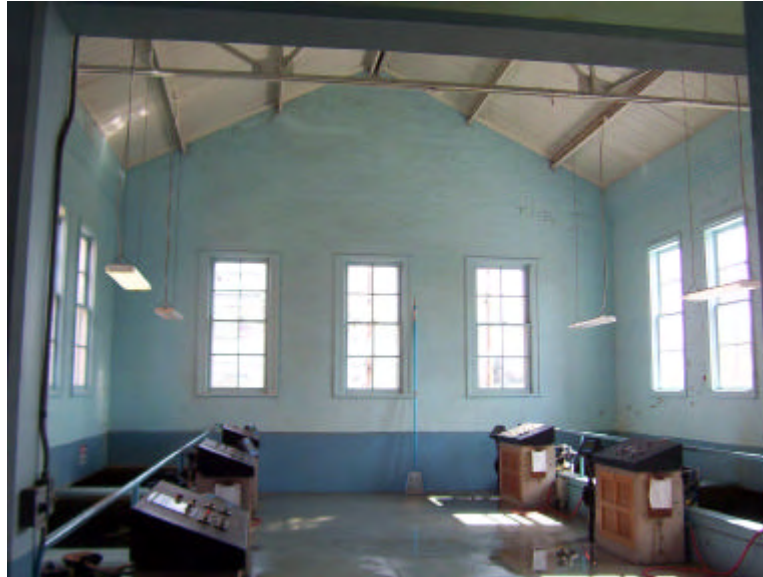
Figure 4.3-2: East wing interior looking east

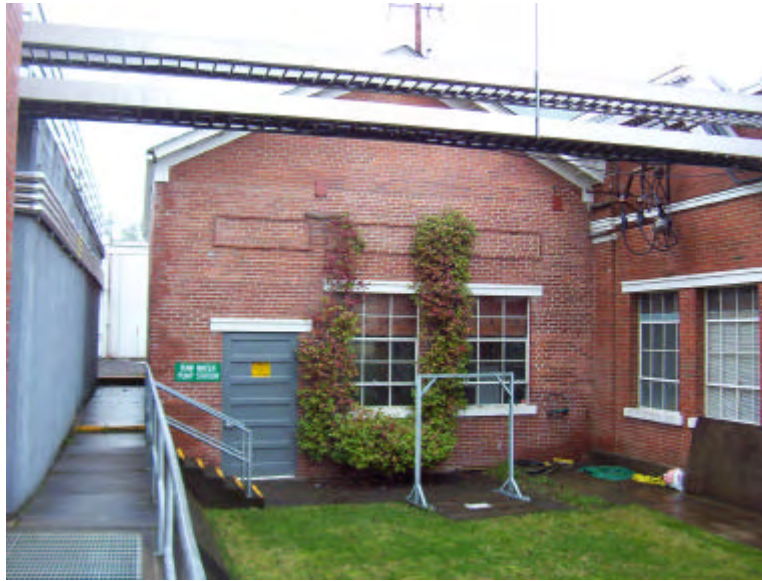
Figure 4.4-1: Raw Water Pumping Station building, east elevation

A portion of the east wall is deficient according to the FEMA criteria, with a DCR of 1.5 for a brick wall “pier” between the entrance door and adjacent window. Note that the other piers in this wall meet the life-safety criteria. Given the configuration of the building, retrofit of the front wall would be difficult. Installation of a braced frame to reduce pier load is not feasible because of the configuration of the door and the location of the basement. It may be possible to shotcrete portions of the wall, which would drive additional load into the roof diaphragm, and also into the common wall with the control building. However, achieving an adequate bond between the new shotcrete and existing brick walls would be questionable because of the limitation on installing anchors in this wall. The mezzanine would have to be removed from the front wall, and the new shotcrete would have to be connected to existing footings. It is estimated that shotcreting this wall and associated footing work could cost \$15,000. Given that the deficiency is limited to one pier, and the difficulty inherent in applying a solution, retrofit of this wall for in-plane loading has not been pursued.

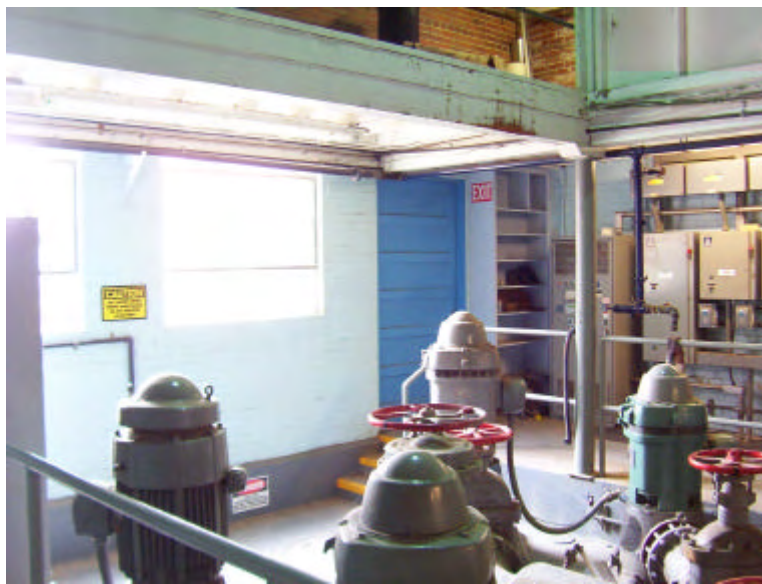
Figure 4.4-2: Interior looking southeast

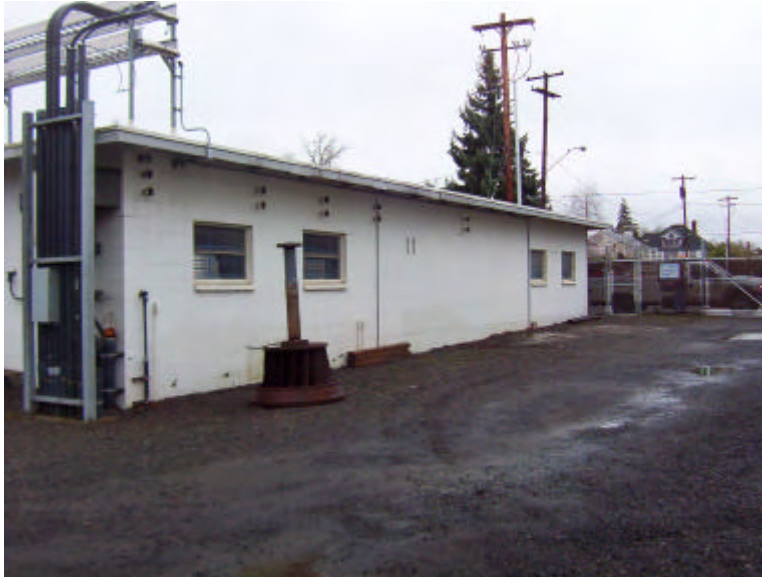
Figure 4.5-1: High Pressure Pumping Plant, west elevation

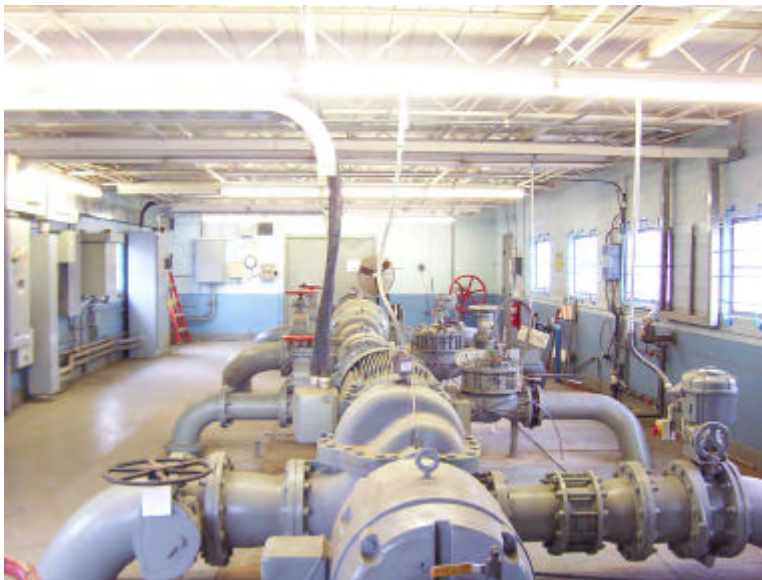
Figure 4.5-2: Interior looking north

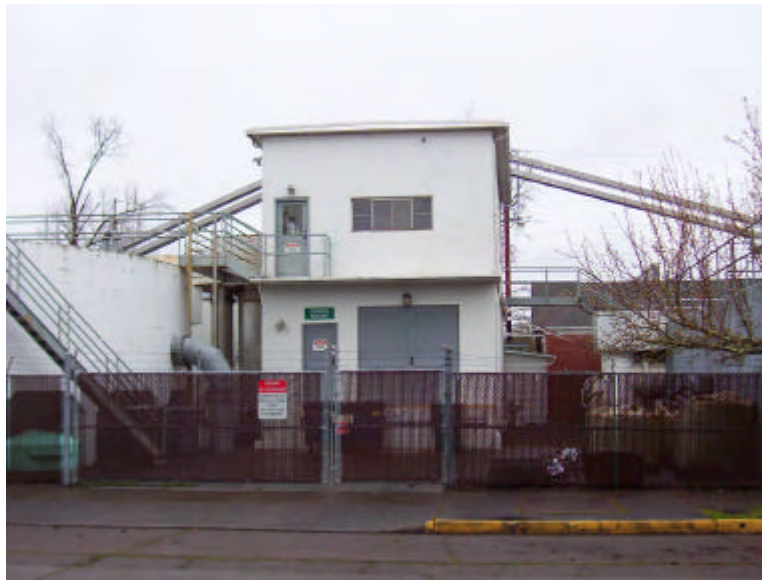
Figure 4.6-1: Chemical building south elevation

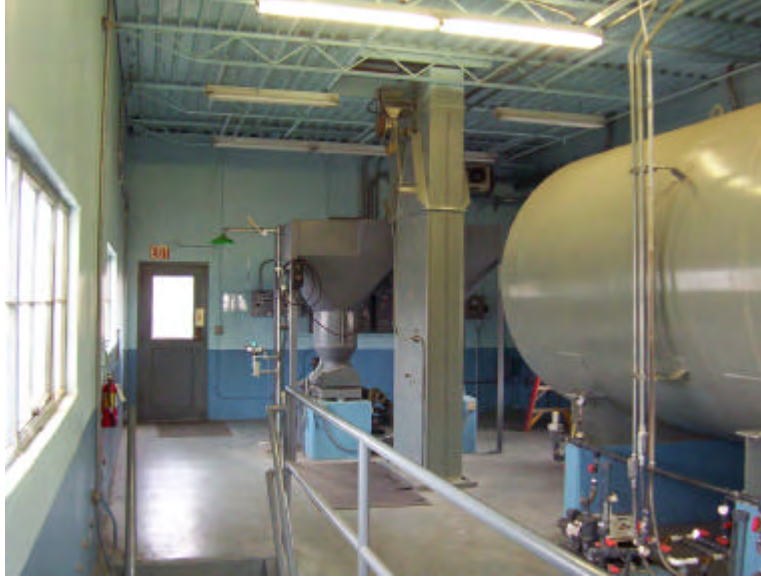
Figure 4.6-2: Interior second floor looking north

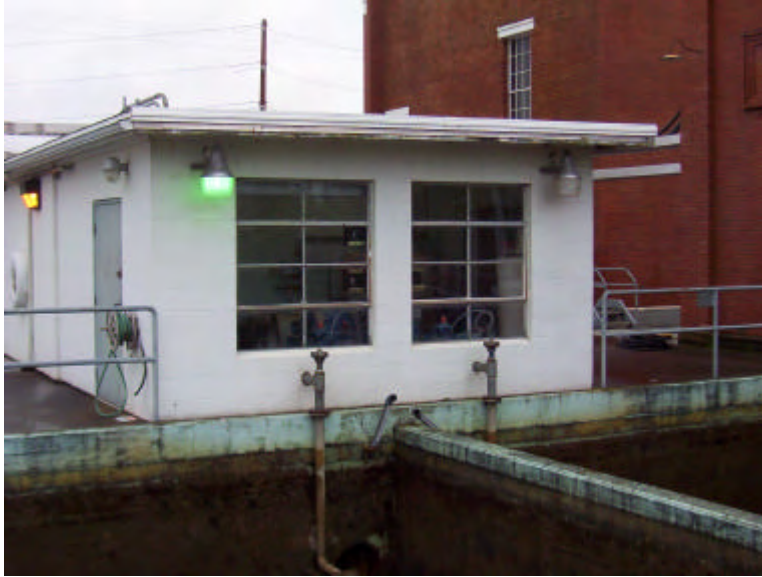
Figure 4.7-1: Large filter building, south elevation

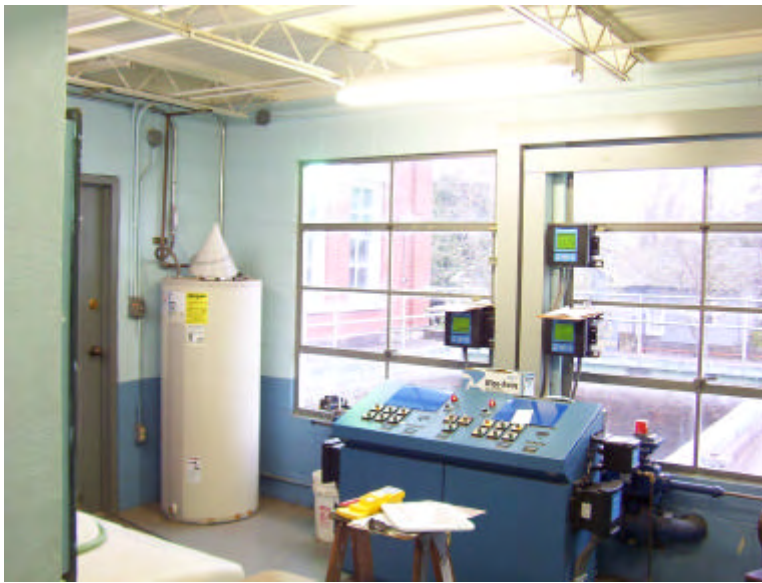
Figure 4.7-2: Interior looking south
