Santiam-Albany Canal Rehabilitation

Bank Stability Analysis

Final

Prepared by:
Otak, Inc.
17355 SW Boones Ferry Rd.
Lake Oswego, OR 97035
Otak Project No. 14079

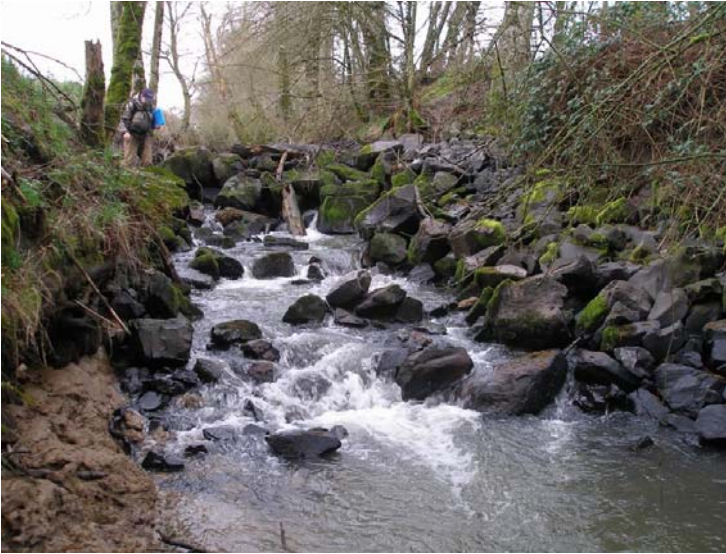
Figure 6: Grade Control Structure Upstream of Fry Road.

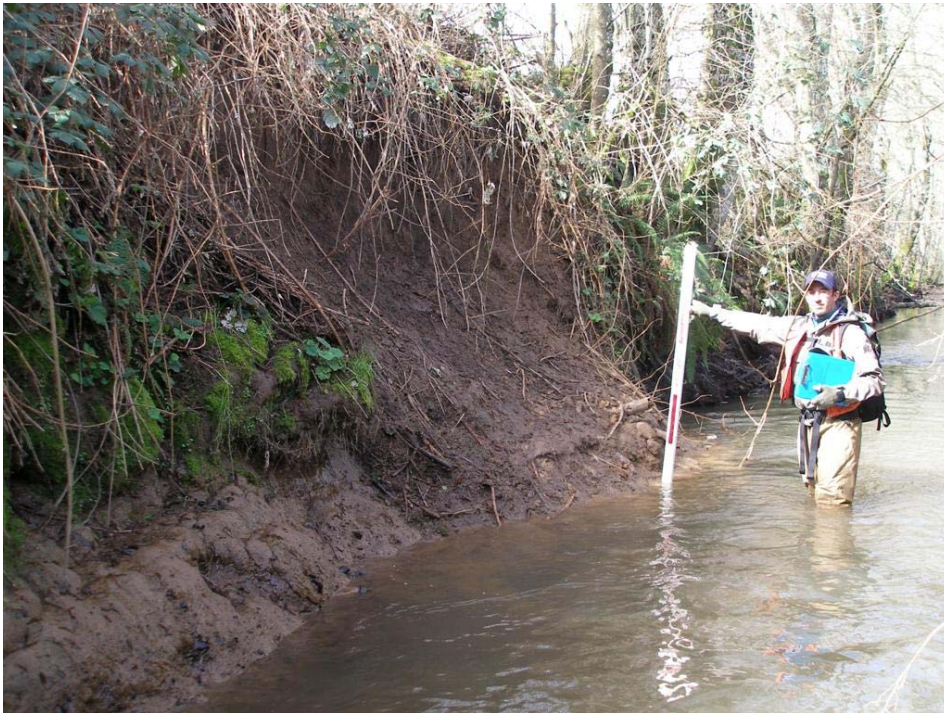
The assumption can be made that the friction angle is zero under fully saturated conditions for cohesive soils, like those found along the canal. Therefore, full saturation is the most likely scenario for geotechnical failure. Overland drainage conditions that promote continuous reaches of bank saturation are prone to failure. Saturated soils exist at approximately 50 percent of the field observed bank failure sites, and significant groundwater seepage exists at 17 percent of those sites. Bank saturation coupled with steep high banks is a primary mechanism of failure along the canal, an example is shown in Figure 14.

Figure 14: Saturated Soils Leading to Bank Failure Near Station 340+00

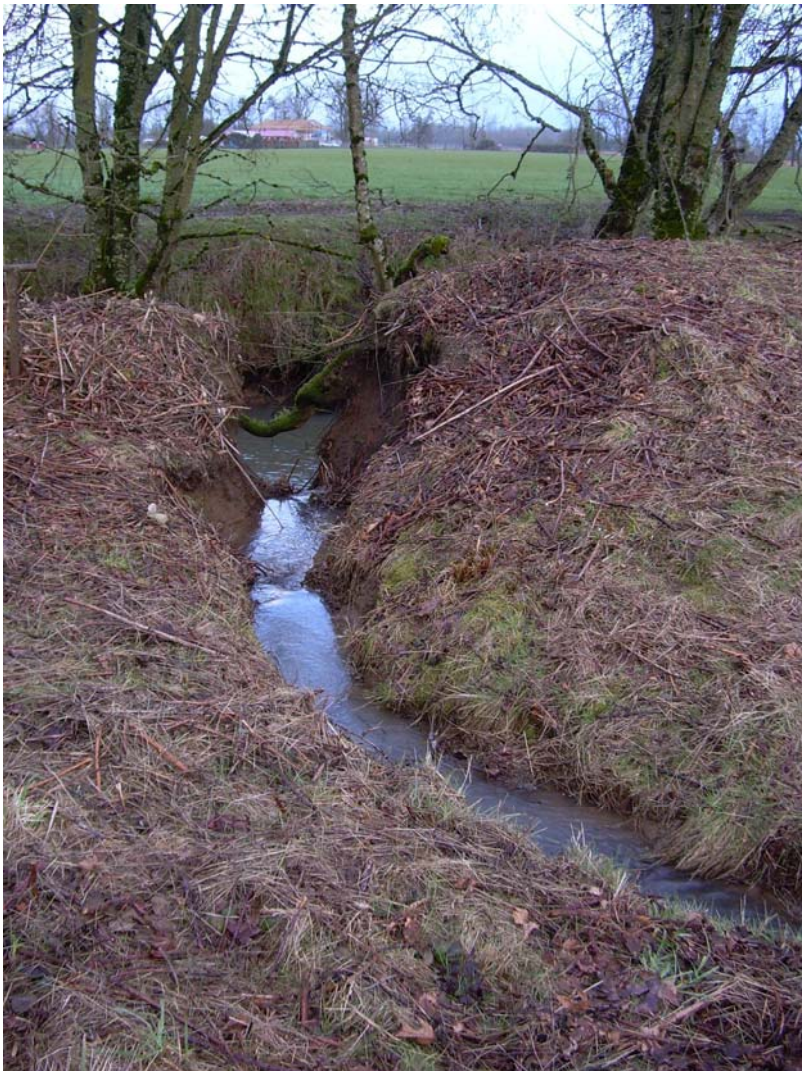
Along the length of the canal overland drainage paths frequently cross the canal. Some of the larger drainages; Cox Creek, Burkhart Creek, and Periwinkle Creek cross under the canal. In other cases overland flow is routed across the canal in above ground pipes. In some instances along the canal overland drainage is allowed to flow directly into the canal (Figure 15). This creates a hazard of creating an overland gully that introduces significant amounts of sediment into the channel and creates localized bank stability problems. Field drainage should be intercepted and routed into the canal at approximately the operational water surface elevations to mitigate the instability at these locations.

Figure 15: Overland Flow Gullying Downstream of Cox Creek Crossing 426+00

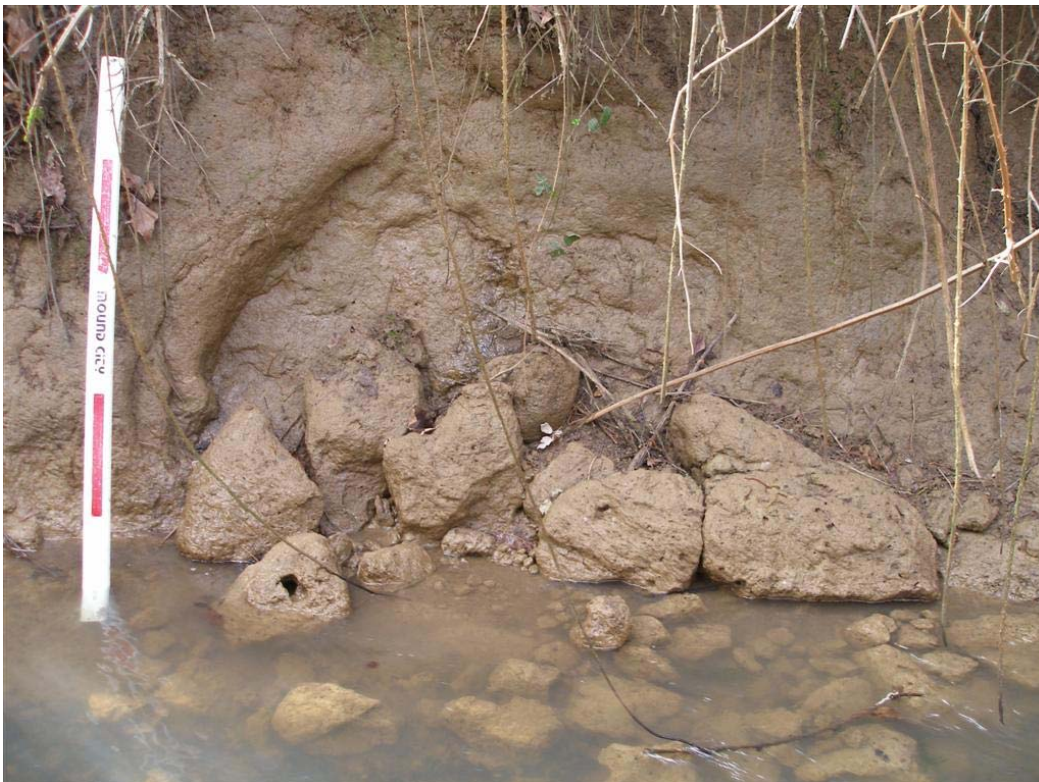
Wetting and drying and freeze/thaw cycles greatly increase potential of failure in cohesive soil banks. Fortunately, the climate of the Willamette Valley is fairly mild, which limits freezing of soils in the area. Freeze/thaw and frost action widens pre-existing cracks and disaggregates surface material (Knighton 1998), acting as a pre-conditioning process for bank failure (Figure 16). Vegetative cover which serves to insulate canal banks from freeze thaw cycles offers the best potential for mitigating this problem.

Figure 16: Disaggregation of Cohesive Bank Material from Freeze/Thaw Action

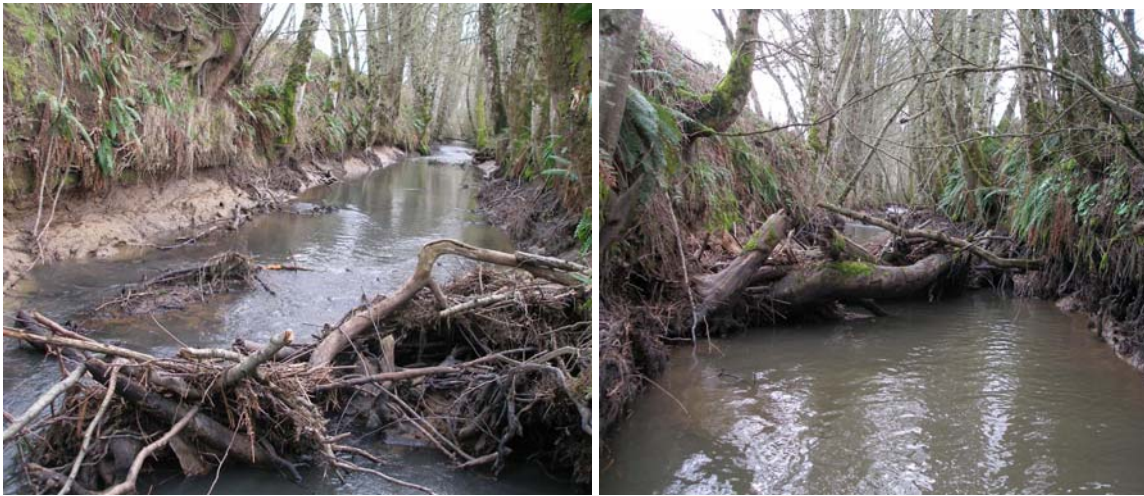
Both of these mechanisms lead to bank failure that introduces both sediment and woody debris into the system. This has severe ramifications for both downstream capacity and flooding issues (Figure 18). These failures can also lead to flow impingement and hydraulic erosion of the opposing stream bank after the wood is introduced into the system.

Figure 18: Debris Introduced Into Canal From Tree Failure Mechanisms

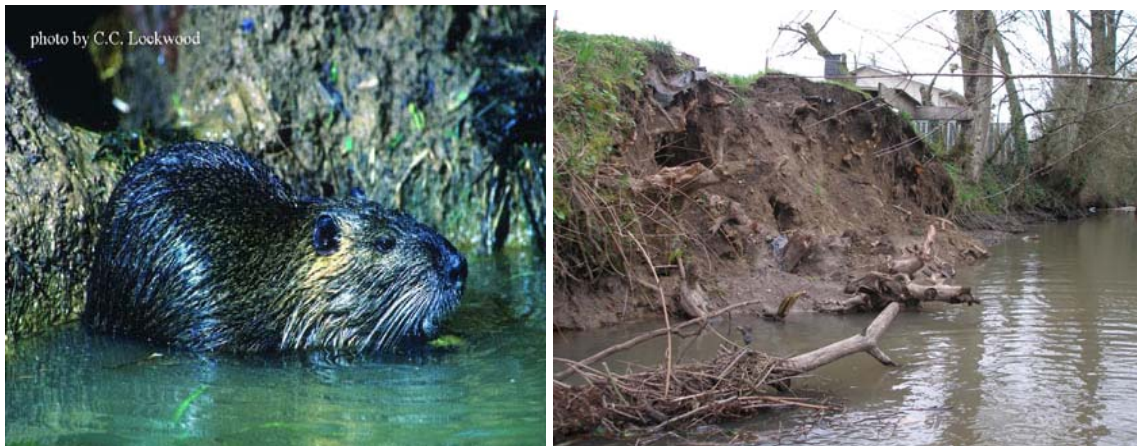
Although nutria damage is prevalent along much of the canal, analysis of the major failures database indicates that burrowing damage was noted at only 6 percent of the major failure locations. This indicates that the nutria damage is certainly a nuisance and one of the causative factors of bank failure, but it is not a major driver of bank stability. Another negative influence of the nutria populations is the negative consequences on water quality from nutria excrement and nematodes that are shed by nutria that lead to skin infections in humans.

A major problem posed by nutria burrows for future canal operating flows is that they will be conduits for seepage flow out of the canal increasing the likelihood of property damage adjacent to the canal when the canal operating flows are augmented.

Figure 19: Nutria and Burrowing Damage Along Bank at Station 22+869

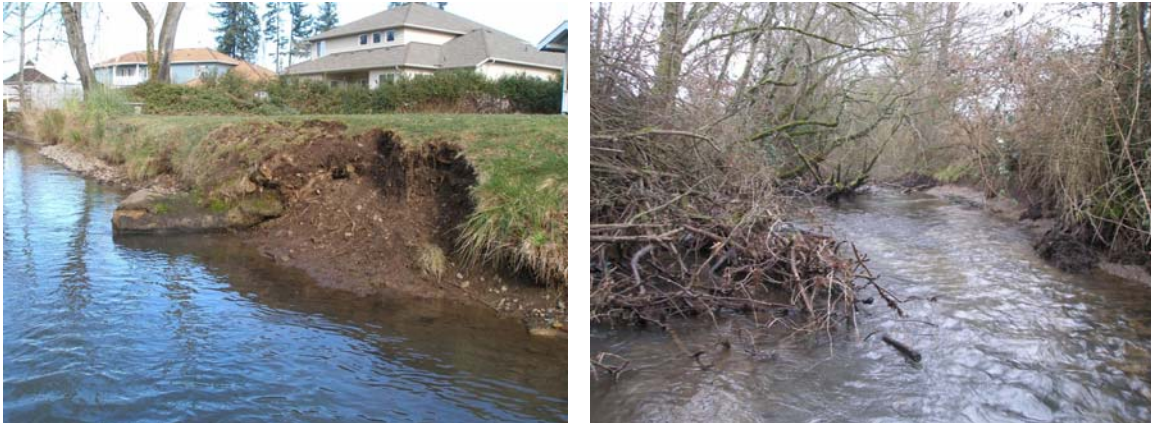
This failure process is common along both the rural and urban portions of the canal (Figure 21). Among the major failure sites, 16 percent of all failure sites introduced debris into the canal that resulted in impinging flow and flow constriction at the failure site. Any debris introduced into the canal should be removed on an annual basis.

Figure 21: Examples of Impinging Flow and Back Eddy Failure Mechanisms

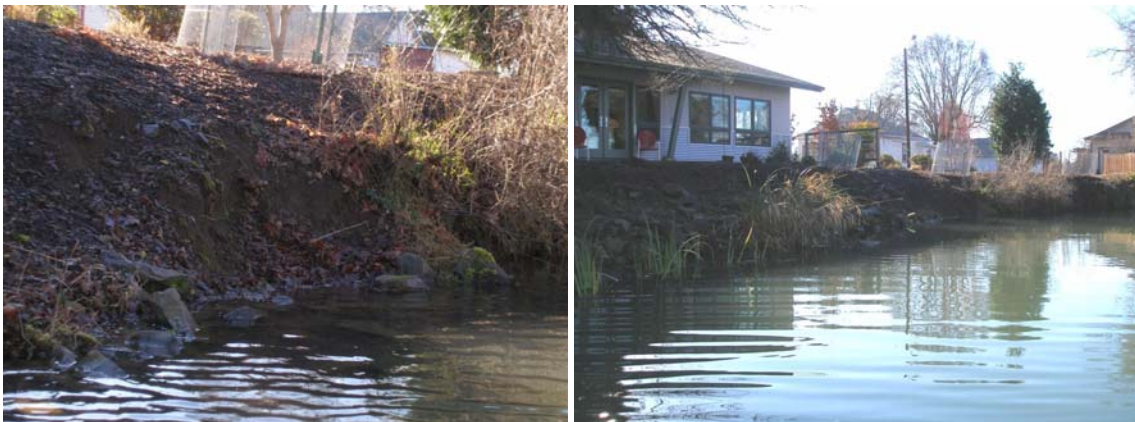
In cases where the canal planform geometry makes sharp bends, erosion will often occur on the outside of the bend. This is due to both accelerated velocities on the outside of the bend and secondary currents that are set up by helical flow patterns typically present in bends. Sharp bends are not common on the canal and thus bend scour is a minor mechanism for bank failure along the canal. One example of bend scour failure is shown in Figure 22.

Figure 22: Bend scour present near station 702+60

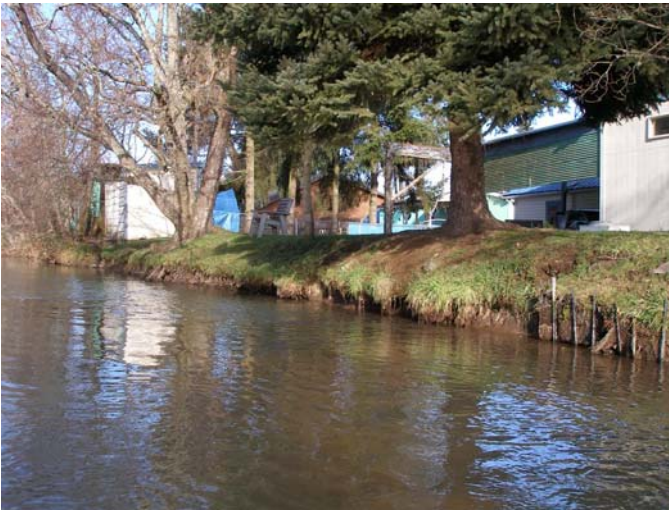
There are many instances along the canal particularly in the urban Lebanon area where bank slump has occurred on banks with fairly low bank height (~4 ft). One potential cause of this failure mechanism is the layered bank stratigraphy associated with residential lawns that result in differing resistance to erosion and wetting/drying cycles. The vegetation provides reinforcement and resistance to erosion. Whereas the underlying layer is subject to wetting/drying and freeze/thaw cycles that weaken the soil structure below the grassy vegetation. The non-vegetated portion of the bank sloughs into the channel and that material is carried away by hydraulic forces, leaving an over-hanging grassy bank that fails by cantilever mechanism. Examples of this mechanism are shown in Figures 23 and 24.

Figure 23: Bank slough failure near station 797+13

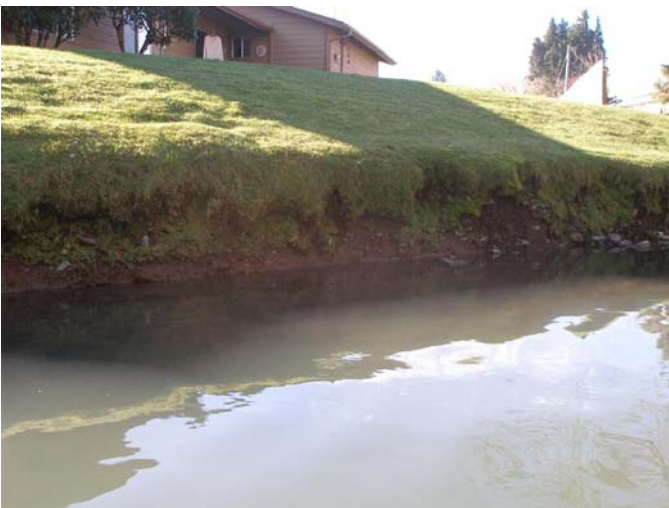
Figure 24: Bank slough failure near station 724+62

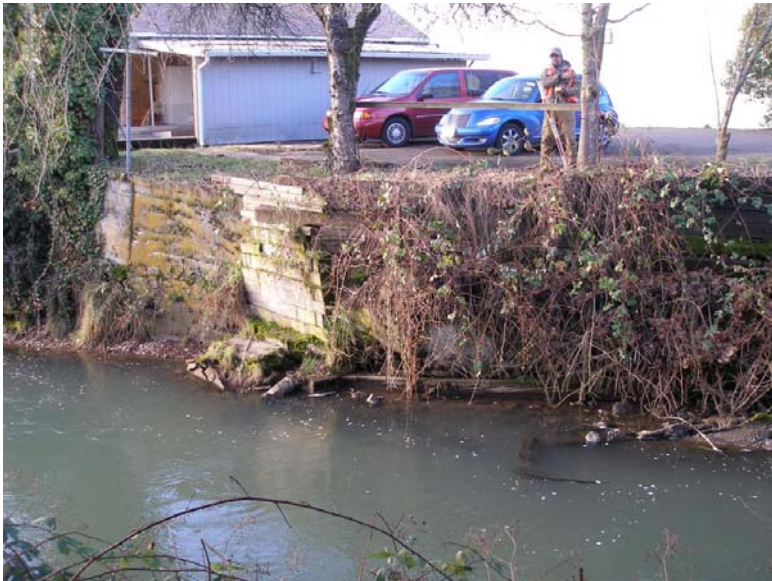
In some cases canal bank failures occur in areas that have been protected previously. These areas are usually retaining walls or revetments that have reached the end of their design life spans. This type of failure typically occurs in the urban portions of the canal in Lebanon and Albany. In some instances rooting from mature trees causes the bank instability; whereas, in other areas, the present infrastructure quality does not meet design criteria for functionality, aesthetics or safety. Examples are shown in Figures 25 and 26.

Figure 25: Failed retaining wall in Lebanon near station 771+45

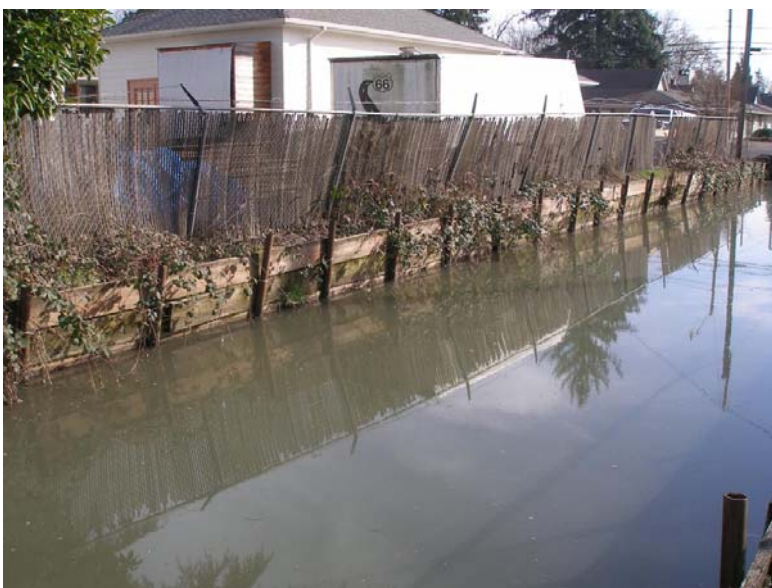
Figure 26: Inadequate Retaining Wall in Albany Station 3+38
