# HAZARDOUS MATERIALS SURVEY REPORT

**City of Albany – 301 W. 1<sup>st</sup> Avenue**  
300 West 1<sup>st</sup> Avenue NW  
Albany, OR 97321

**Inspection Dates:** August 3 & 5, 2021  
**Report Prepared:** August 13, 2021

TRC Project Number: 455185

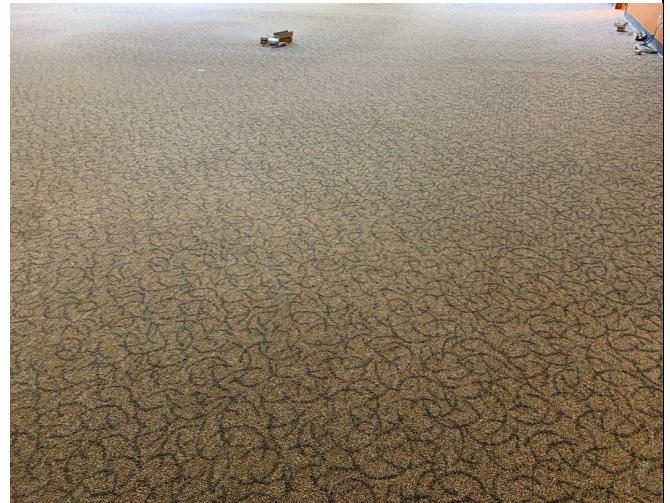
**Sample Numbers:** FB-01A, FB-01B, FB-01C  
**Material Description:** Carpet Glue  
**Material Color:** Not Indicated  
**Accessible Material:** Accessible  
**Reason Inaccessible:** N/A  
**Asbestos Detected:** Negative  
**Asbestos Type:** No Asbestos Detected  
**Homogeneous Area:** Throughout  
**Total Approximate Quantity:** 9898 SF  
**Condition:** Good  
**Material Type:** Misc.  
**NESHAP Category:** N/A  
**Notes:** Not Applicable

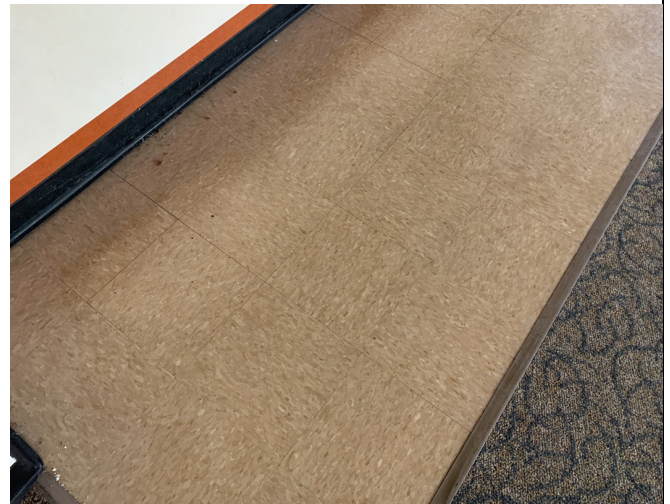
**Sample Numbers:** FB-02A, FB-02B, FB-02C  
**Material Description:** 12" X 12" Floor Tile & Associated Glue  
**Material Color:** Not Indicated  
**Accessible Material:** Accessible  
**Reason Inaccessible:** N/A  
**Asbestos Detected:** Negative  
**Asbestos Type:** No Asbestos Detected  
**Homogeneous Area:** Teller Row  
**Total Approximate Quantity:** 100 SF  
**Condition:** Good  
**Material Type:** Misc.  
**NESHAP Category:** N/A  
**Notes:** Not Applicable

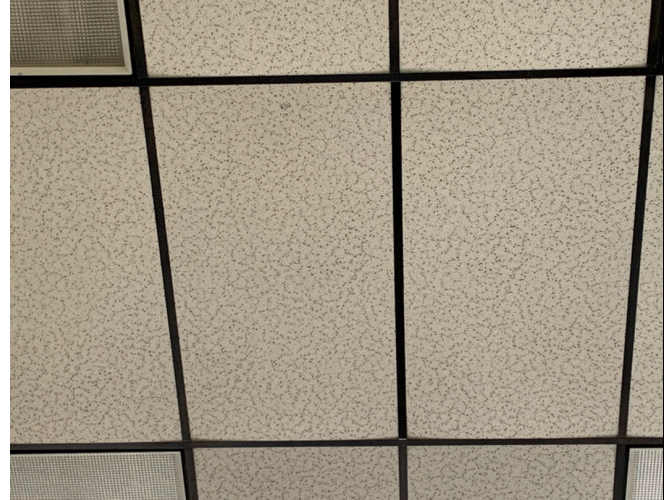
**Sample Numbers:** FB-03A, FB-03B, FB-03C  
**Material Description:** 2' X 4' Drop-in Ceiling Tile (Pinholes & Fissures)  
**Material Color:** Not Indicated  
**Accessible Material:** Accessible  
**Reason Inaccessible:** N/A  
**Asbestos Detected:** Negative  
**Asbestos Type:** No Asbestos Detected  
**Homogeneous Area:** Throughout 2nd Floor  
**Total Approximate Quantity:** 4949 SF  
**Condition:** Good  
**Material Type:** Misc.  
**NESHAP Category:** N/A  
**Notes:** Not Applicable

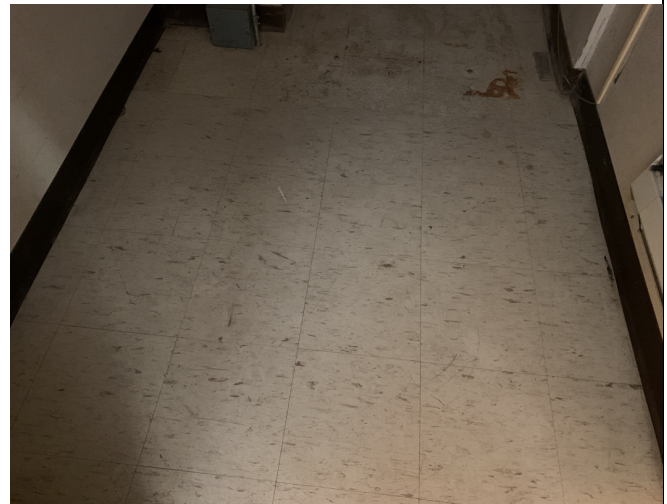
**Sample Numbers:** FB-04A, FB-04B, FB-04C  
**Material Description:** 12" X 12" Floor Tile & Associated Glue  
**Material Color:** Not Indicated  
**Accessible Material:** Accessible  
**Reason Inaccessible:** N/A  
**Asbestos Detected:** Positive  
**Asbestos Type:** Tile - 3% Chrysotile  
 Glue - 10% Chrysotile  
**Homogeneous Area:** Throughout Building  
**Total Approximate Quantity:** 9898 SF  
**Condition:** Good  
**Material Type:** Misc.  
**NESHAP Category:** Cat I  
**Notes:** Not Applicable

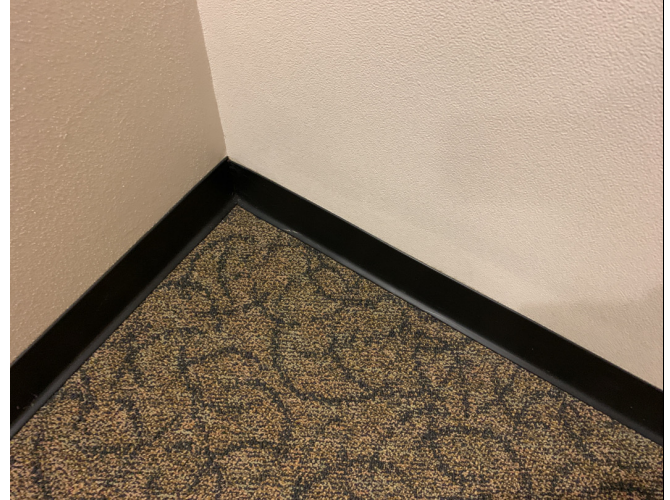
**Sample Numbers:** FB-05A, FB-05B, FB-05C  
**Material Description:** Cove Base With Adhesive  
**Material Color:** Not Indicated  
**Accessible Material:** Accessible  
**Reason Inaccessible:** N/A  
**Asbestos Detected:** Negative  
**Asbestos Type:** No Asbestos Detected  
**Homogeneous Area:** Throughout  
**Total Approximate Quantity:** 500 LF  
**Condition:** Good  
**Material Type:** Misc.  
**NESHAP Category:** N/A  
**Notes:** Not Applicable

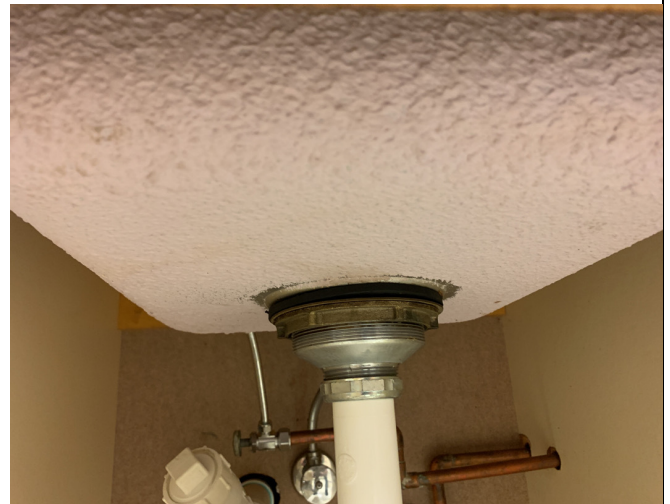
**Sample Numbers:** FB-06A, FB-06B, FB-06C  
**Material Description:** Sink Undercoat  
**Material Color:** Not Indicated  
**Accessible Material:** Accessible  
**Reason Inaccessible:** N/A  
**Asbestos Detected:** Positive  
**Asbestos Type:** 10% Chrysotile  
**Homogeneous Area:** 2nd Floor Break Room  
**Total Approximate Quantity:** 1 Each  
**Condition:** N/A  
**Material Type:** N/A  
**NESHAP Category:** Cat II  
**Notes:** Not Applicable

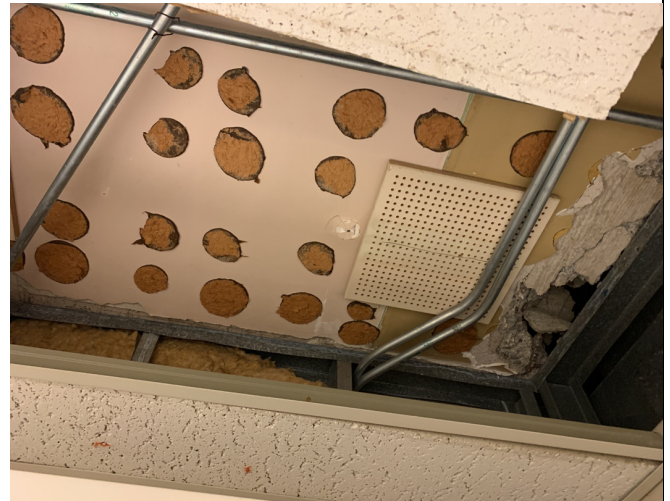
**Sample Numbers:** FB-07A, FB-07B, FB-07C  
**Material Description:** 1' X 1' Glued-on Ceiling Tile & Associated Glue  
**Material Color:** Not Indicated  
**Accessible Material:** Accessible  
**Reason Inaccessible:** N/A  
**Asbestos Detected:** Negative  
**Asbestos Type:** No Asbestos Detected  
**Homogeneous Area:** 2nd Floor, Above Drop-in Ceiling Tiles  
**Total Approximate Quantity:** 4949 SF  
**Condition:** Significantly Damaged  
**Material Type:** Misc.  
**NESHAP Category:** N/A  
**Notes:** Not Applicable

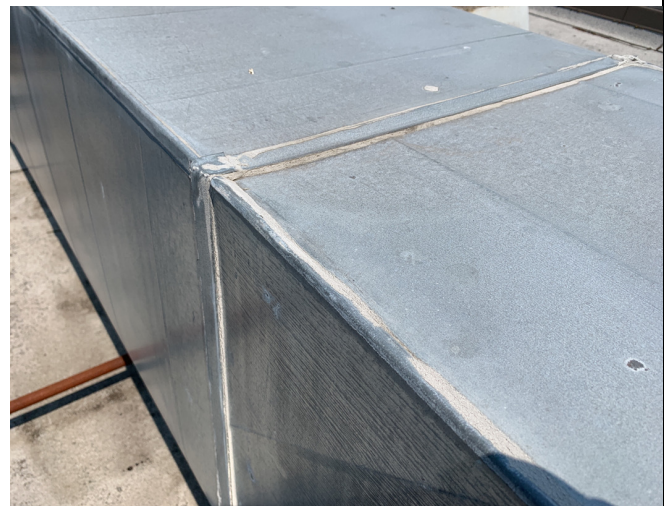
**Sample Numbers:** FB-08A, FB-08B, FB-08C  
**Material Description:** HVAC Caulking  
**Material Color:** Not Indicated  
**Accessible Material:** Accessible  
**Reason Inaccessible:** N/A  
**Asbestos Detected:** Negative  
**Asbestos Type:** No Asbestos Detected  
**Homogeneous Area:** Roof HVAC Duct Work  
**Total Approximate Quantity:** 300 LF  
**Condition:** Good  
**Material Type:** Misc.  
**NESHAP Category:** N/A  
**Notes:** Not Applicable

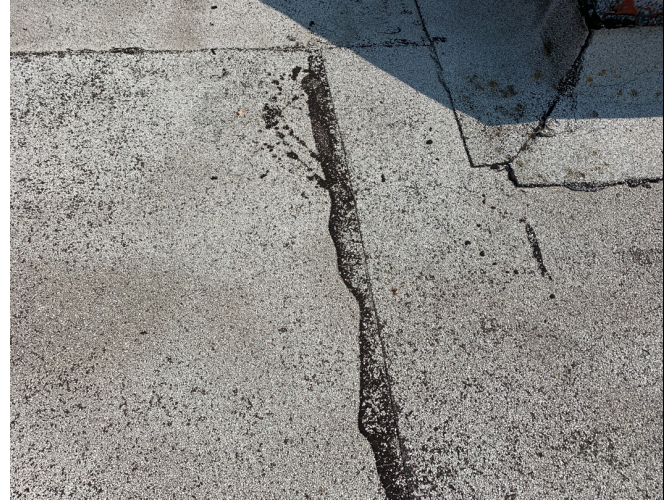
**Sample Numbers:** FB-09A, FB-09B, FB-09C  
**Material Description:** Roof Mastic  
**Material Color:** Not Indicated  
**Accessible Material:** Accessible  
**Reason Inaccessible:** N/A  
**Asbestos Detected:** Negative  
**Asbestos Type:** No Asbestos Detected  
**Homogeneous Area:** Roof  
**Total Approximate Quantity:** 100 SF  
**Condition:** Good  
**Material Type:** Misc.  
**NESHAP Category:** N/A  
**Notes:** Not Applicable

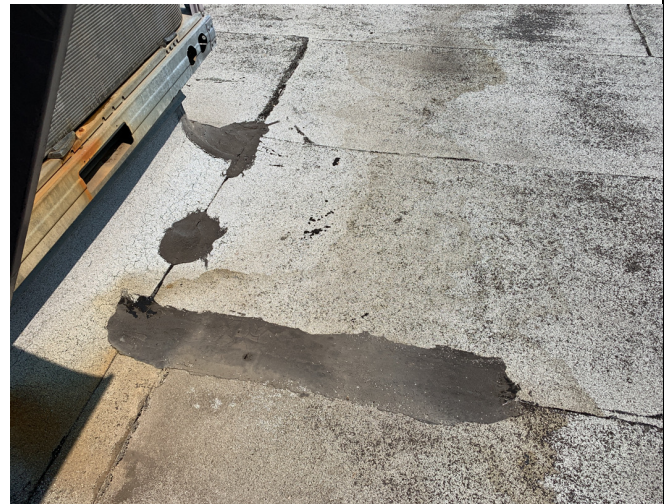
**Sample Numbers:** FB-10A, FB-10B, FB-10C  
**Material Description:** Roof Patch  
**Material Color:** Not Indicated  
**Accessible Material:** Accessible  
**Reason Inaccessible:** N/A  
**Asbestos Detected:** Negative  
**Asbestos Type:** No Asbestos Detected  
**Homogeneous Area:** Roof  
**Total Approximate Quantity:** 100 SF  
**Condition:** Good  
**Material Type:** Misc.  
**NESHAP Category:** N/A  
**Notes:** Not Applicable

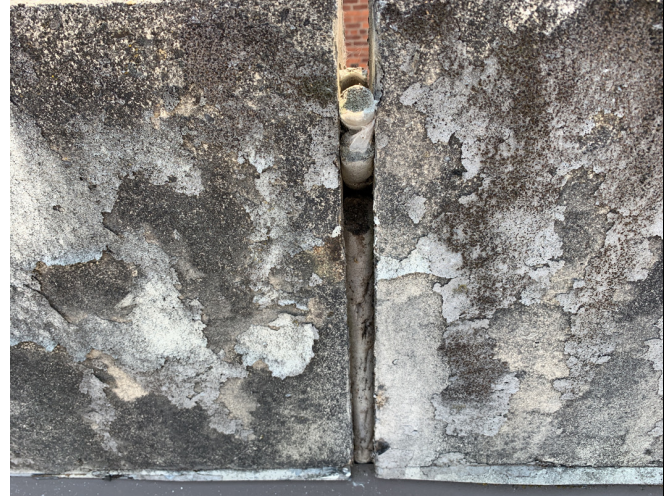
**Sample Numbers:** FB-11A, FB-11B, FB-11C  
**Material Description:** Roof Parapet Expansion Caulking  
**Material Color:** Not Indicated  
**Accessible Material:** Accessible  
**Reason Inaccessible:** N/A  
**Asbestos Detected:** Negative  
**Asbestos Type:** No Asbestos Detected  
**Homogeneous Area:** Roof Perimeter  
**Total Approximate Quantity:** 1000 LF  
**Condition:** Damaged  
**Material Type:** Misc.  
**NESHAP Category:** N/A  
**Notes:** Not Applicable

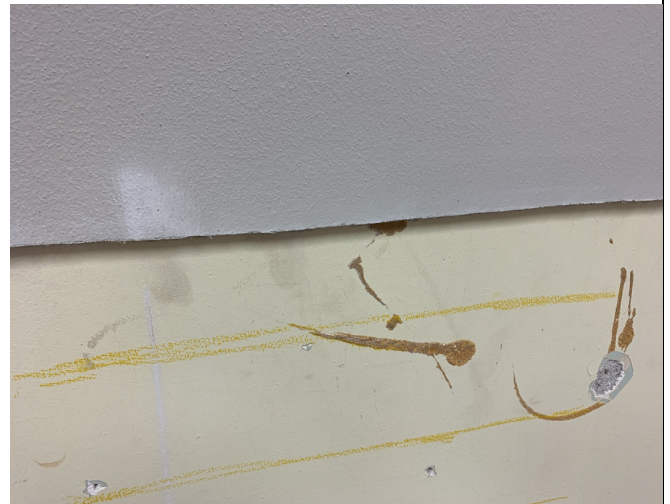
**Sample Numbers:** FB-12A, FB-12B, FB-12C  
**Material Description:** Gypsum Board And Associated Glue  
**Material Color:** Not Indicated  
**Accessible Material:** Accessible  
**Reason Inaccessible:** N/A  
**Asbestos Detected:** Negative  
**Asbestos Type:** No Asbestos Detected  
**Homogeneous Area:** 2nd Floor Walls  
**Total Approximate Quantity:** 3000 SF  
**Condition:** Good  
**Material Type:** Misc.  
**NESHAP Category:** N/A  
**Notes:** Not Applicable

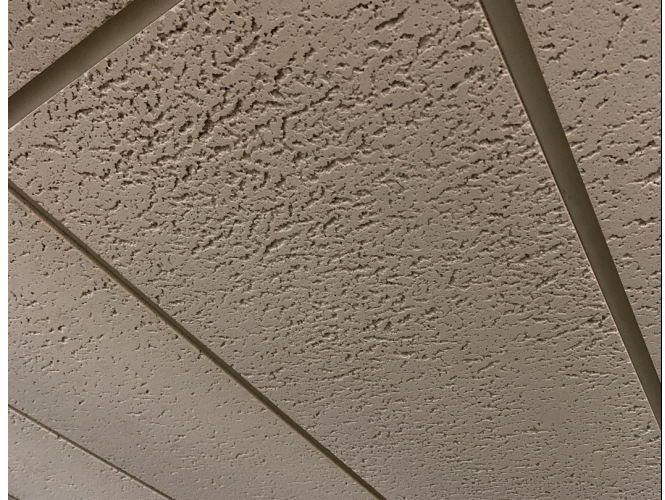
**Sample Numbers:** FB-13A, FB-13B, FB-13C  
**Material Description:** 2' X 4' Drop-in Ceiling Tile (Fissures & Silver Paper Backing)  
**Material Color:** Not Indicated  
**Accessible Material:** Accessible  
**Reason Inaccessible:** N/A  
**Asbestos Detected:** Negative  
**Asbestos Type:** No Asbestos Detected  
**Homogeneous Area:** 1st Floor  
**Total Approximate Quantity:** 4000 SF  
**Condition:** Good  
**Material Type:** Misc.  
**NESHAP Category:** N/A  
**Notes:** Not Applicable

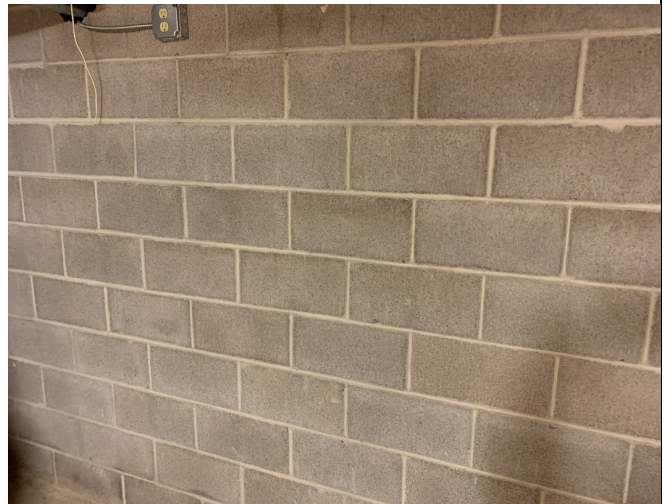
**Sample Numbers:** FB-14A, FB-14B, FB-14C  
**Material Description:** CMU Grout  
**Material Color:** Not Indicated  
**Accessible Material:** Accessible  
**Reason Inaccessible:** N/A  
**Asbestos Detected:** Negative  
**Asbestos Type:** No Asbestos Detected  
**Homogeneous Area:** Basement  
**Total Approximate Quantity:** 130 SF  
**Condition:** Good  
**Material Type:** Misc.  
**NESHAP Category:** N/A  
**Notes:** Not Applicable

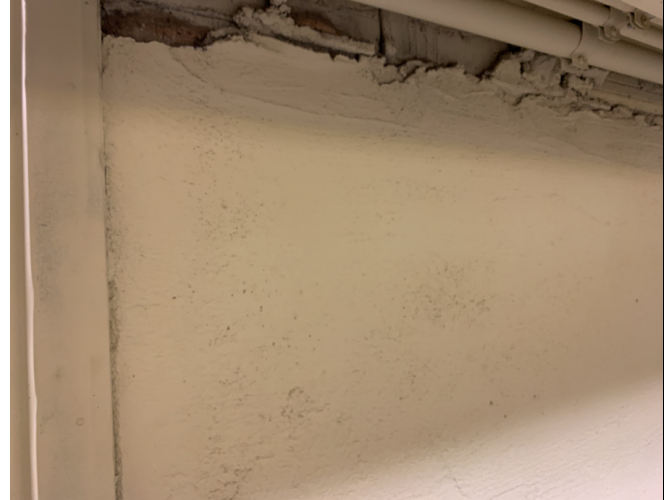
**Sample Numbers:** FB-15A, FB-15B, FB-15C, FB-15D, FB-15E  
**Material Description:** Plaster Skim Coat With Base Coat  
**Material Color:** Not Indicated  
**Accessible Material:** Accessible  
**Reason Inaccessible:** N/A  
**Asbestos Detected:** Negative  
**Asbestos Type:** No Asbestos Detected  
**Homogeneous Area:** Basement  
**Total Approximate Quantity:** 3000 SF  
**Condition:** Good  
**Material Type:** Surfacing  
**NESHAP Category:** N/A  
**Notes:** Not Applicable

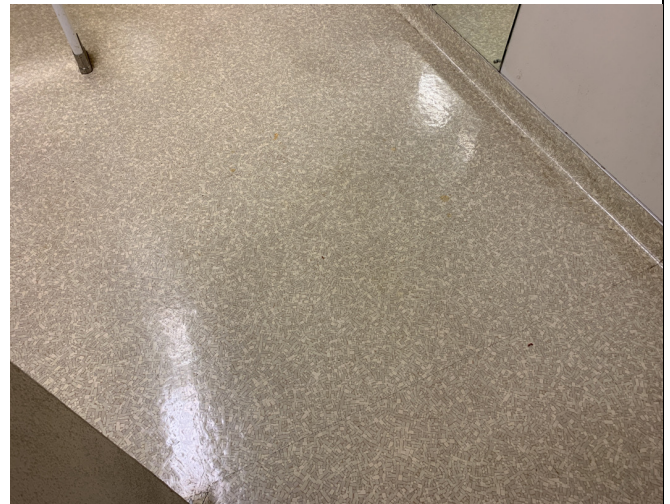
**Sample Numbers:** FB-16A, FB-16B, FB-16C  
**Material Description:** Sheet Vinyl Flooring & Associated Glue  
**Material Color:** Not Indicated  
**Accessible Material:** Accessible  
**Reason Inaccessible:** N/A  
**Asbestos Detected:** Positive  
**Asbestos Type:** S.V.F. - 80% Chrysotile  
 Glue - ND  
**Homogeneous Area:** Restrooms  
**Total Approximate Quantity:** 324 SF  
**Condition:** Good  
**Material Type:** Misc.  
**NESHAP Category:** RACM  
**Notes:** Not Applicable

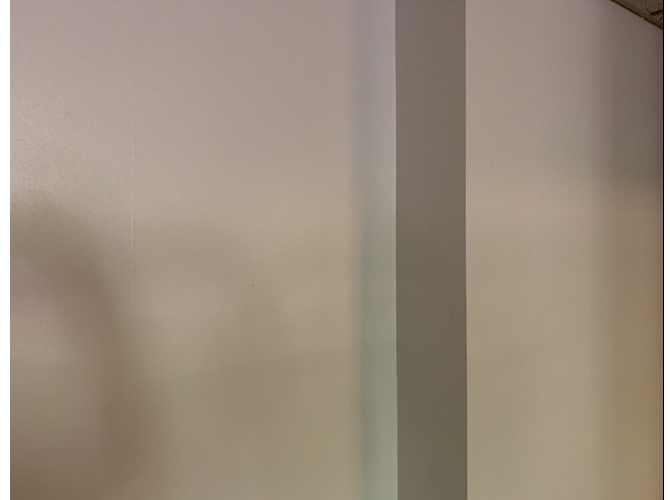
**Sample Numbers:** FB-17A, FB-17B, FB-17C  
**Material Description:** Wallboard Gypsum With Joint Compound  
**Material Color:** Not Indicated  
**Accessible Material:** Accessible  
**Reason Inaccessible:** N/A  
**Asbestos Detected:** Negative  
**Asbestos Type:** No Asbestos Detected  
**Homogeneous Area:** Throughout Building  
**Total Approximate Quantity:** 9000 SF  
**Condition:** Good  
**Material Type:** Misc.  
**NESHAP Category:** N/A  
**Notes:** Not Applicable

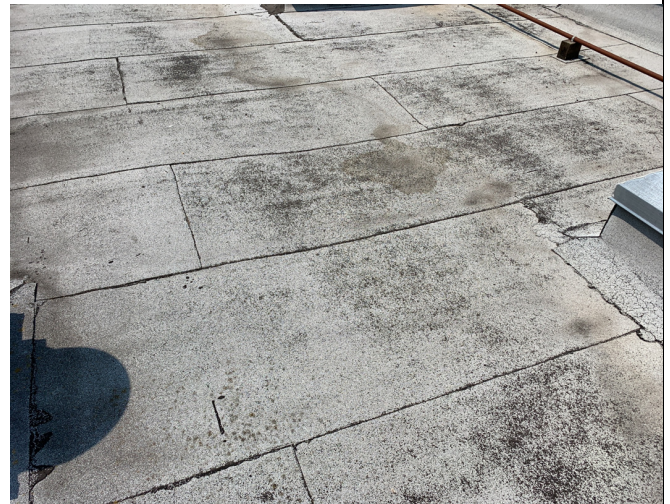
**Sample Numbers:** FB-18A, FB-18B, FB-18C  
**Material Description:** Built-up Roofing  
**Material Color:** Not Indicated  
**Accessible Material:** Accessible  
**Reason Inaccessible:** N/A  
**Asbestos Detected:** Negative  
**Asbestos Type:** No Asbestos Detected  
**Homogeneous Area:** Roof  
**Total Approximate Quantity:** 4949 SF  
**Condition:** Good  
**Material Type:** Misc.  
**NESHAP Category:** N/A  
**Notes:** Not Applicable

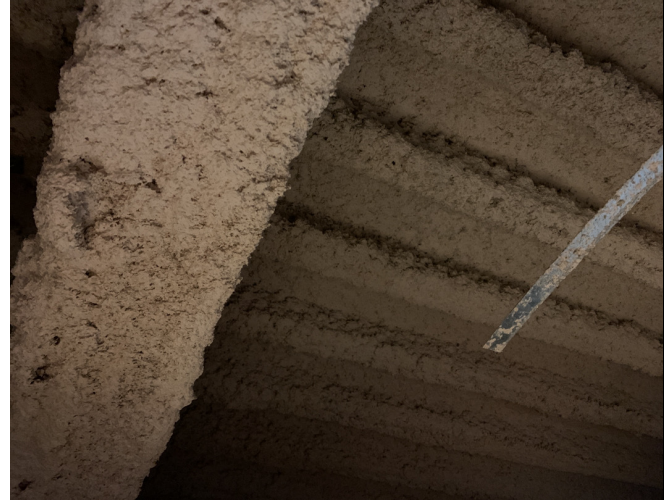
**Sample Numbers:** FB-19A, FB-19B, FB-19C, FB-19D, FB-19E, FB-19F, FB-19G  
**Material Description:** Spray Applied Fireproofing  
**Material Color:** Not Indicated  
**Accessible Material:** Accessible  
**Reason Inaccessible:** N/A  
**Asbestos Detected:** Negative  
**Asbestos Type:** No Asbestos Detected  
**Homogeneous Area:** Above Ceiling Tiles  
**Total Approximate Quantity:** 9898 SF  
**Condition:** Good  
**Material Type:** Surfacing  
**NESHAP Category:** N/A  
**Notes:** Not Applicable

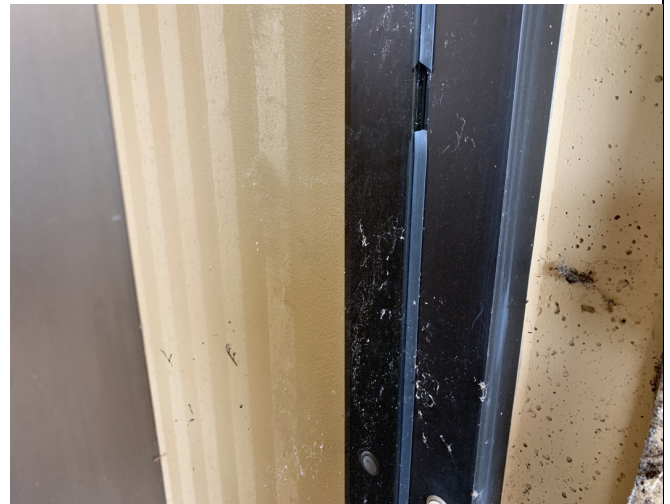
**Sample Numbers:** FB-20A, FB-20B, FB-20C  
**Material Description:** Window Caulking  
**Material Color:** Not Indicated  
**Accessible Material:** Accessible  
**Reason Inaccessible:** N/A  
**Asbestos Detected:** Negative  
**Asbestos Type:** No Asbestos Detected  
**Homogeneous Area:** Exterior Windows  
**Total Approximate Quantity:** 500 LF  
**Condition:** Good  
**Material Type:** Misc.  
**NESHAP Category:** N/A  
**Notes:** Not Applicable

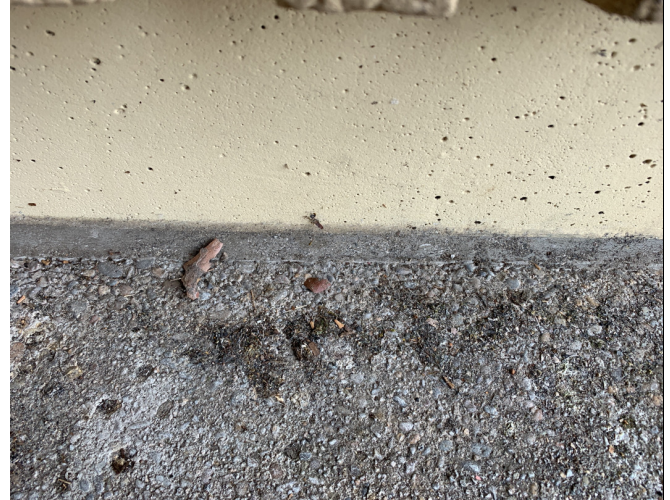
**Sample Numbers:** FB-21A, FB-21B, FB-21C  
**Material Description:** Perimeter Caulking  
**Material Color:** Not Indicated  
**Accessible Material:** Accessible  
**Reason Inaccessible:** N/A  
**Asbestos Detected:** Negative  
**Asbestos Type:** No Asbestos Detected  
**Homogeneous Area:** Exterior Perimeter Base  
**Total Approximate Quantity:** 300 LF  
**Condition:** Good  
**Material Type:** Misc.  
**NESHAP Category:** N/A  
**Notes:** Not Applicable

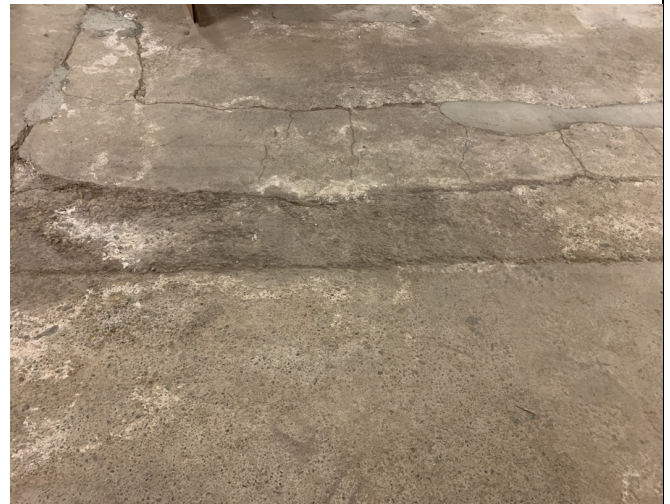
**Sample Numbers:** FB-22A, FB-22B, FB-22C  
**Material Description:** Concrete  
**Material Color:** Not Indicated  
**Accessible Material:** Accessible  
**Reason Inaccessible:** N/A  
**Asbestos Detected:** Negative  
**Asbestos Type:** No Asbestos Detected  
**Homogeneous Area:** Throughout  
**Total Approximate Quantity:** 15000 SF  
**Condition:** Good  
**Material Type:** Misc.  
**NESHAP Category:** N/A  
**Notes:** Not Applicable

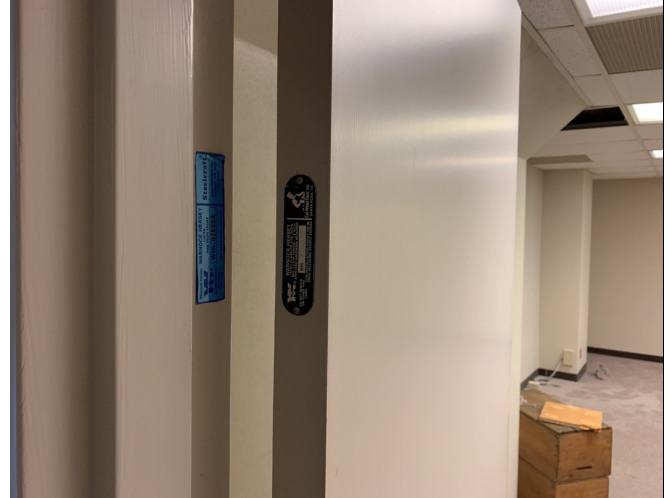
**Sample Numbers:** N/A  
**Material Description:** Fire Doors  
**Material Color:** Not Indicated  
**Accessible Material:** Inaccessible  
**Reason Inaccessible:** No Access  
**Asbestos Detected:** N/A  
**Asbestos Type:** N/A  
**Homogeneous Area:** Throughout  
**Total Approximate Quantity:** 29 Each  
**Condition:** Good  
**Material Type:** Misc.  
**NESHAP Category:** N/A  
**Notes:** Not Applicable

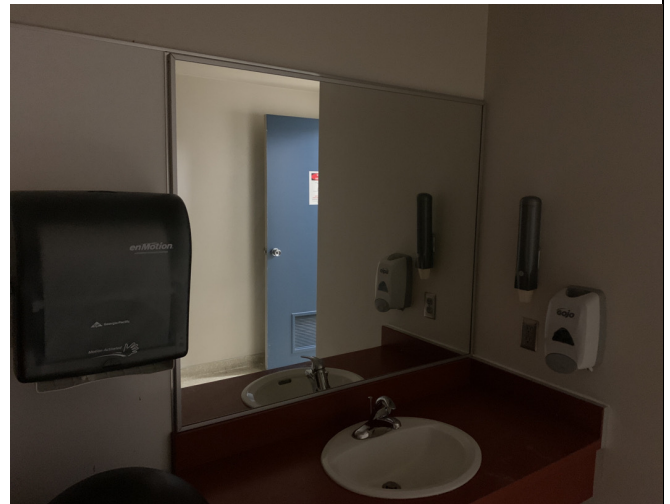
**Sample Numbers:** N/A  
**Material Description:** Mirror Glue  
**Material Color:** Not Indicated  
**Accessible Material:** Inaccessible  
**Reason Inaccessible:** No Access  
**Asbestos Detected:** N/A  
**Asbestos Type:** N/A  
**Homogeneous Area:** Restrooms  
**Total Approximate Quantity:** 4 Each  
**Condition:** Good  
**Material Type:** Misc.  
**NESHAP Category:** N/A  
**Notes:** Not Applicable

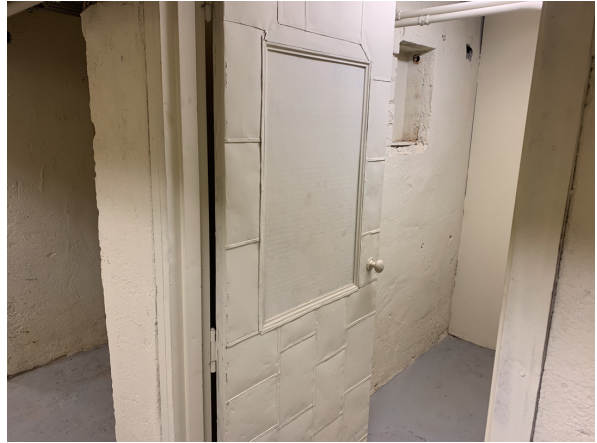
**Sample Numbers:** FB-L-01  
**Sample Location:** Basement  
**Description:** White Panel Metal Door  
**Laboratory Result (%):**22.6%  
**Substrate:** Metal  
**Paint Locations:** Basement Door & Case  
**Quantity of Deteriorated Paint (SF):** 50

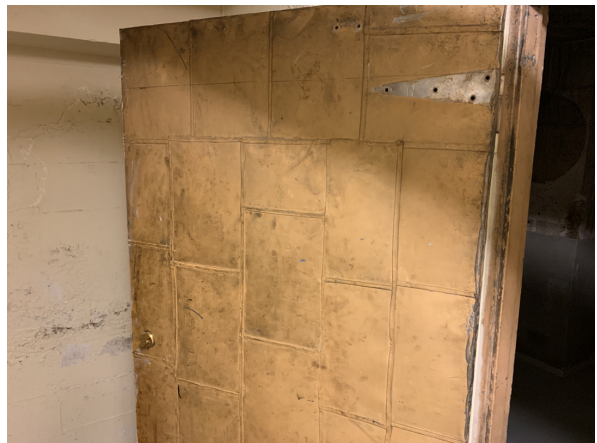
**Sample Numbers:** FB-L-02  
**Sample Location:** Basement Door  
**Description:** Beige Panel Metal Door  
**Laboratory Result (%):**35.7%  
**Substrate:** Metal  
**Paint Locations:** Basement Door & Case  
**Quantity of Deteriorated Paint (SF):** 50

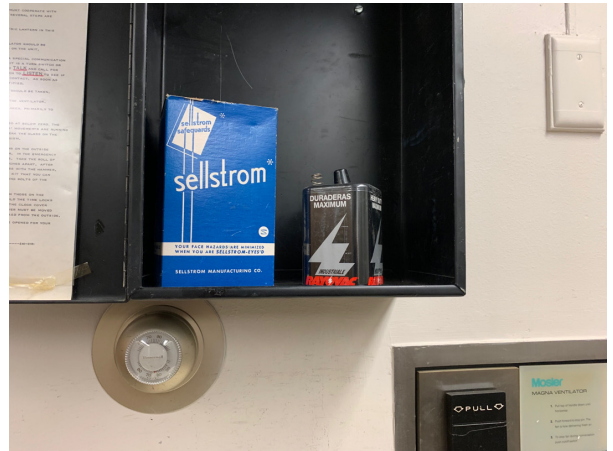
**Area:** 300 W. 1st Avenue  
**Description:** Miscellaneous Batteries  
**Quantity:** 3  
**Notes:** N/A

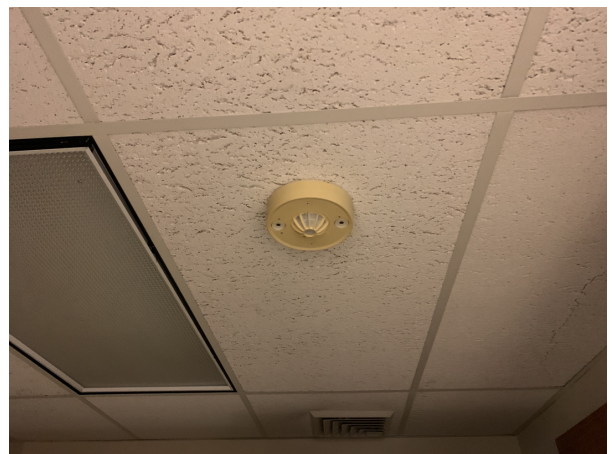
**Area:** 300 W. 1st Avenue  
**Description:** Heavy Metal Containing Devices Smoke Detector Batteries  
**Quantity:** 1  
**Notes:** N/A

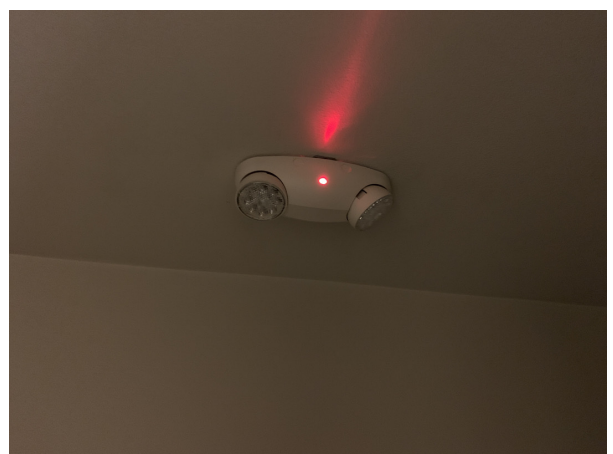
**Area:** 300 W. 1st Avenue  
**Description:** Heavy Metal Containing Devices Emergency Lighting System Batteries  
**Quantity:** 4  
**Notes:** N/A

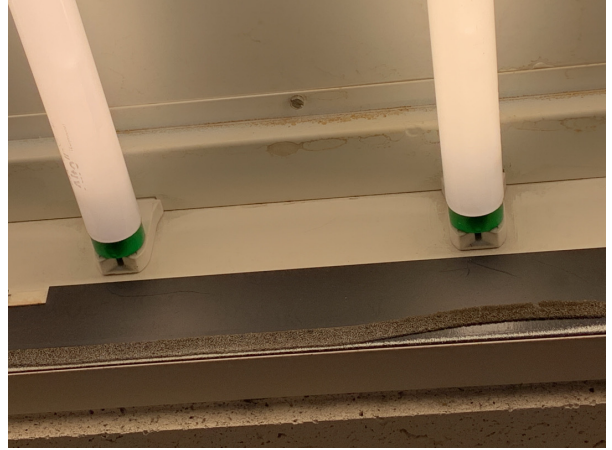
**Area:** 300 W. 1st Avenue  
**Description:** Heavy Metal Containing Devices Fluorescent (Green Tip)  
**Quantity:** 266  
**Notes:** N/A

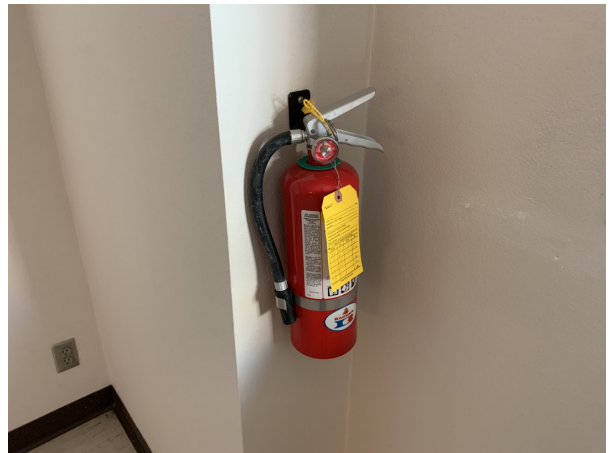
**Area:** 300 W. 1st Avenue  
**Description:** Refrigerants Fire Extinguisher  
**Quantity:** 8  
**Notes:** N/A

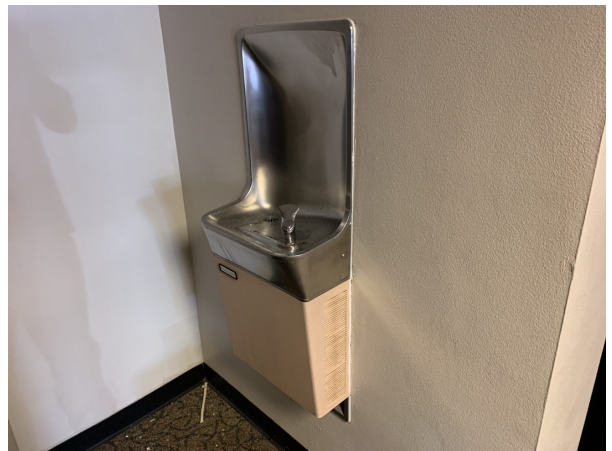
**Area:** 300 W. 1st Avenue  
**Description:** Refrigerants Water Fountains  
**Quantity:** 2  
**Notes:** N/A

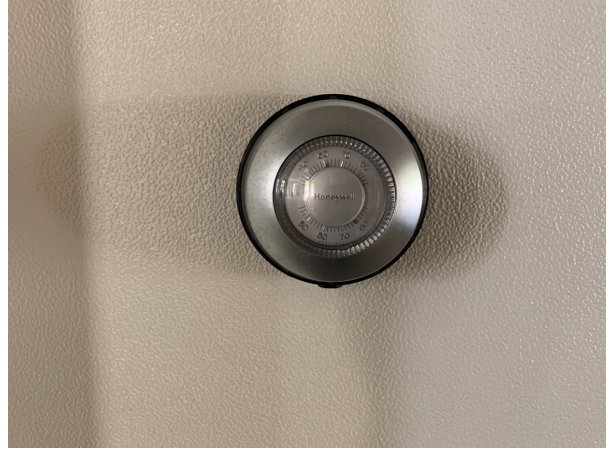
**Area:** 300 W. 1st Avenue  
**Description:** Heavy Metal Containing Devices Thermostats  
**Quantity:** 4  
**Notes:** N/A

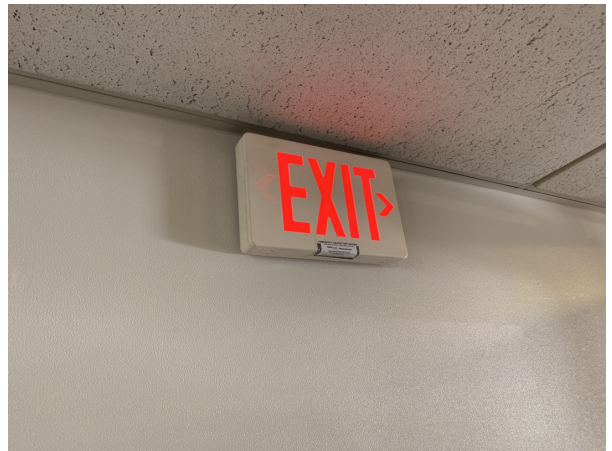
**Area:** 300 W. 1st Avenue  
**Description:** Heavy Metal Containing Devices Exit Sign Batteries  
**Quantity:** 7  
**Notes:** N/A

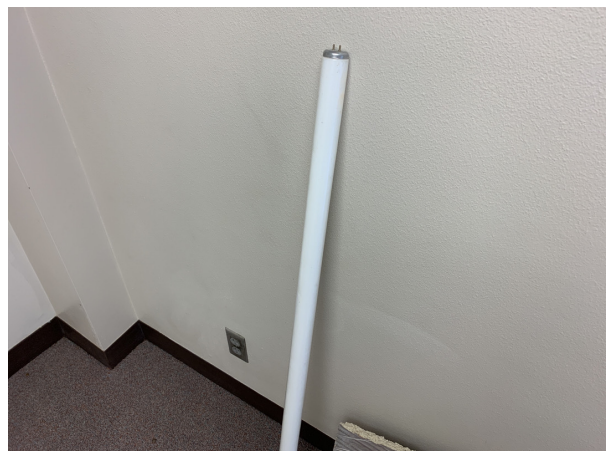
**Area:** 300 W. 1st Avenue  
**Description:** Heavy Metal Containing Devices Fluorescent (Silver Tip)  
**Quantity:** 267  
**Notes:** N/A
