Joint Permit Application

Project Name Albany Waterfront Redevelopment		<u>Latitude & Longitude*</u> 44.63859 & -123.111314		
Project Address / Location 489 NW Water Ave along waterfront		City (nearest) Albany	County Linn	
Township	Range	Section	Quarter / Quarter	Tax Lot
11S	04W	01 DD	SE/NW	102, 200
11S	03W	06 CC	NW,NE/NE,NW	200, 300, 400, 401, 500, 501, 502, 600
11S	03W	06 CD	NW,NE/NE,NW	100, 5600, 11500
11S	03W	06 DC	NE/NW	100, 6901, 7001
11S	03W	06 DA	N, NW/NW, NE	11000, 11100, 1700

ALBANY WATERFRONT REDEVELOPMENT: PHOTOGRAPHIC LOG

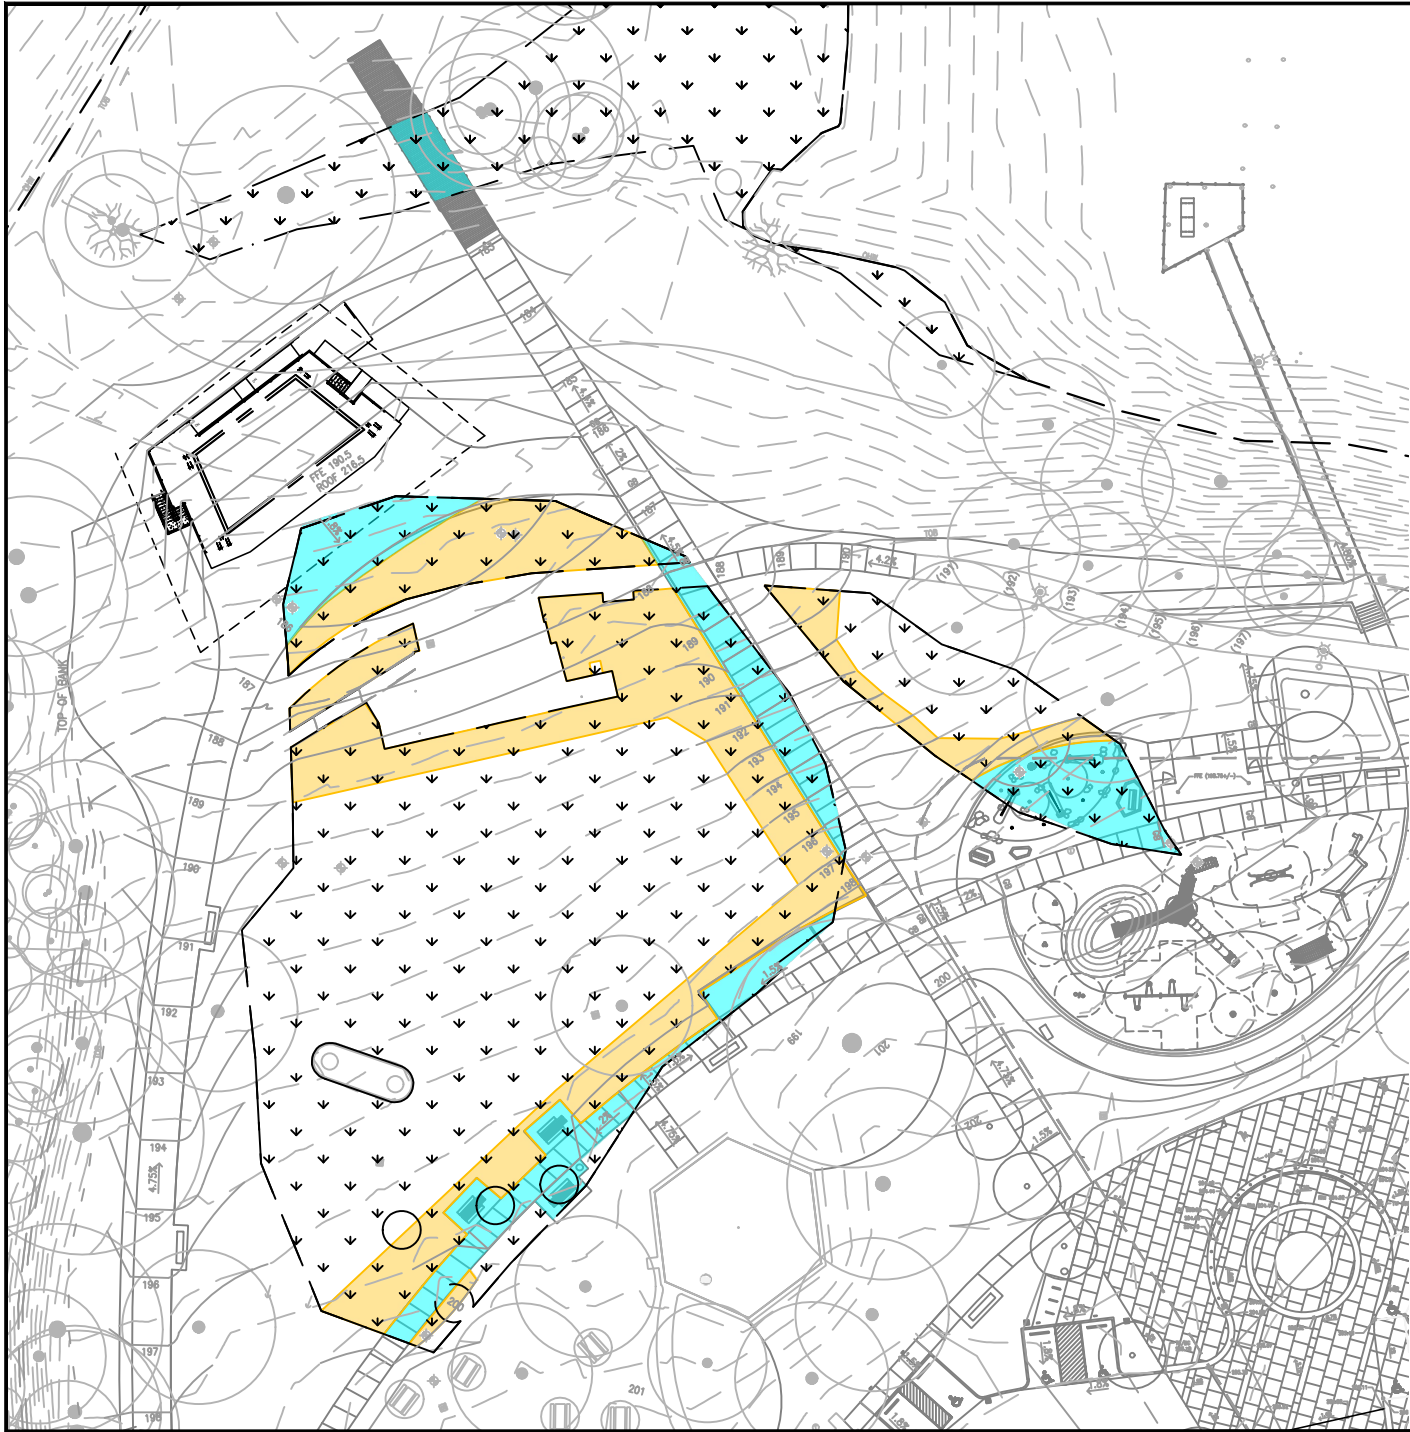
**Figure 5.
Wetland Impacts**

- Wetland Impacts -
Temporary = .23 Acres
- Wetland Impacts - Direct
= .13 Acres

Work in Wetland A includes construction of a boardwalk spanning the wetland and will disturb a total of 0.008 acres of wetland area. Aside from minor intrusions into the wetland by constructing the boardwalk foundations there will be no fill associated with the boardwalk. However, the entire crossing is considered a permanent impact due to indirect impacts, such as shading, associated with the boardwalk. Hydrology flow will be maintained below the elevated boardwalk.

Wetland / Waterbody Name*	Fill Dimensions					Time Fill is to remain**	Material***
	Length (ft.)	Width (ft.)	Depth (ft.)	Area (sq. ft. or ac.)	Volume (c.y.)		
Wetland A	27	10	1	0.008 ac.	<1		Boardwalk anchor/foundation
Wetland E	var	var	var	0.090 ac.	45		Soil/paved trail
Wetland F	15	12	var	0.024 ac.	19		Soil/paved trail

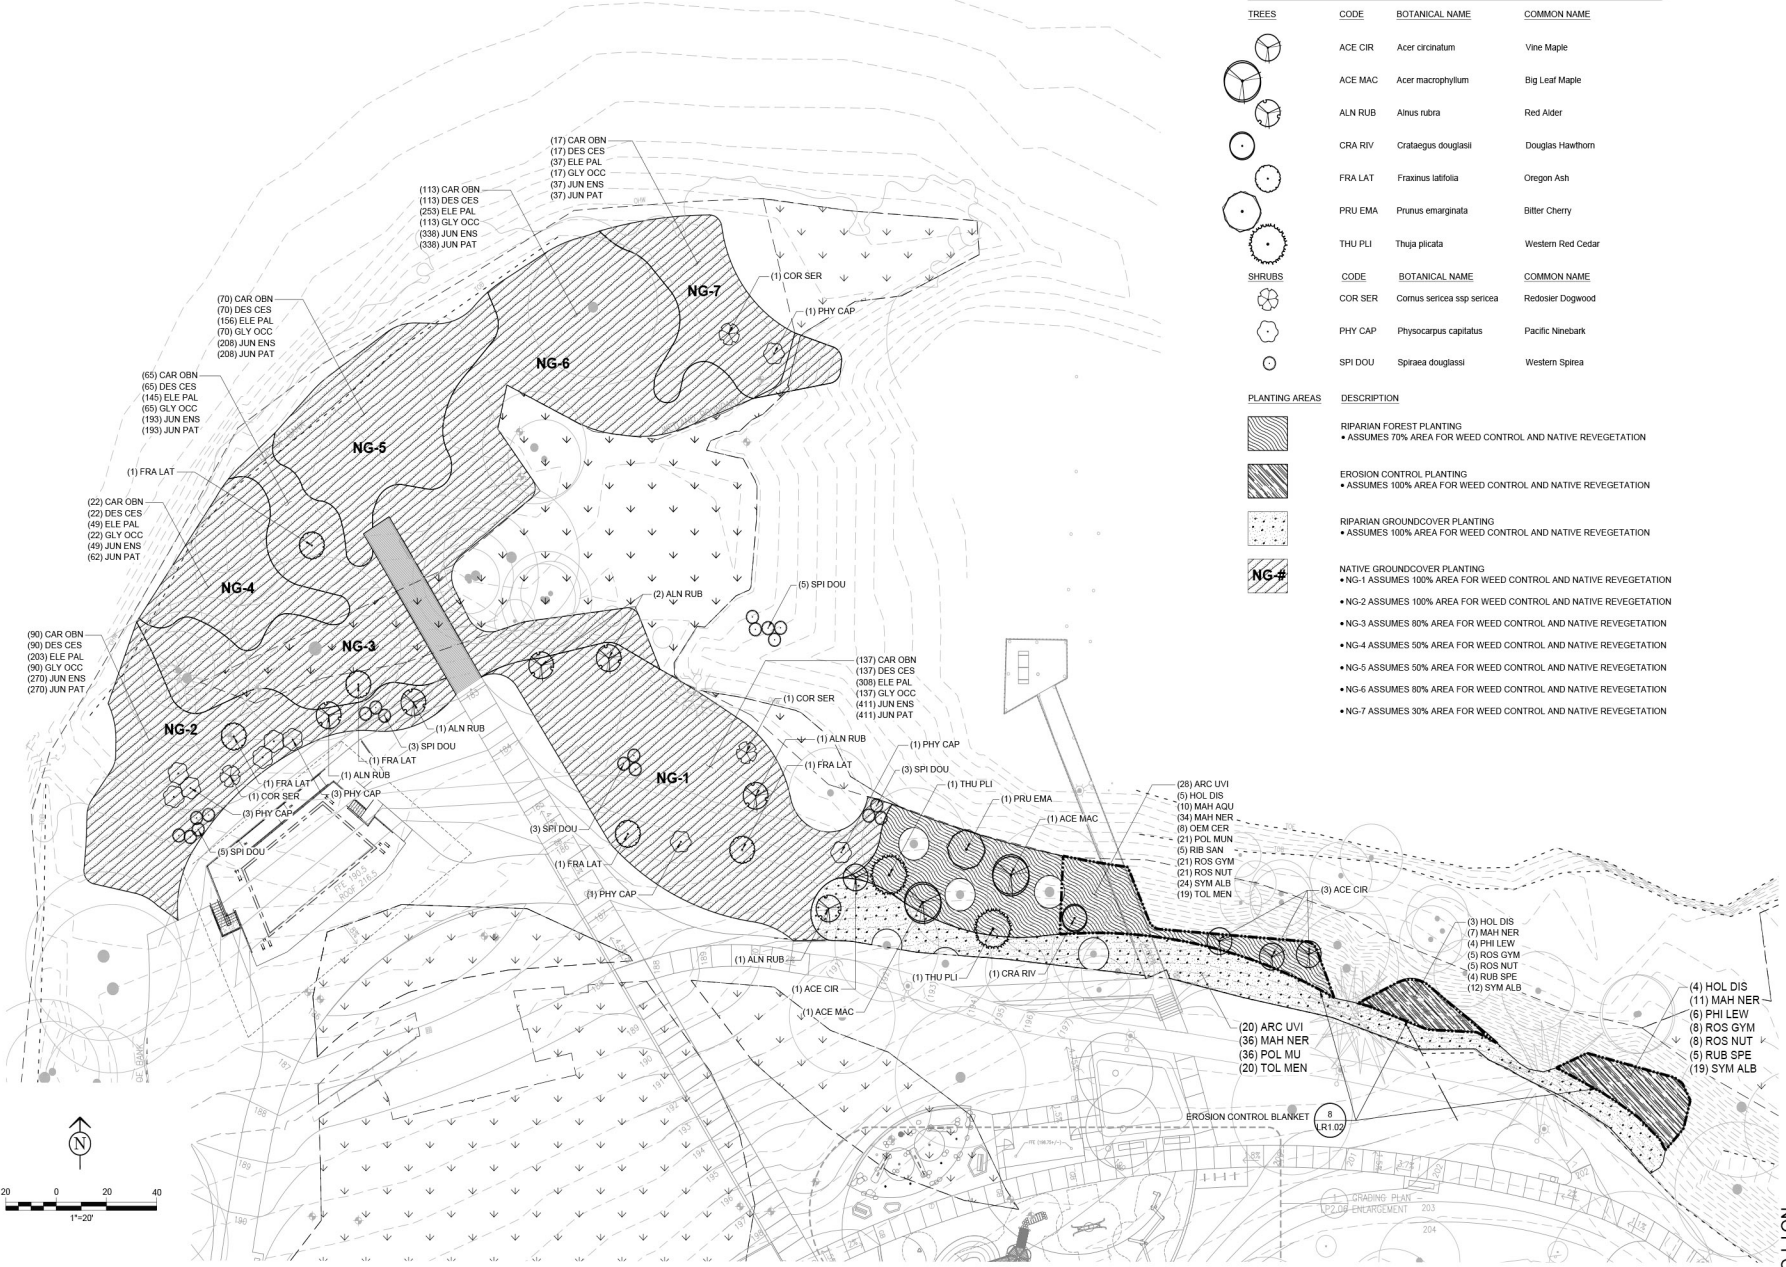
LANDSCAPE PLANTING PLAN
2003
204

PLANTING AREAS

- RIPARIAN FOREST PLANTING
• ASSUMES 70% AREA FOR WEED CONTROL AND NATIVE REVEGETATION
- EROSION CONTROL PLANTING
• ASSUMES 100% AREA FOR WEED CONTROL AND NATIVE REVEGETATION
- RIPARIAN GROUNDCOVER PLANTING
• ASSUMES 100% AREA FOR WEED CONTROL AND NATIVE REVEGETATION
- NATIVE GROUNDCOVER PLANTING
• NG-1 ASSUMES 100% AREA FOR WEED CONTROL AND NATIVE REVEGETATION
• NG-2 ASSUMES 100% AREA FOR WEED CONTROL AND NATIVE REVEGETATION
• NG-3 ASSUMES 80% AREA FOR WEED CONTROL AND NATIVE REVEGETATION
• NG-4 ASSUMES 50% AREA FOR WEED CONTROL AND NATIVE REVEGETATION
• NG-5 ASSUMES 50% AREA FOR WEED CONTROL AND NATIVE REVEGETATION
• NG-6 ASSUMES 80% AREA FOR WEED CONTROL AND NATIVE REVEGETATION
• NG-7 ASSUMES 30% AREA FOR WEED CONTROL AND NATIVE REVEGETATION

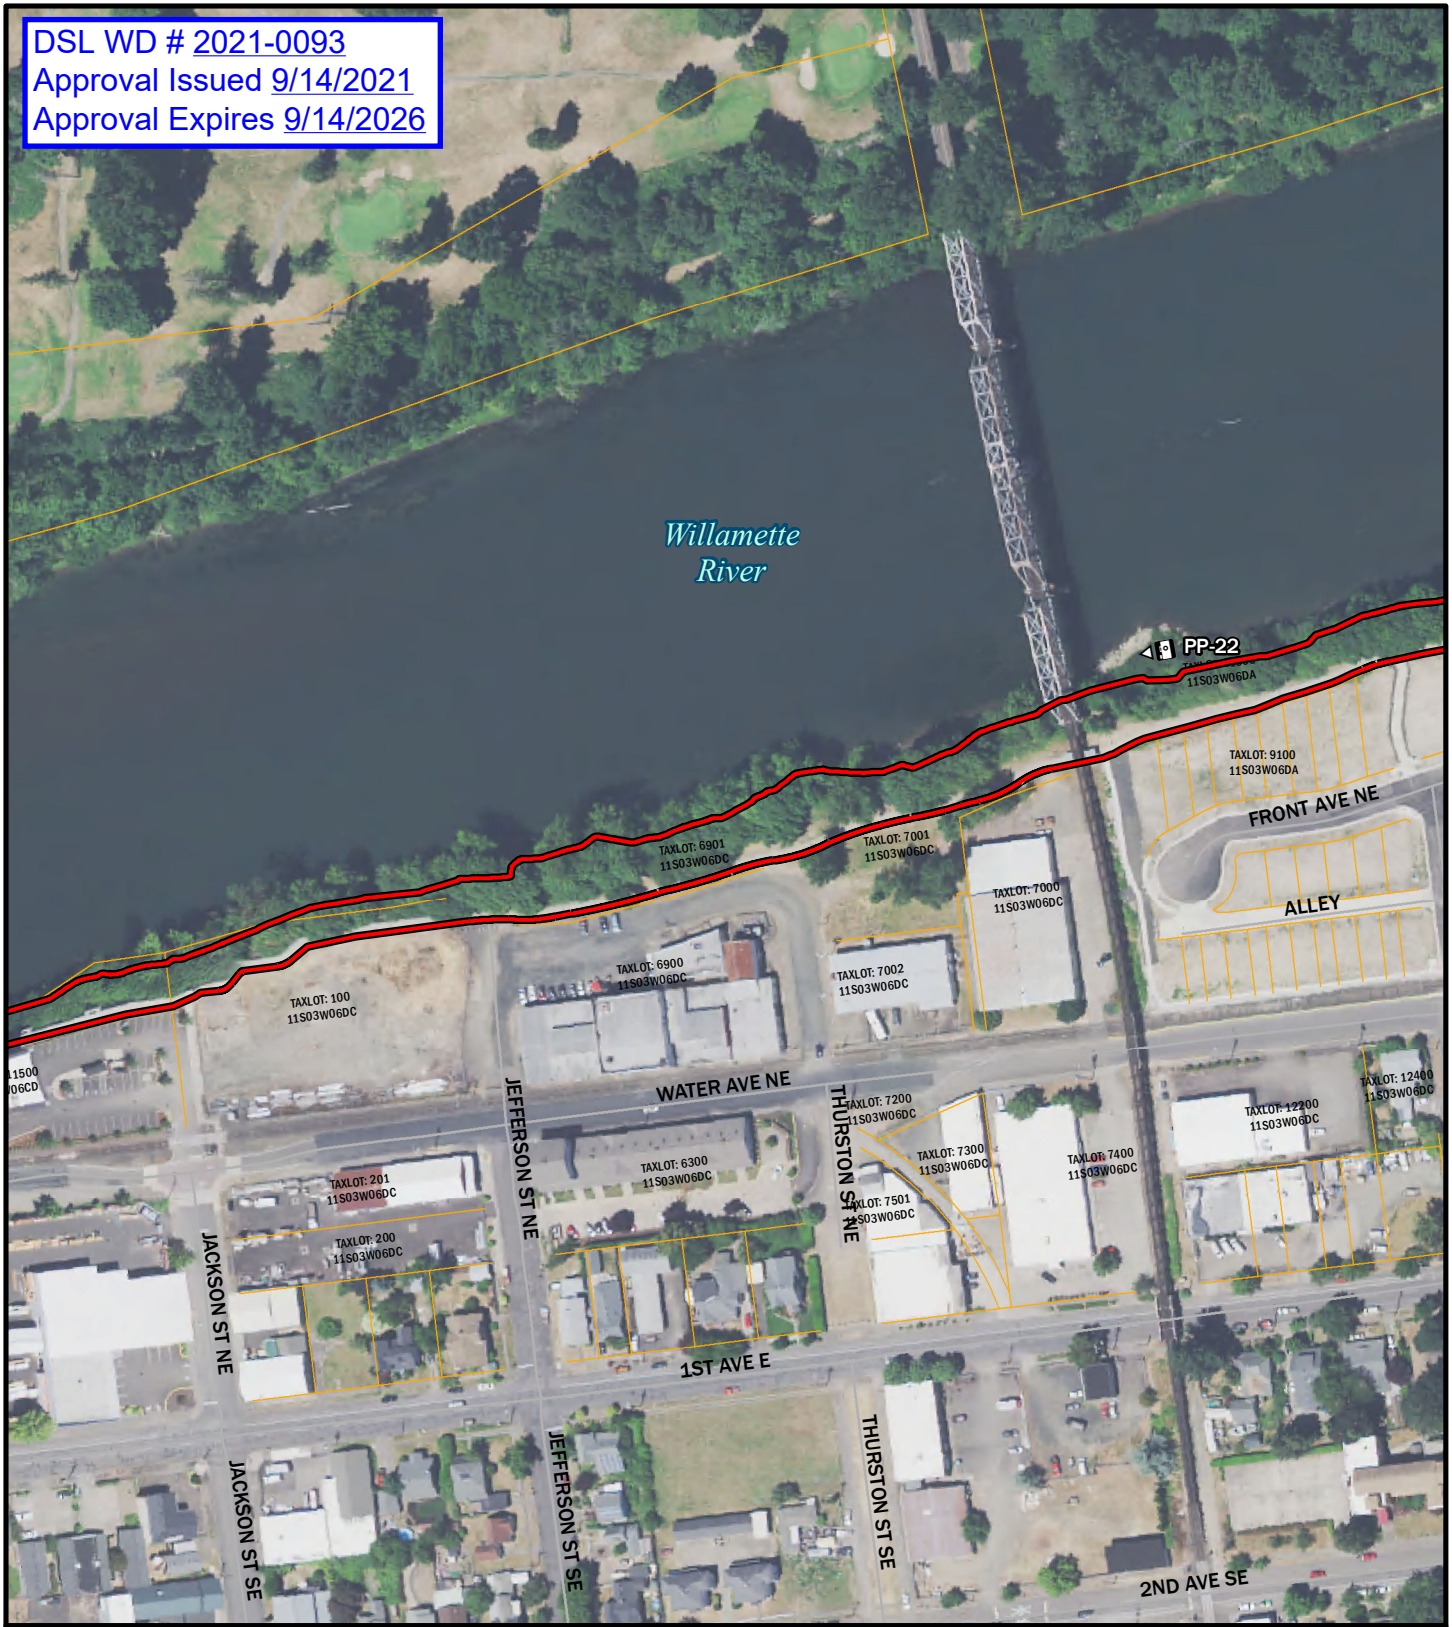
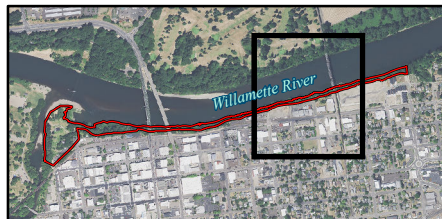
Figure 6-E.
Wetland Delineation Map for the Albany Waterfront Redevelopment.

Note: All wetland boundaries and sample plots professionally surveyed by K&D Engineering, Inc. to sub-foot accuracy. Tax lot boundaries are from Linn County. Study area boundary is approximated from surveyed south boundary of existing path pavement and OHWM.

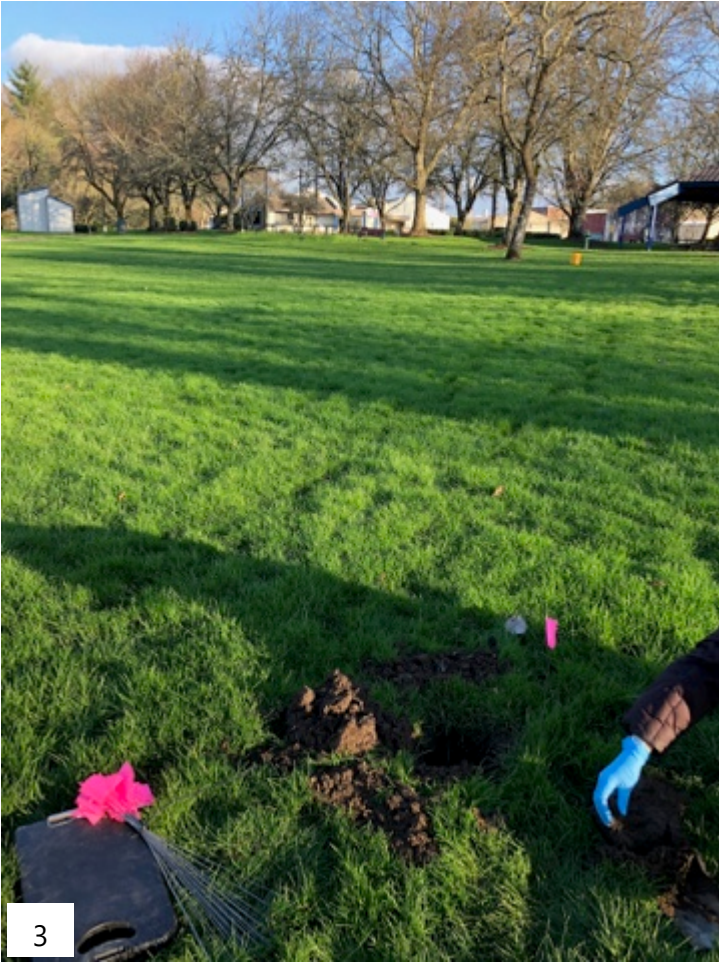
Photo Point Number	Photo Description
1	Representative existing conditions in Wetland A.
2	Representative existing conditions in Wetland A.
3	Representative existing conditions in Wetlands E and F.
4	Representative existing conditions in Wetlands E and F.
5	Representative existing conditions in Wetlands E and F.
6	Representative existing conditions in Wetlands E and F.

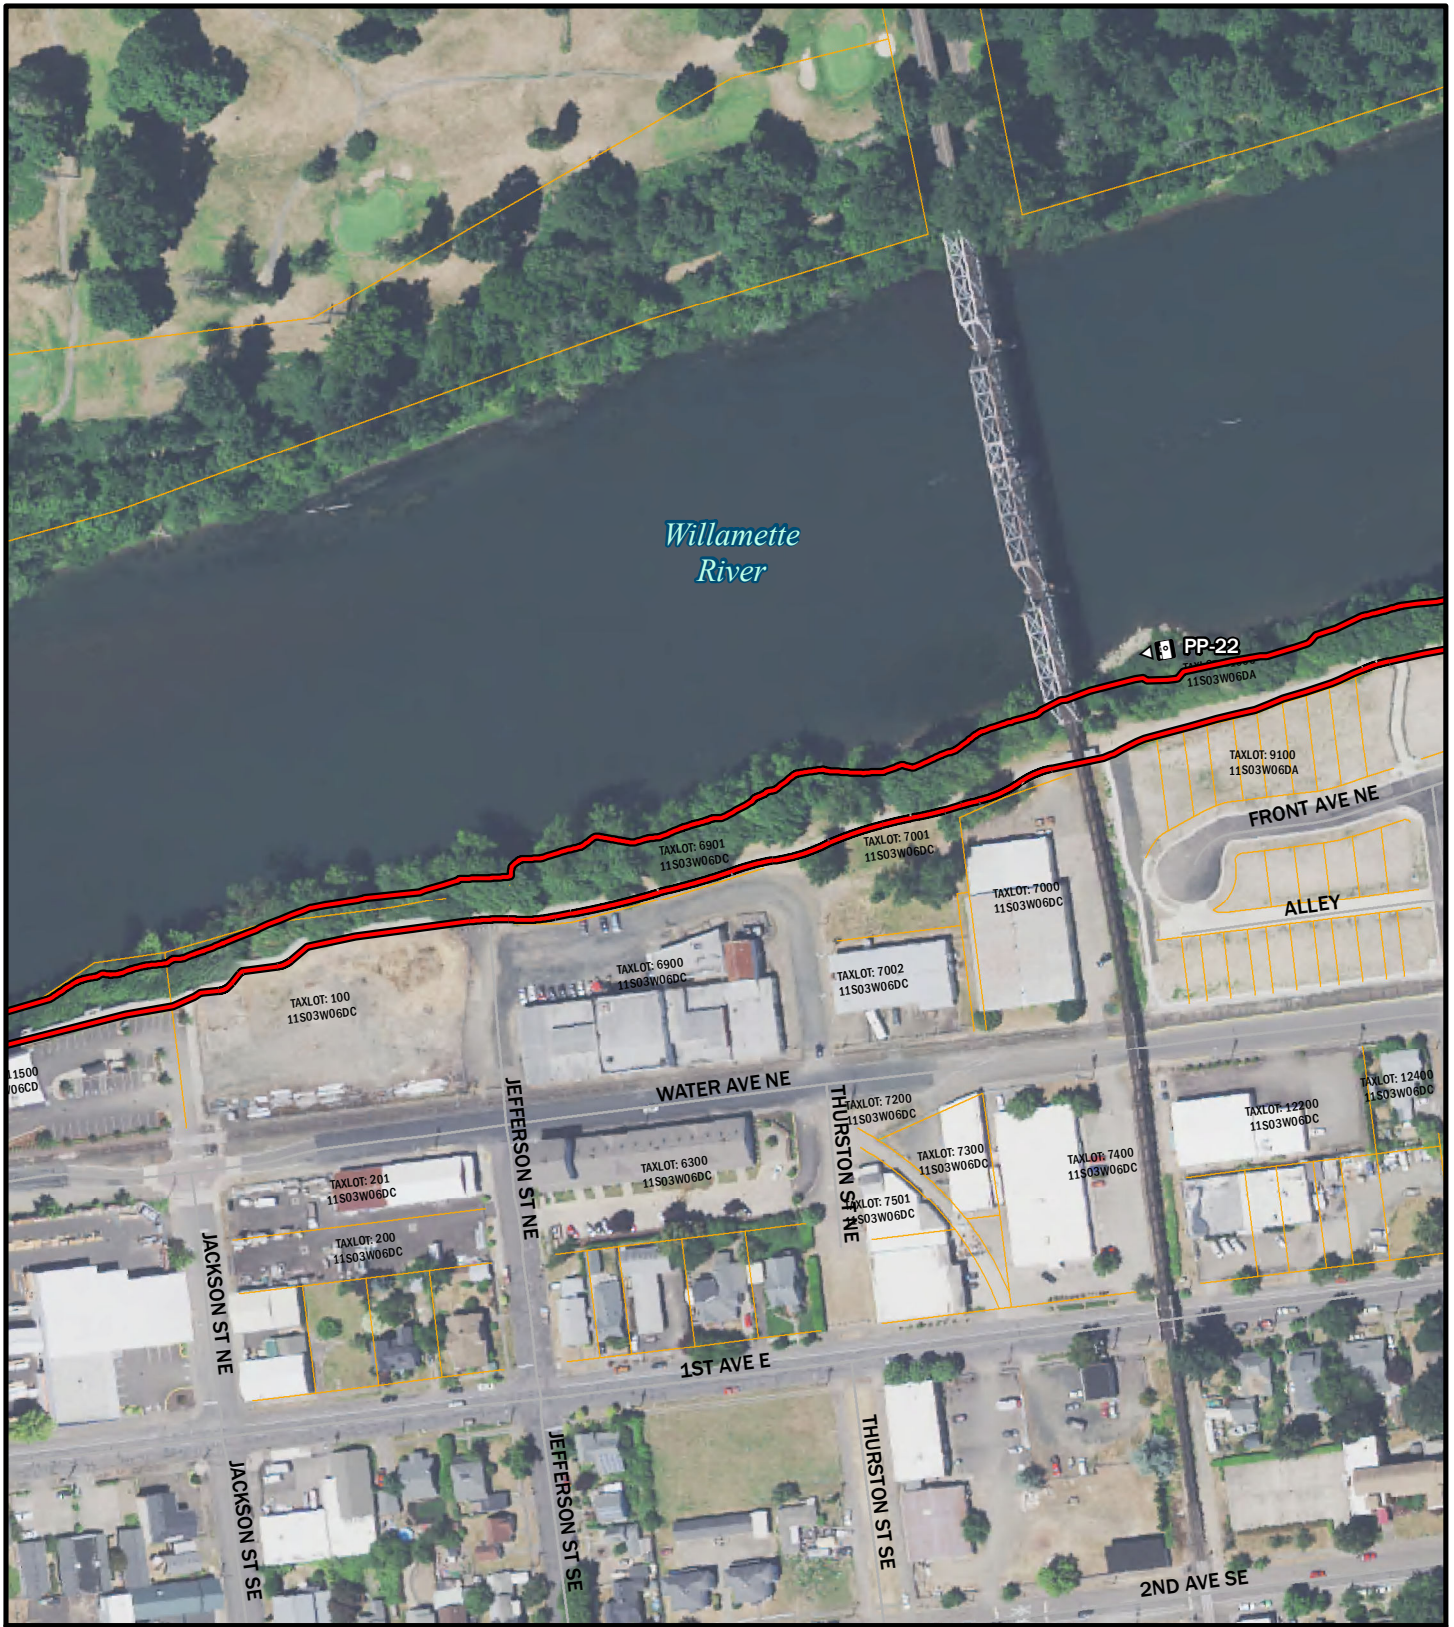
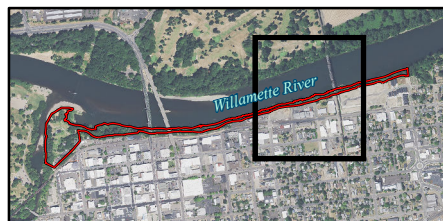
Figure 6-E.
Wetland Delineation Map for the Albany Waterfront Redevelopment.

Note: All wetland boundaries and sample plots professionally surveyed by K&D Engineering, Inc. to sub-foot accuracy. Tax lot boundaries are from Linn County. Study area boundary is approximated from surveyed south boundary of existing path pavement and OHWM.
