Albany Water System

City of Albany

G&E Engineering Systems Inc.

*G&E Report 32.34.01, Revision 0
January 30, 2006*

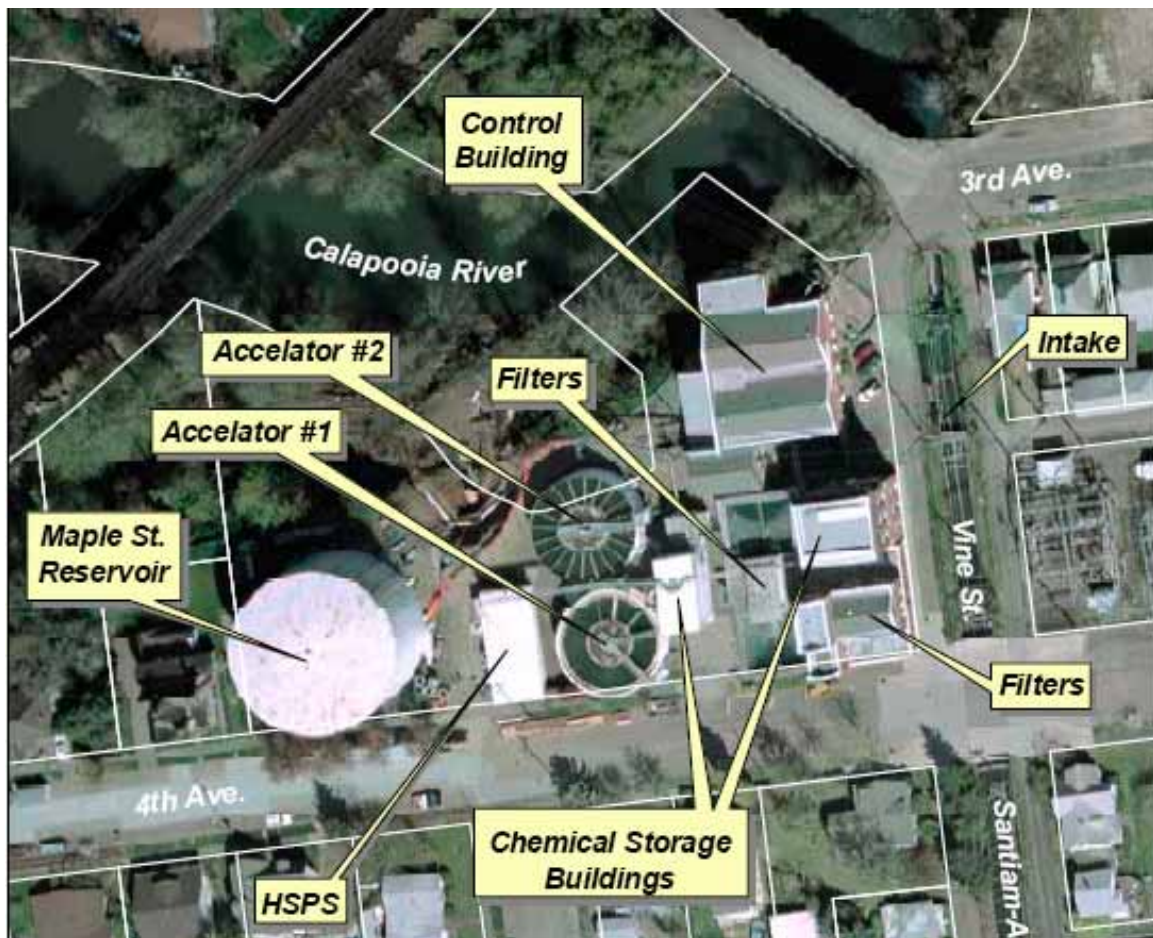
Figure 2-3. Aerial View of Vine Street WTP

A review of the drawings for the 1948, 1960s, 1970s and 1991 upgrades reveals that none were designed with significant seismic capacity in mind. The 1991 upgrade shows seismic design per UBC Zone 2; but details suggest that detailing was governed by water leak tightness, and not seismic loads.

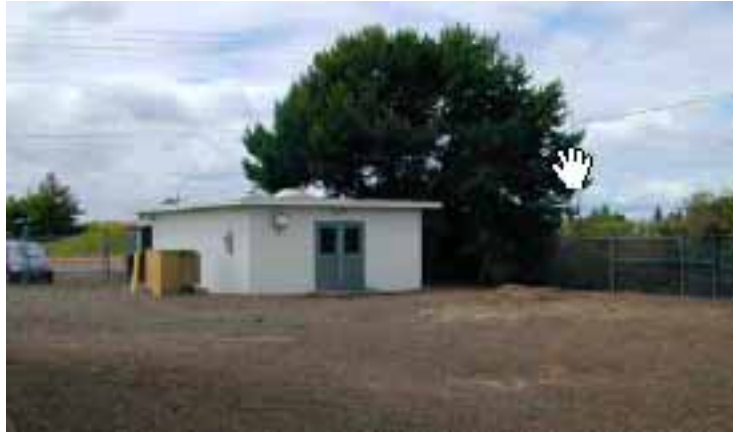
Figure 2-6. 34th Avenue Pump Station

The 34th Avenue pump station is located in a small rectangular reinforced masonry (CMU) building, built in 1971. The building has doors on one side, and solid walls elsewhere. It does not have emergency backup power or quick connect coupling.

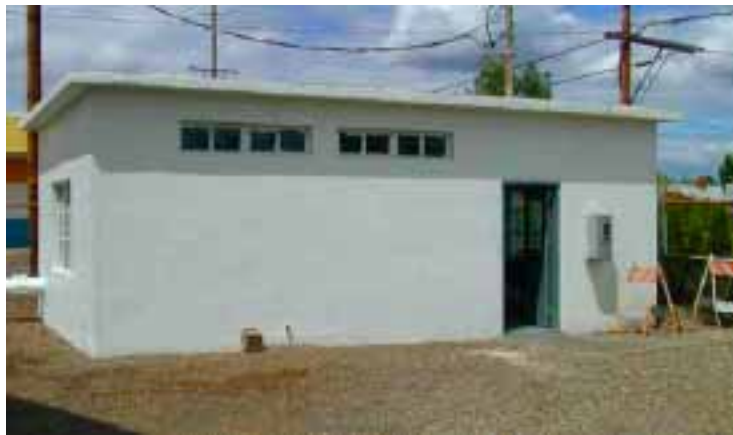
Figure 2-7. Queen Avenue Pump Station

The Queen Avenue pump station is located in a small rectangular reinforced masonry (CMU) building, built in 1955. The building has doors on one side, and windows in other walls. It does not have emergency backup power or quick connect coupling.

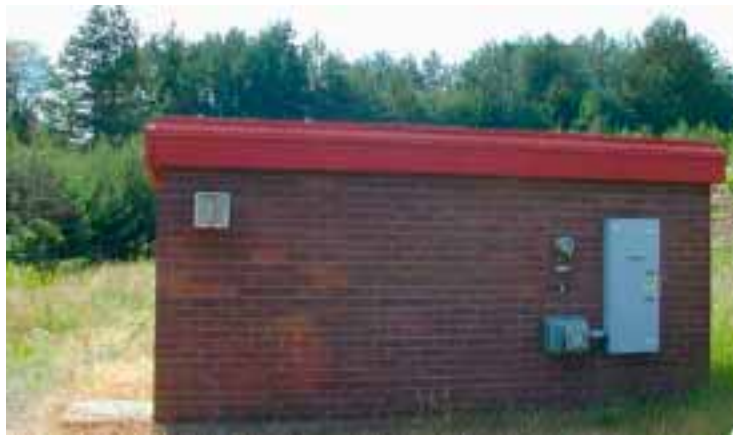
Figure 2-8. North Albany Pump Station

The North Albany pump station is located in a small rectangular reinforced masonry (brick) building, built in 1998. The building has a large door on one side, and solid walls on the other walls. It does not have emergency backup power, but does have a quick connect coupling.

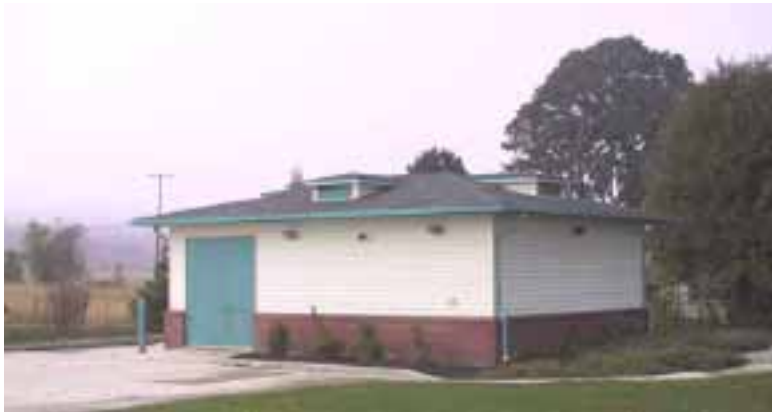
Figure 2-9. Gibson Hill Pump Station

The Gibson Hill pump station is located in a small rectangular wood frame building with wood roof, built in 1998. The building has a large door on one side, and solid walls on other walls. It does not have emergency backup power, but does have a quick connect coupling.

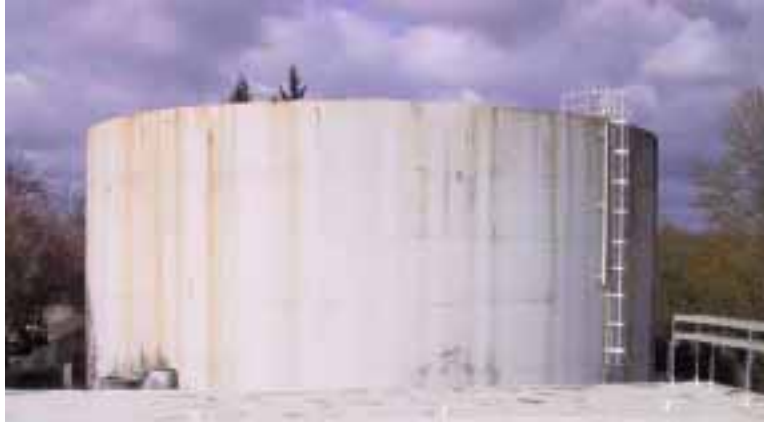
Figure 2-10. Maple Street Tank

The Maple Street tank is a 2 MG, at grade steel tank. It rests on a concrete ring girder, unanchored. It has 1 inlet and 2 outlet pipes, an overflow pipe and a drain pipe (floor entry near wall). It has diameter 93 feet, bottom elevation 220 feet, overflow elevation 259.8 feet.

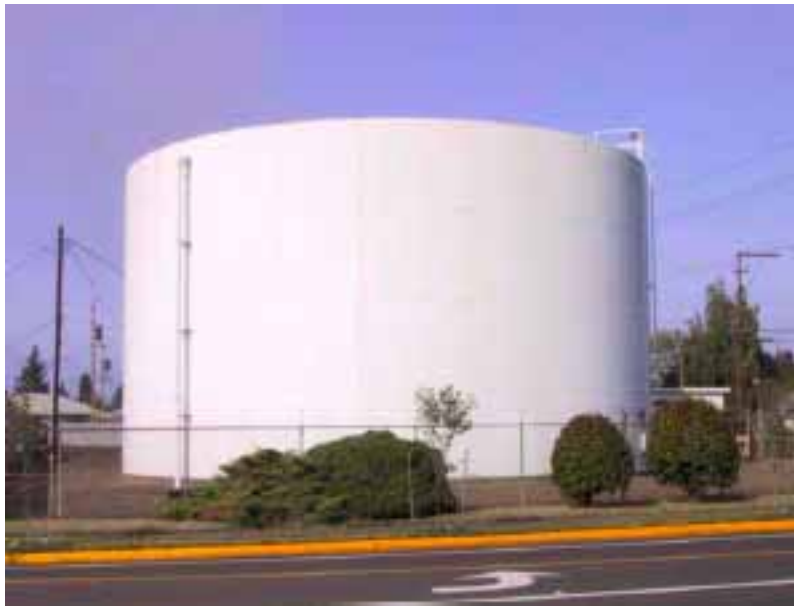
Figure 2-12. Queen Avenue Tank

The Queen Avenue tank is a 1 MG at grade steel tank, unanchored, built in 1955. It rests on a concrete ring girder. It has diameter 74 feet, bottom elevation 229 feet, overflow elevation 260.5 feet. It has one inlet/outlet pipe, side entry. It has an overflow pipe connected to the drain line.

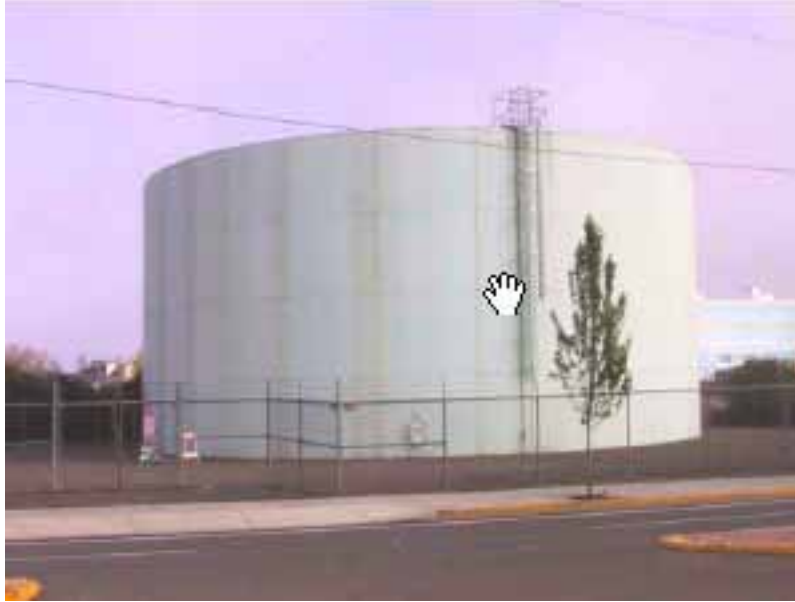
Figure 2-13. 34th Avenue Tank

The 34th Avenue tank is a 2 MG at grade steel tank, unanchored, built in 1971. It rests on a concrete ring girder. It has diameter 104 feet, bottom elevation 224 feet, overflow elevation 255.5 feet. It has one inlet/outlet pipe, bottom entry. It has an overflow pipe and a drain line.

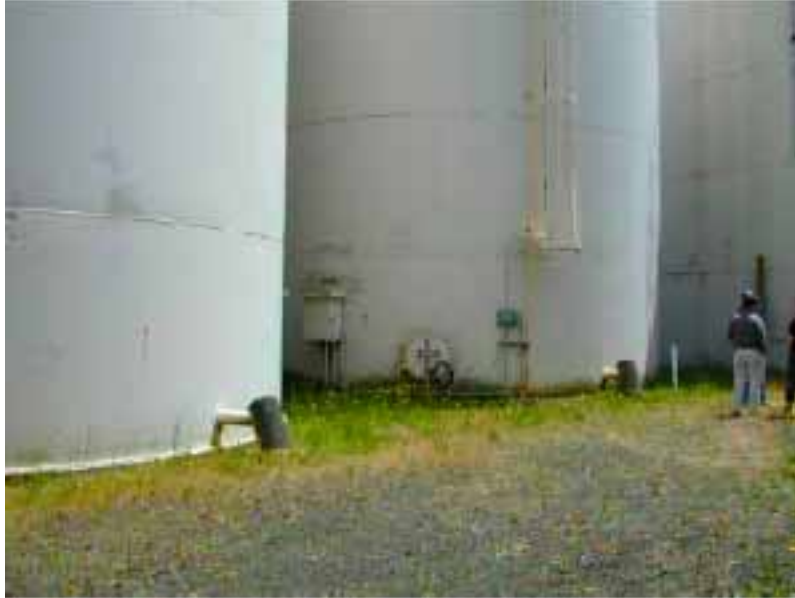
Figure 2-16. Valley View Tanks

The Valley View tank 1 is a 0.25 MG at grade steel tank, unanchored, built in 1963. It has diameter 25 feet, bottom elevation 520 feet, overflow elevation 567.5 feet. There is a catwalk connecting between Tanks 1, 2 and 3 at this site. The inlet-outlet pipes are side entry.

The Valley View tank 2 is a 0.25 MG at grade steel tank, unanchored, built in 1967. It has diameter 25 feet, bottom elevation 520 feet, overflow elevation 567.5 feet. The inlet-outlet pipes are side entry.

The Valley View tank 3 is a 0.85 MG at grade steel tank, unanchored, built in 1982. It has diameter 55 feet, bottom elevation 520 feet, overflow elevation 569.5 feet. The inlet-outlet pipes are side entry.

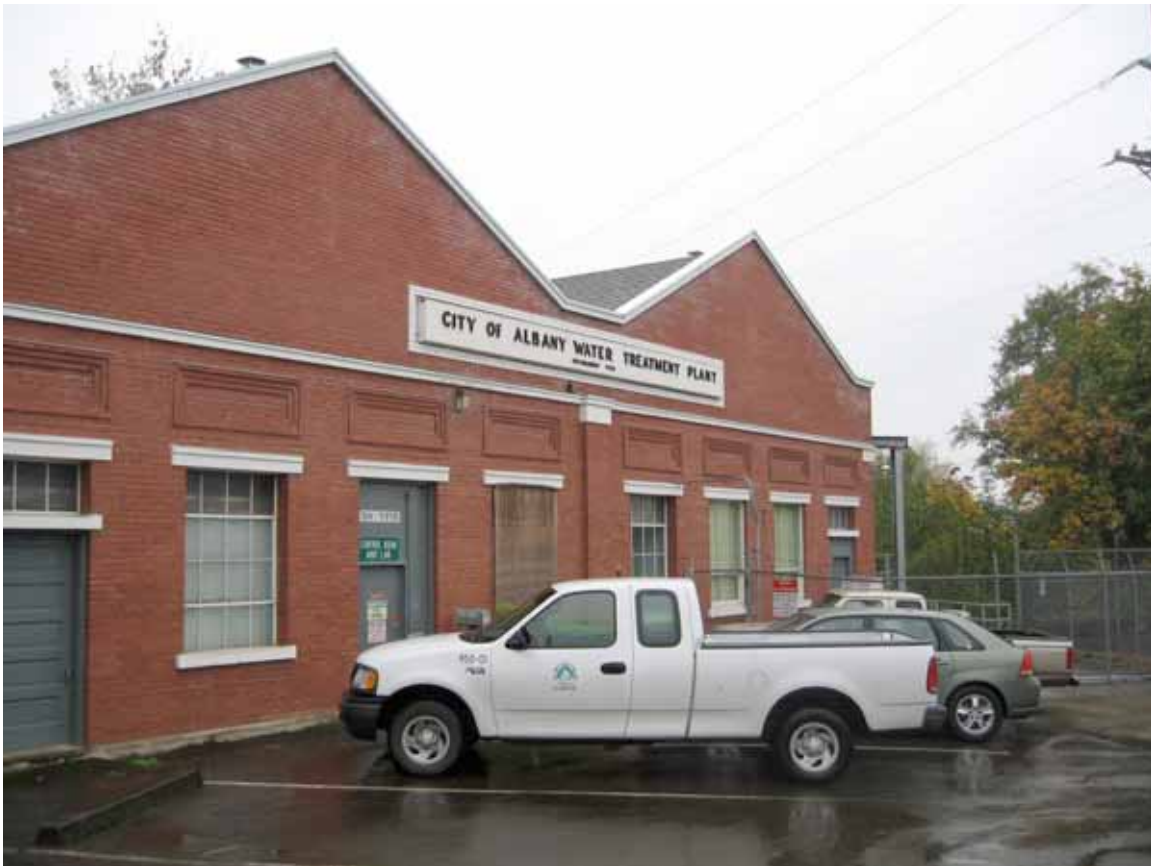
Figure 5-1. Control Building, East Elevation

Control building. This is a pre-1900 URM Building, with additions built in 1912 and with modifications made in the 1920s/1930s. The building houses the Control Room and Water Quality Lab. The roof diaphragm is straight timber sheathing supported on steel trusses. Relatively recently installed interior CMU walls are used to provide a modern work environment for staff; but these walls provide no lateral force resisting path for the exterior brick URM building. The upgrade plan is to improve the in-plane and out-of-plane capacity of existing brick walls; modify diaphragms; and improve diaphragm connections. As this building is a historic brick structure, the upgrades would be done to preserve the look-and-feel of the exterior facades. Interior walls are generally accessible. The upgrade would include a new interior steel braced frame structure with suitable connections to the brick structure; an enhanced roof diaphragm; shotcrete walls might be used at selected interior locations. Common occupancy is 5 people (day time) or 2 people (off hours).

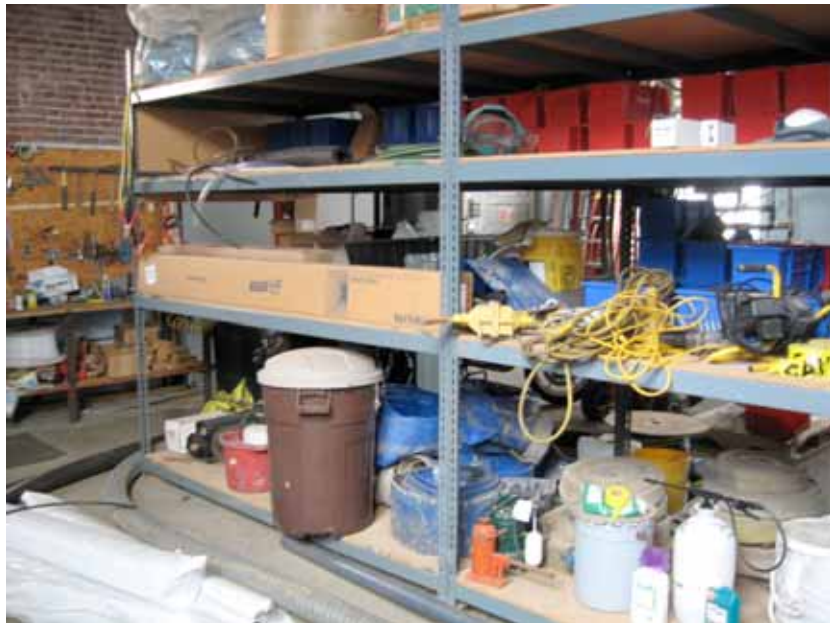
Figure 5-7. Storage Rack in Old Filter Building

Old Filter building. This building is normally unoccupied (Figure 5-6). At its lower levels, there are small reinforced concrete basins that can serve as part of system operation to provide flows after earthquakes. CH2M-Hill recommended a full upgrade, but the lack of occupancy suggests a moderate priority and cost-effectiveness. Seismic upgrades would include improving the in-plane and out-of-plane capacity of the existing brick walls; modify straight sheathing wood roof diaphragm; and improving the diaphragm connections. As this building is a historic brick structure, the upgrades would be done to preserve the roof-and-feel of the exterior facades. Interior walls are easily accessible. Possibly, the upgrade would include a new interior steel braced frame structure with suitable connections to the brick structure; with an enhanced diaphragm; shotcrete walls might be used at interior locations.

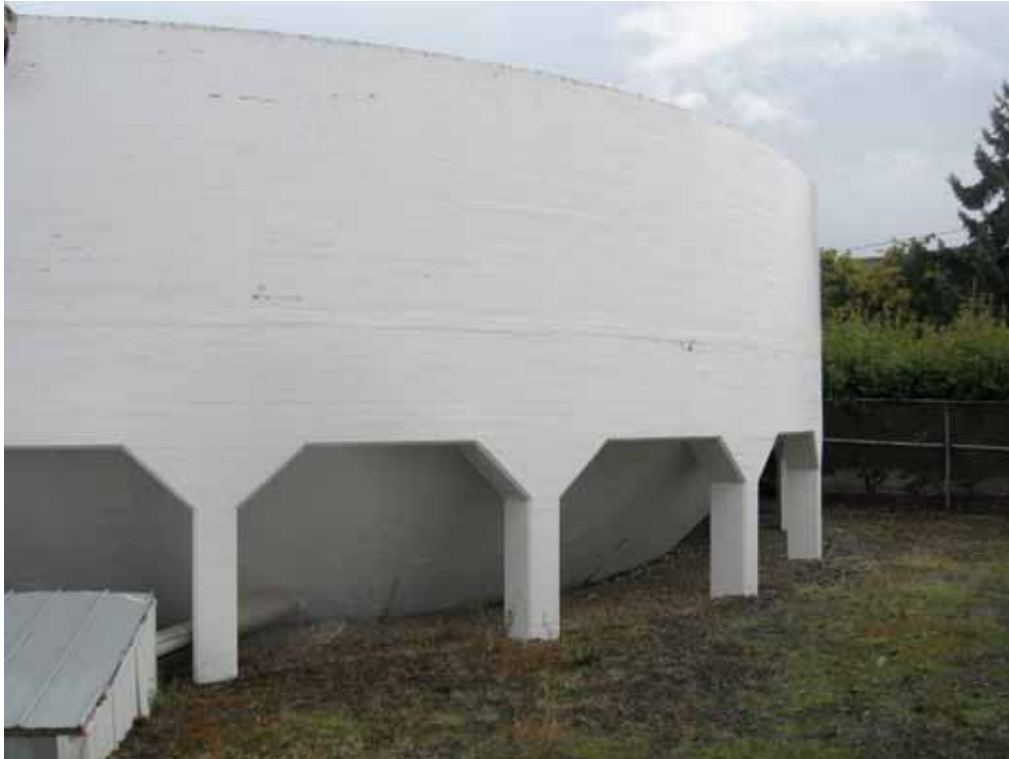
Figure 5-13. Accelerator 1

Accelerator #1 is a reinforced concrete tank (Figure 5-13). The existing tank performance is considered suitable for a 475-year earthquake. The exterior reinforced concrete columns, while using non-ductile shear reinforcement, are probably adequate as long as the in-plane shear diaphragm action of the concrete tank shell limits top level deflections so low as to preclude much lateral load being taken by the columns. Further, Accelerator #1 is somewhat made redundant by Accelerator #2 with regards to providing minimum post-earthquake plant capacity. Upgrades could include adding exterior reinforced concrete

walls to provide additional seismic capacity, but these are considered relatively lower priority.
