Santiam-Albany Canal Rehabilitation

Bank Stability Analysis

Final

Prepared by:
Otak, Inc.
17355 SW Boones Ferry Rd.
Lake Oswego, OR 97035
Otak Project No. 14079

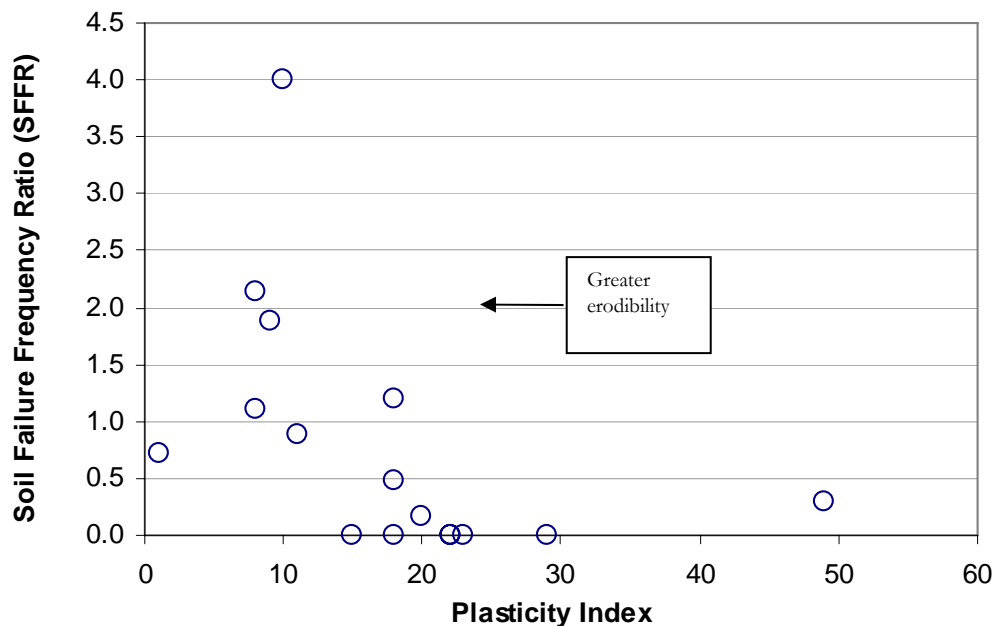
Figure 2: SFFR As a Function of Soil Plasticity Index (PI)

The SFFR values for each soil are plotted as a function of the Plasticity Index (PI) in Figure 2. This shows a strong correlation between bank failure occurrences and soil PI. Bank failures are much less likely to occur in soils with a PI greater than 20. This is the suggested cutoff between medium and high plasticity soils proposed by Burmister (1949) (Table 3). Local soil plasticity indexes should be taken into account during bank stabilization design. Projects planned in locations with soils having low plasticity indexes should generally incorporate more conservative designs. The river stationing as well as the geotechnical properties of various soil layers occurring along the canal is presented in Appendix A.

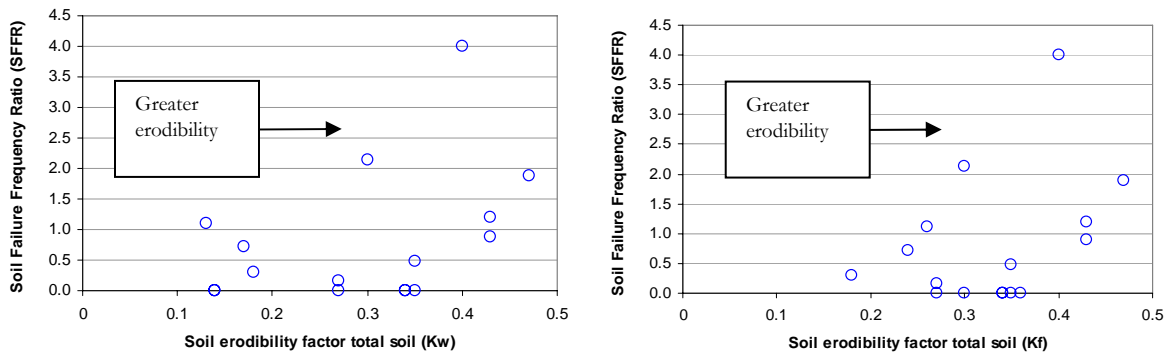
Figure 3: SFFR As a Function of Soil Erodibility Kf and Kw.

SFFR values were also plotted as a function of erodibility factors Kf and Kw. Susceptibility to erosion increases with increasing Kf and Kw values. This trend is evident in Figure 3. The local Kf and Kw values should be checked at proposed bank stabilization sites, if these values are high (0.25) then it may be advisable to incorporate more conservative bank stabilization designs and incorporate more rigorous site erosion control practices.

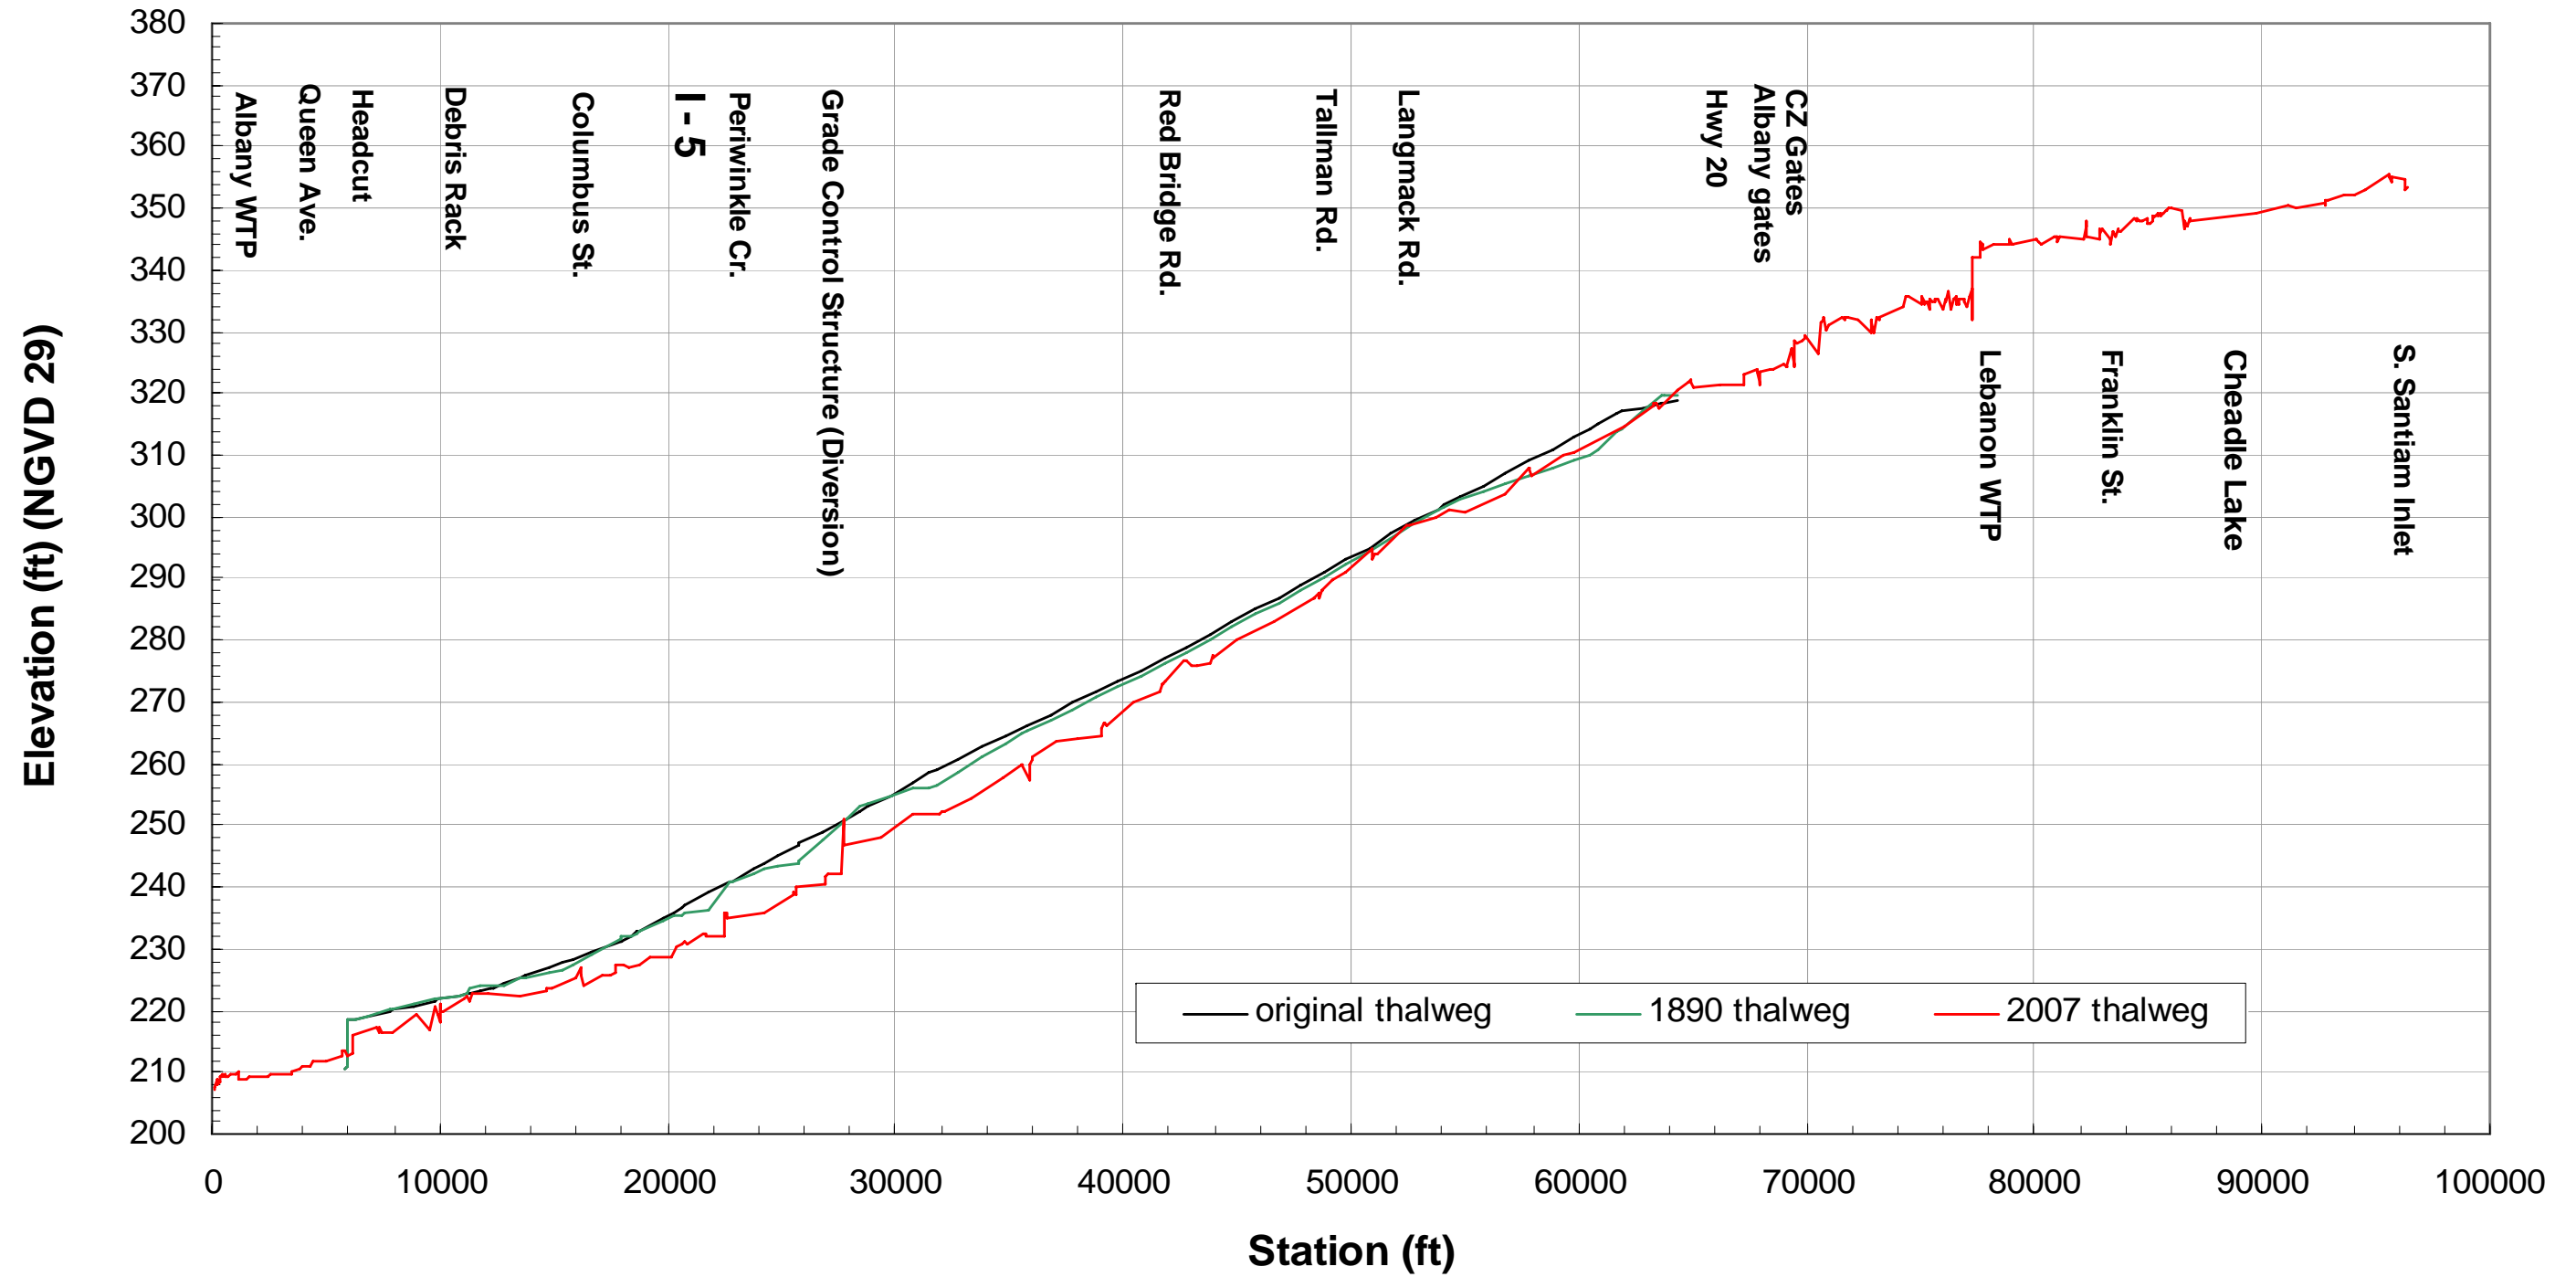
Figure 4: Historic and Current Longitudinal Profiles of the Santiam-Albany Canal

The historical longitudinal profiles provide insight into the erosional characteristics of the canal. All reaches available for comparison (stations 61+88 to 643+00) have degraded or incised historically. From a geomorphic perspective, this occurs due to the relatively clear water diverted into the canal from the South Santiam River, and the lack of channel sinuosity which is common in canal design. Energy in alluvial channels is utilized to perform work against friction at the channel boundary, against internal friction, in transporting the sediment load, and in eroding the channel boundary. In the Albany-Santiam canal there is essentially no sediment load supplied to the channel from upstream and clear water scour results. Canal design typically involves following the steepest gradient available in the valley (valley slope) and lateral constraint to maximize agricultural land use. By contrast natural streams typically adjust their gradient over time through planform change (meandering). If this mechanism is not available (i.e., from linear canal design), gradient adjustment occurs via channel incision (i.e., lowering the elevation of the thalweg). This is the case for the Albany-Santiam canal. The resulting channel degradation has direct consequences for reach stability and subsequently, bank stability because bank heights and angles are raised above critical failure thresholds. Canal hydraulic reaches have been delineated and discussed in previous technical memoranda (Otak February 26,2008). Table 4 depicts the reach average degradation rates calculated along the canal. The degradation rates range from 1.5 to 7.5 feet along the canal profile.

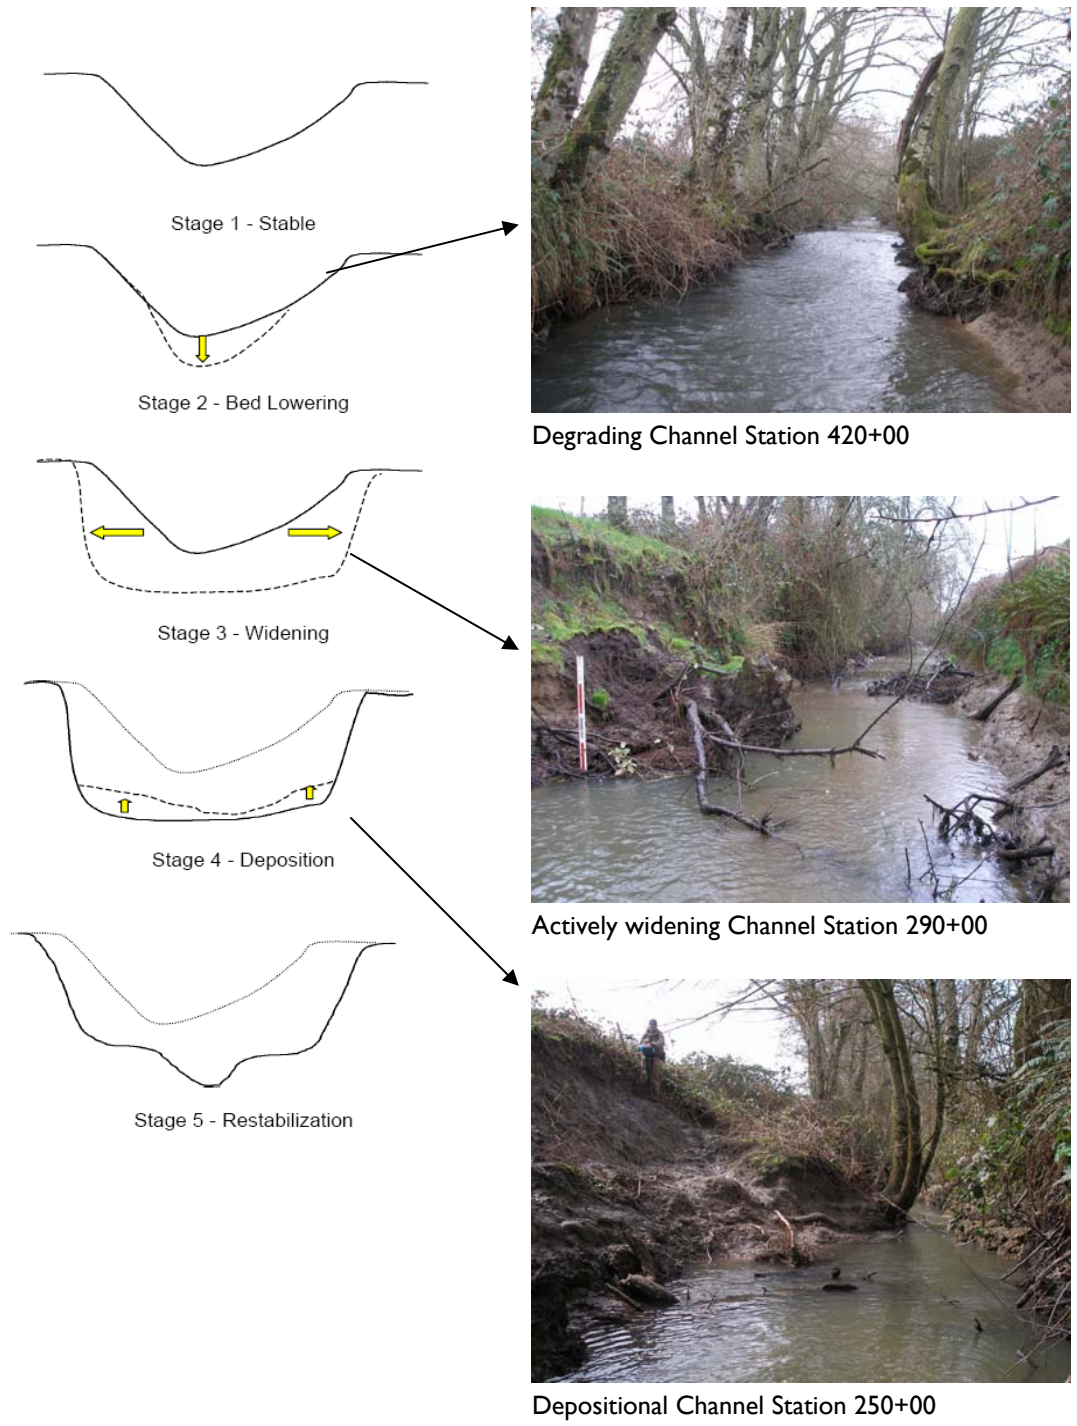
Figure 5: Channel Evolution Sequence (adapted from Fischenich and Morrow 2000)

Space for time substitution (Schumm et al. 1984) indicates a sequence of morphological changes that will occur in incised channels (Figure 5). The well-documented sequence is termed the channel evolution model (CEM). In the case of the canal, Stage 1 would be the original canal digging in 1873. Due to reasons described in the preceding discussion, the canal began to degrade or incise. This would be considered Stage 2. During Stage 2 of the channel evolution, process sediment transport capacity within a reach is at a maximum. Once a critical stability threshold for bank height is exceeded, Stage 3 begins where channel widening is the dominant process. As the channel widens, bed shear stress and erosive velocities are reduced. This reduced reach transport capacity is coupled with increased sediment supply from the failing banks upstream and the dominant channel process is deposition for Stage 4. After some period of time, quasi-equilibrium is reached in Stage 5 within the enlarged channel cross-section and restabilization occurs with an inset floodplain and channel cross-section in the enlarged channel section.

The aforementioned, geomorphic process is most prevalent in the canal reaches in the non-urbanized agricultural portions of the canal that are free to adjust (river stations 226+00 to 671+21). A photo sequence in this vicinity (Figure 5) illustrates the ramifications of these geomorphic processes on bank stability and canal conveyance capacity loss. Over time degradation is continuing to move upstream and resulting bank erosion problems will progress upstream from the reaches that presently have the greatest stability problems in the rural reaches of Linn County. This migration is partially halted by a large grade control structure located at station 275+00, approximately 700 feet upstream of the Fry Road crossing (Figure 6), and coarse gravel bed material present in reaches upstream from this structure. Areas with the highest potential for future incision include the portion of the canal extending from Goltra Road upstream to Tallman Rd. These future incision problems could be halted by installing grade control structures or check dams at key locations to restrain further canal incision and associated instability problems.

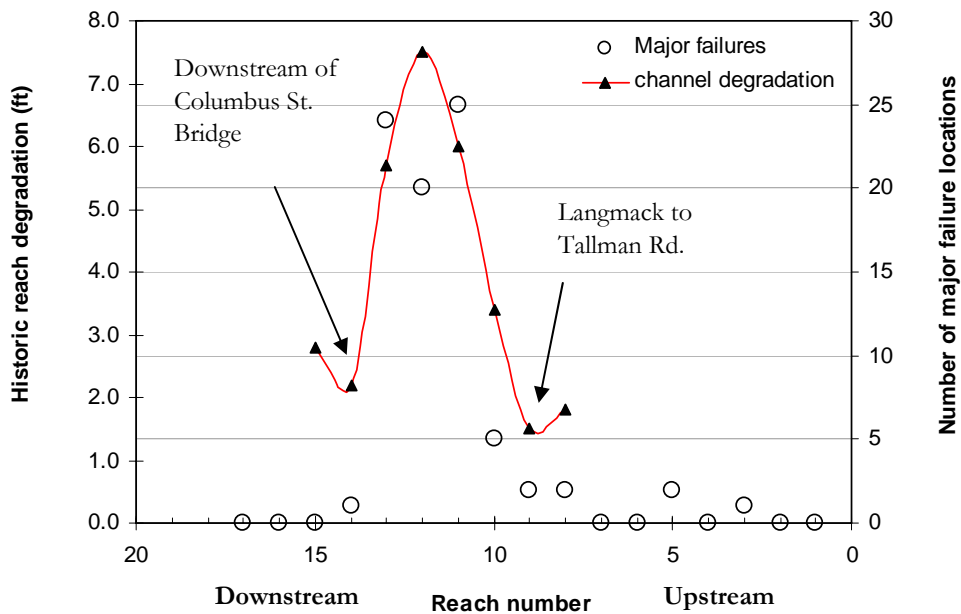
Figure 7: Major Bank Failure Frequency and Channel Degradation Along the Longitudinal Profile of the Albany Canal

CEM stage and the depth of historical canal entrenchment were utilized to differentiate reaches within the rural sections of Linn county and portions of the canal within the City of Albany (Otak February 26, 2008). Canal segments with the highest historical rate of entrenchment are highly correlated to areas with frequent bank failures (Figure 7). Reaches that are currently in CEM Stages 2 or 3 are susceptible to future bank failure problems.

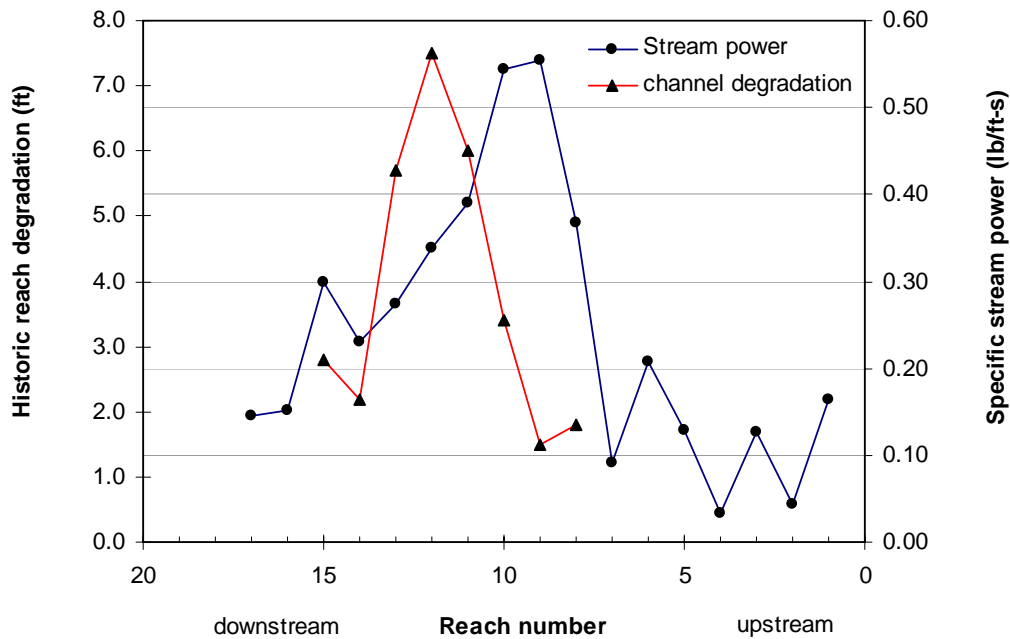
Figure 8: Historical Canal Degradation and Current Specific Stream Power Plotted for Each Hydraulic Reach (reach numbers increase sequentially from upstream to downstream)

Historical reach degradation rates and specific stream power (for the current average flow rate of 85 ft³/s) plotted on Figure 8 reveal that the maximum stream power rates are proceeding upstream of the observed bank failures as predicted by the CEM theory. Maximum historical degradation rates, and subsequent bank failure prone areas noted in the field reconnaissance, fall downstream of this zone of maximum stream power (Figure 8) as the incision progresses upstream. This process can be complicated by local grade control features and outcrops of more resistant geologic bed material, which slow down the migration of the incision zone.

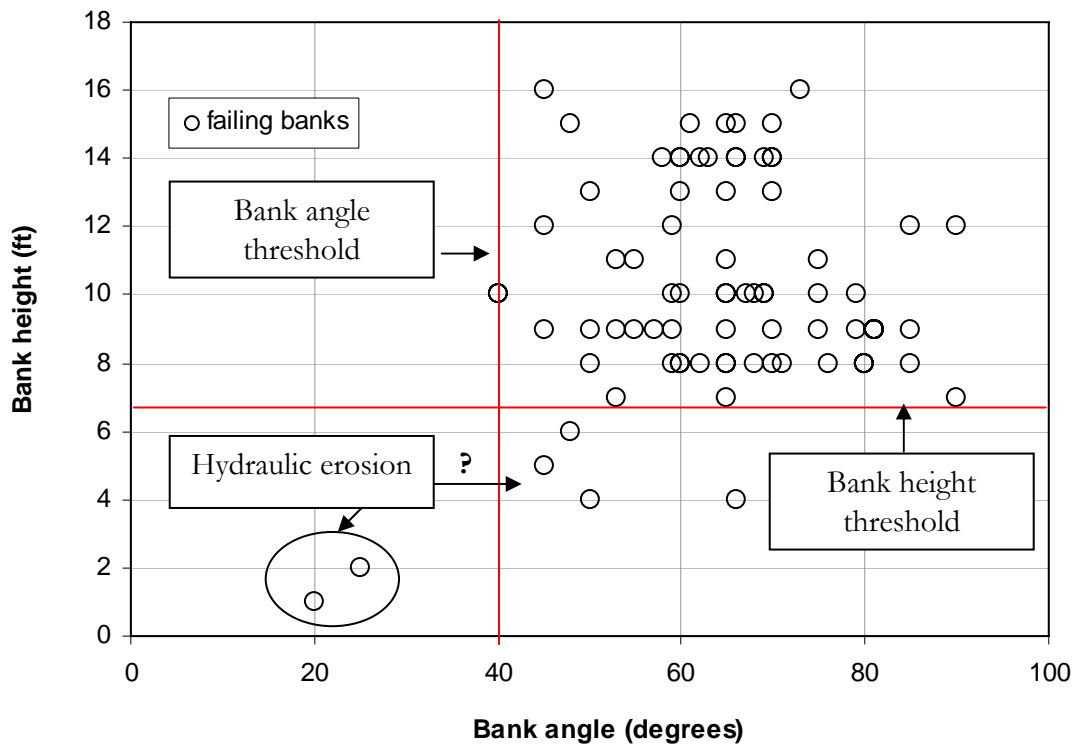
Figure 9 Bank Height and Angle for Major Failure Locations

A threshold for differentiating Stage 2 and Stage 3 channels is the critical bank height for incipient failure. Bank angle is also an important factor for stability. Measured bank angle and bank height are plotted for the major failures field database in Figure 9. This data indicates a bank angle threshold of 40 degrees and a bank height threshold of seven feet for incipient geotechnical failure for the soils in this area. Some soils and vegetation characteristics will withstand steeper angles and higher banks, but this lower envelope should be considered the threshold for failure. Outliers in the lower left corner of the figure indicate cases where hydraulic erosion generates bank failure. In these cases of excess velocity and or shear stress is capable of mobilizing sediment at the bank toe, thus creating scour and bank instability. This is a different failure mechanism than the majority of failures observed along the canal, which are primarily geotechnical failures. Any bank failures occurring below bank heights of seven feet could possibly be attributed to hydraulic erosion processes.

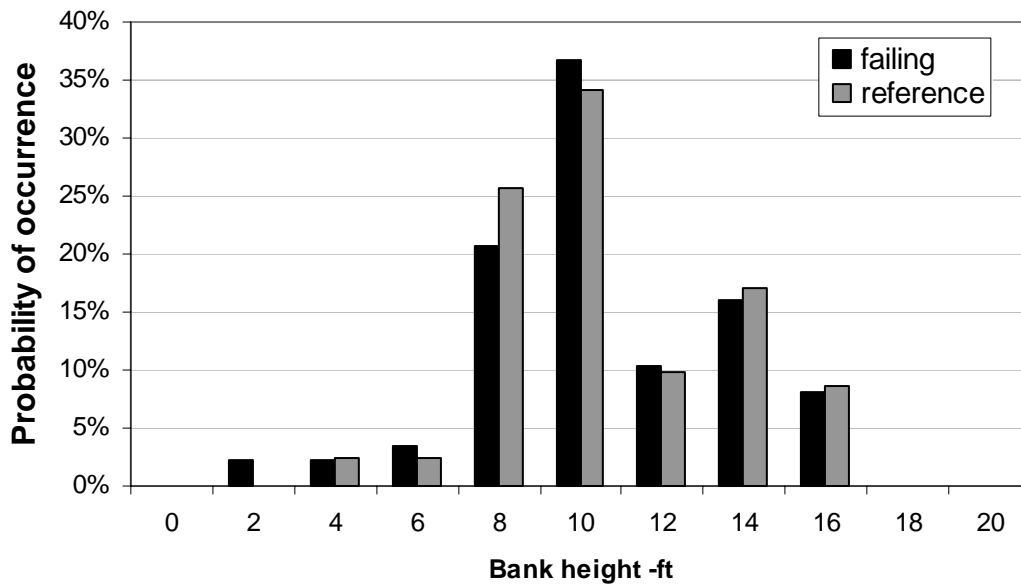
Figure 10: Probability Distribution of Bank Heights for Santiam-Albany Canal Failure and Reference Banks at Major Failure Locations

Measurements of the bank angle and height of nearby stable or reference banks were collected at each major failure site. Probability distributions of these measurements are shown in Figures 10 and 11. These data indicate that banks can be stable at similar heights to the failed banks, but the reference median bank angle (~50 degrees) is significantly less steep than the median bank angle for the failure locations (~70 degrees). This trend indicates two possible conclusions: 1) Bank angle is stronger driver of instability than bank height, or 2) Bank angles are steeper because the failure plane of the bank angle was measured, which would indicate that the data show effects of bank failure on bank geometry rather than bank angle being a cause of bank failure. Analysis of this field data also indicates that local soils can support bank angles up 40 degrees, nearly a 1:1 slope. Beyond this threshold bank failure is common. Given this data, layback slopes for non-reinforced canal banks should be greater than 1:1 (Horizontal to Vertical), particularly if the stabilized slope has a bank height greater than seven feet. Layback slopes in the range of 1:1 to 1.5:1 can be utilized if revegetation measures and turf reinforcements mating are incorporated into the design. Slopes approaching 1:1 could be utilized if the consequences of slope adjustment and minor sluffing are acceptable at the bank stabilization location otherwise larger factors of safety would be advisable.

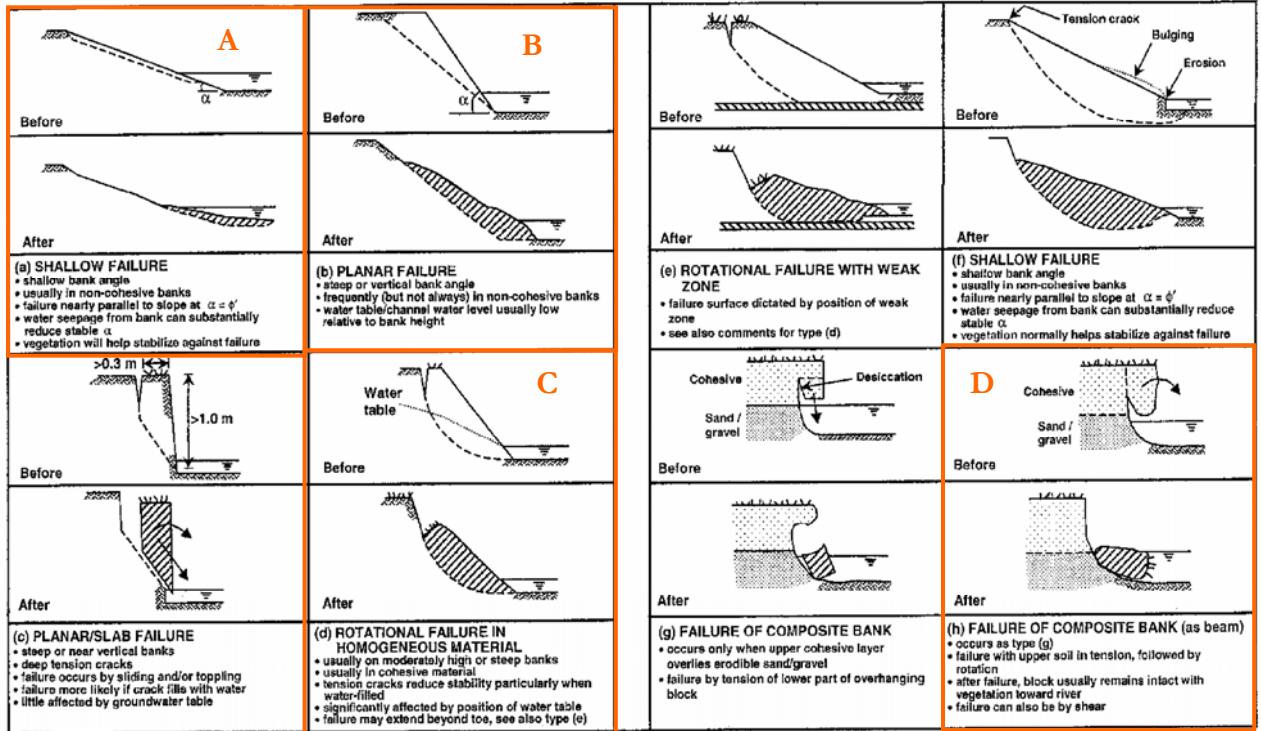
Figure 12: Qualitative Bank Failure Mechanisms Noted in Field Measurements of the Santiam-Albany Canal (Adapted from Lagasse et al. 2001)

A qualitative estimate of bank failure type was also noted during the winter 2007 field reconnaissance of the bank failures in the canal. The results of these observations are reported in Tables 5 and 6. Four typical scenarios were delineated in the field, as shown in Figure 12. The presence of tension cracks and undercutting were also documented. Plane slip and rotational slip failures are geotechnical failures that result from exceeding a critical bank height threshold. Results of the data analysis of field observations indicate that 89 percent of the bank failures observed in the canal is geotechnical in nature. Only 2 percent of the failures are the result of scour, and 5 percent are related to cantilever type failures which can also be a result of hydraulic erosion of stratified soil layers that exhibit varying erosion resistance properties. In these failures a more easily eroded soil type may underlie a more resistant layer. Tension cracks are observed in 33 percent of the failures, these are another indicator of geotechnical failure. Only 9 percent of the plane slip failures exhibited undercutting. Undercutting could be attributed to fluvial erosion. Results of these analyses indicate that geotechnical type bank failures are the dominant failure mechanism for the canal. These geotechnical failures are primarily due to over heightened and over steepened banks resulting from long-term channel incision. However, failure in these banks can be triggered by other contributing factors such as bank saturation, tree surcharge, animal burrowing, etc., that will be discussed in the following sections.

A – Equivalent of the *Shallow Slide*
B – Equivalent of the *Plane Slip*
C – Equivalent of the *Rotational Slip*
D – Equivalent of the *Cantilever Failure*

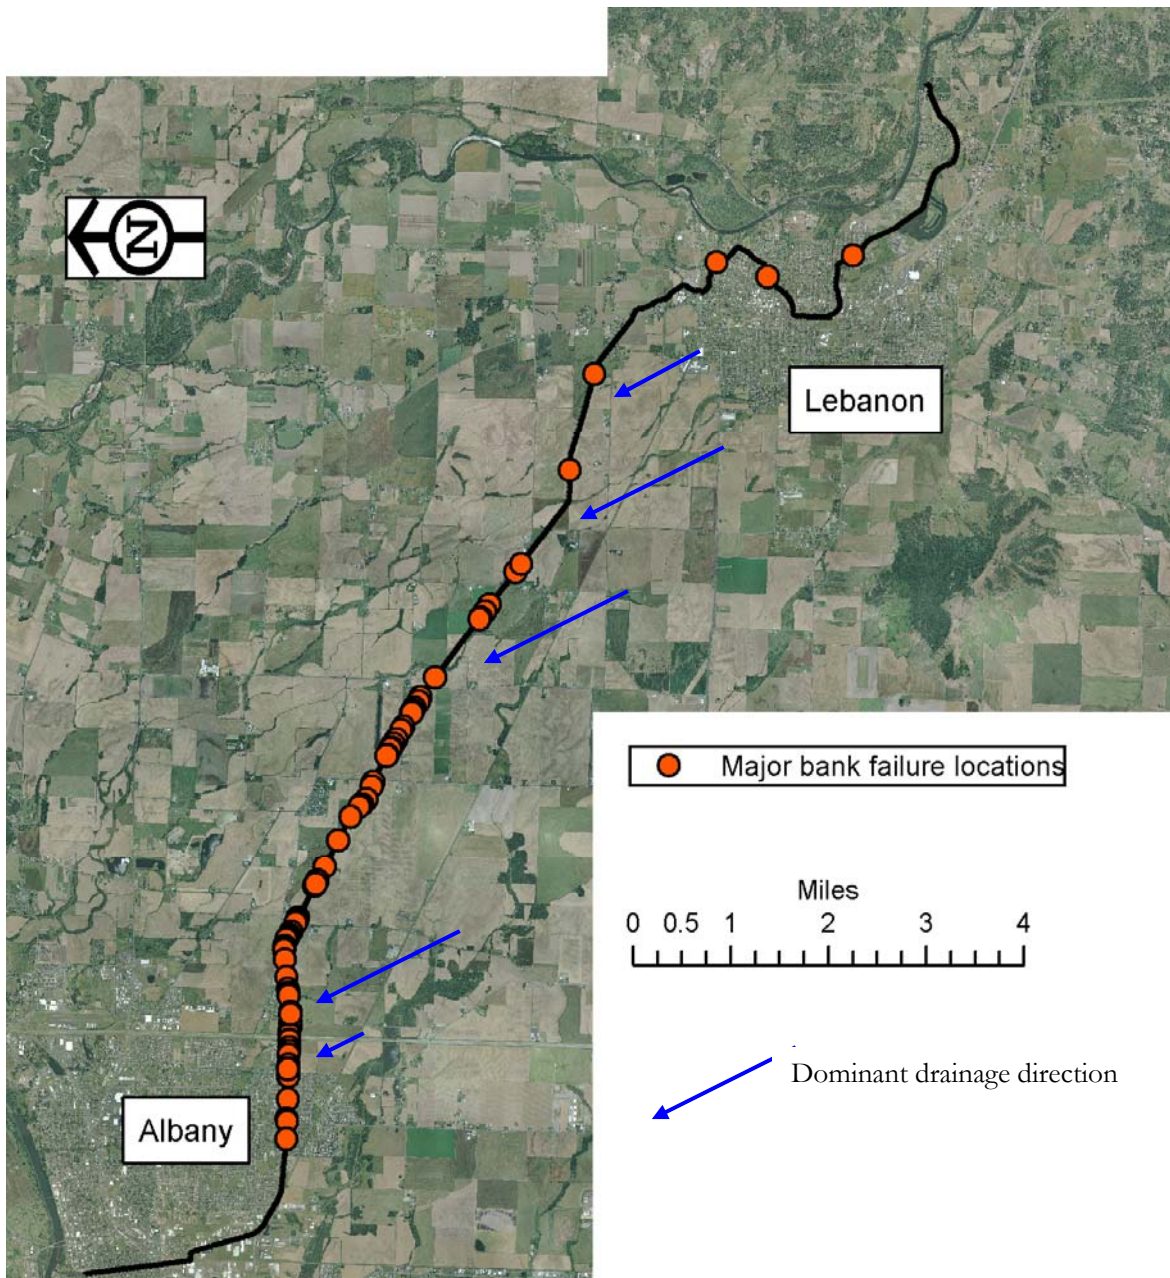
Figure 13: Aerial view of dominant overland drainage paths and bank failure locations along the Santiam-Albany canal

The dominant drainage pattern along the canal is from southwest to the northeast (Figure 13). This generally results in significant overland flow drainage effecting the left bank (facing downstream) of the canal. Data from the field survey indicates that 63 percent of the failures occurred on the left bank side of the canal

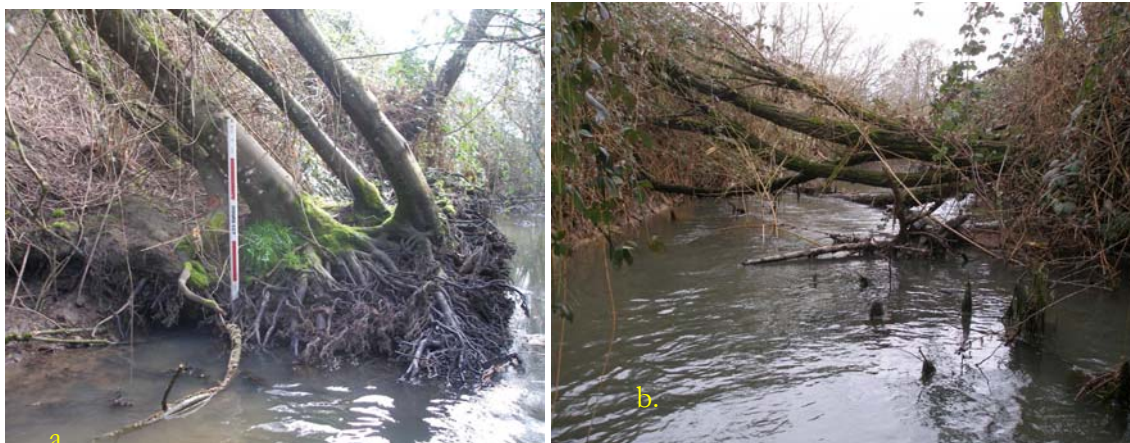
Figure 17: a. Rotational Slip and b. Leaning Moment Arm Tree Failure Mechanisms

Bank vegetation can also be a detriment to canal stability. One problem in particular is the abundance of large trees that are reaching the end of their lifespan along the canal. These trees add excess surcharge (weight) to the bank. There are two different failure mechanisms that result from these trees:

1. The excess surcharge from the tree leads to a rotational slip failure leaving the tree rootball at the toe of the slope (Figure 17)
2. The tree leaning into the canal creates a moment arm for bank failure toppling the tree into the canal (Figure 17).

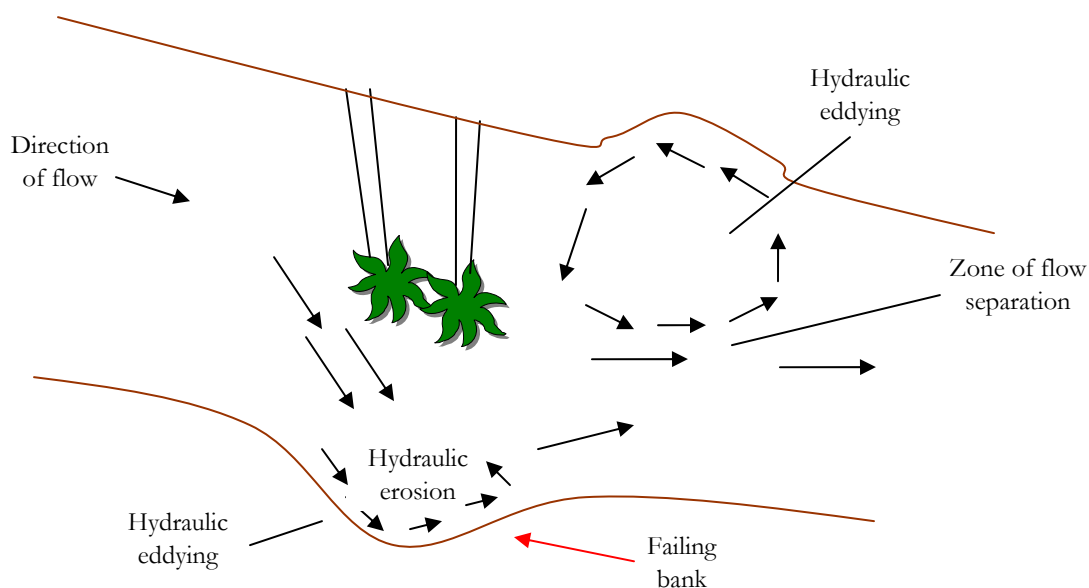
Figure 20 Impinging Flow and Schematic

When trees and debris from failing banks and tree mortality failures enter the canal they can initiate further bank failure by changing the channel hydraulics. This mechanism can also be set up in the urban environment with flow obstructions and infrastructure. Typically flow is constricted or redirected into the opposing bank creating increased velocity and hydraulic erosion of the canal bank (Figure 20). This is referred to as impinging flow. Secondary currents both behind the obstruction and at the impinging flow failure site are also set up with this mechanism leading to further scour. This is referred to as hydraulic eddying.
