*Final Report*

# **Condition Assessment: Water Pump Stations and Wastewater Lift Stations**

Submitted to  
**City of Albany**

February 2007

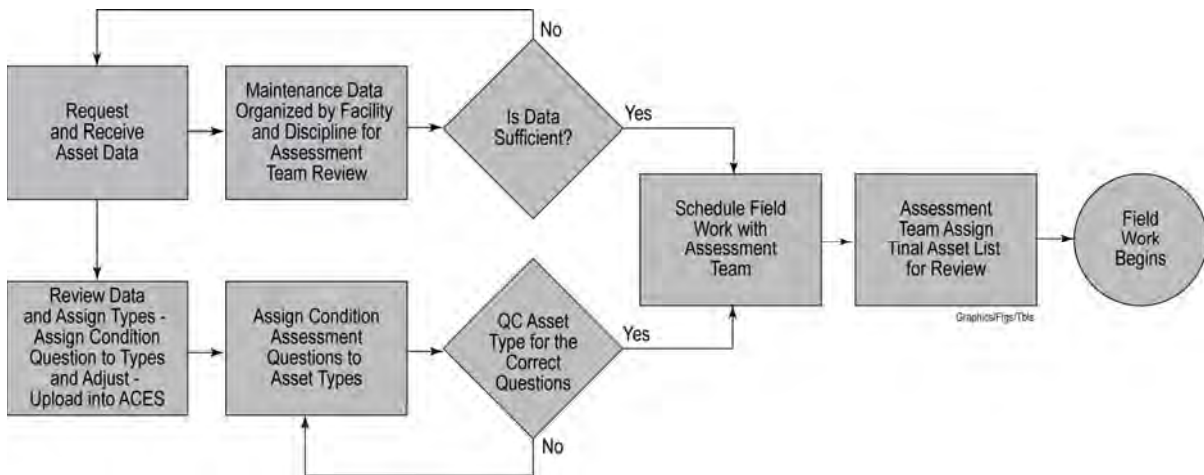
EXHIBIT 1-2  
Condition Assessment Preparation Process

The condition assessment personnel reviewed operation and maintenance (O&M) data and activities with the City of Albany staff to gain an understanding of the maintenance being performed on the identified assets.

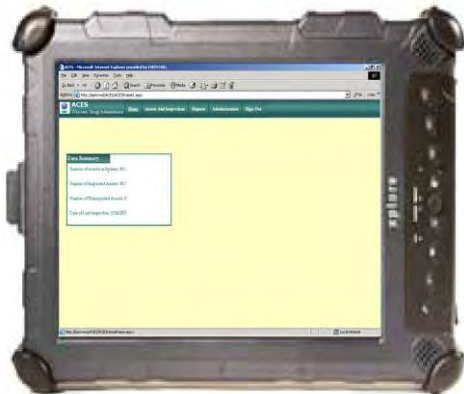
EXHIBIT 1-3  
Xplore Tablet

Field condition assessment personnel used Xplore™ tablet computers (**Exhibit 1-3**) with the Asset Condition Evaluation System (ACES®) software to perform the field condition assessment. **Exhibit 1-4** provides an example of the computer screen staff used during the field assessment to record their findings.

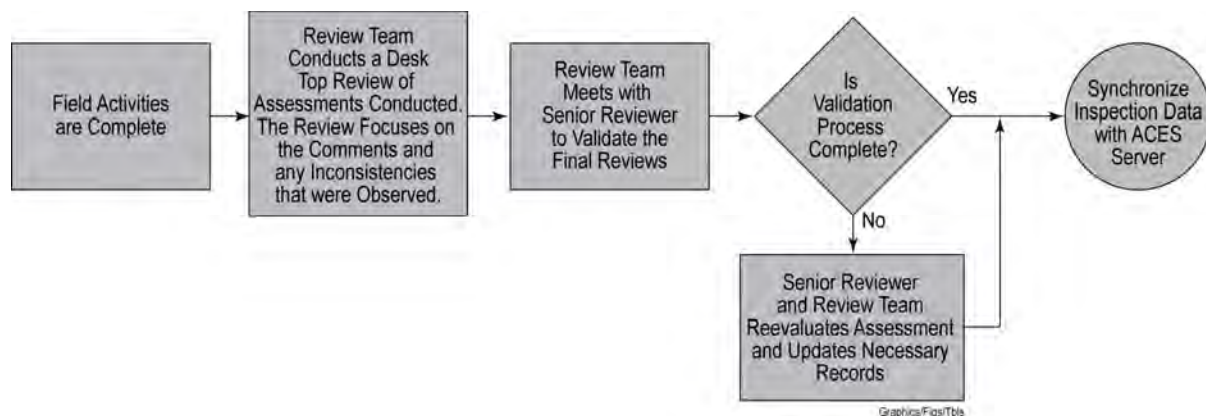
EXHIBIT 1-6  
Condition Assessment Quality Review Process

At the end of the field assessment, the field personnel participated in a quality review process to ensure that consistent ratings were assigned to the assets. Upon completion of the review, the condition ratings and comments were updated as necessary. This quality review process is essential to ensuring the reliability of the condition assessment process. **Exhibit 1-6** shows the steps involved in the quality review process.

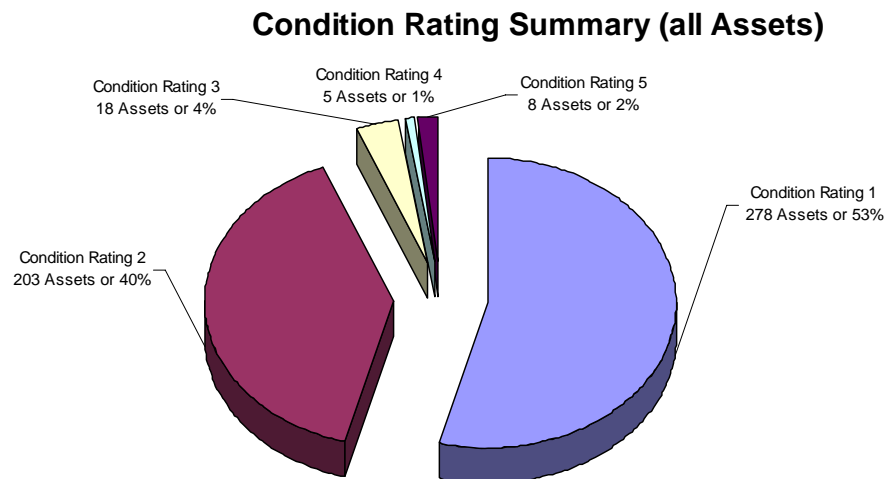
### EXHIBIT 1-7

The assessment personnel were able to assess 516 assets (402 lift station assets and 114 pump station assets) at the designated facilities. Most of the assets assessed showed typical signs of wear and tear for their age. Overall, 93 percent of the assets reviewed fall in either Condition Rating 1 or 2. Generally a condition rating of 2 means an asset or facility is in good condition with some minor asset defects that may require maintenance. **Exhibit 1-7** shows the number of assets and percentage for each condition rating (1 through 5). The condition rating for all assets can be found in Appendix B; backup field data is presented in Appendix C.

Condition Assessment Ranking by Number of Assets and Percentage

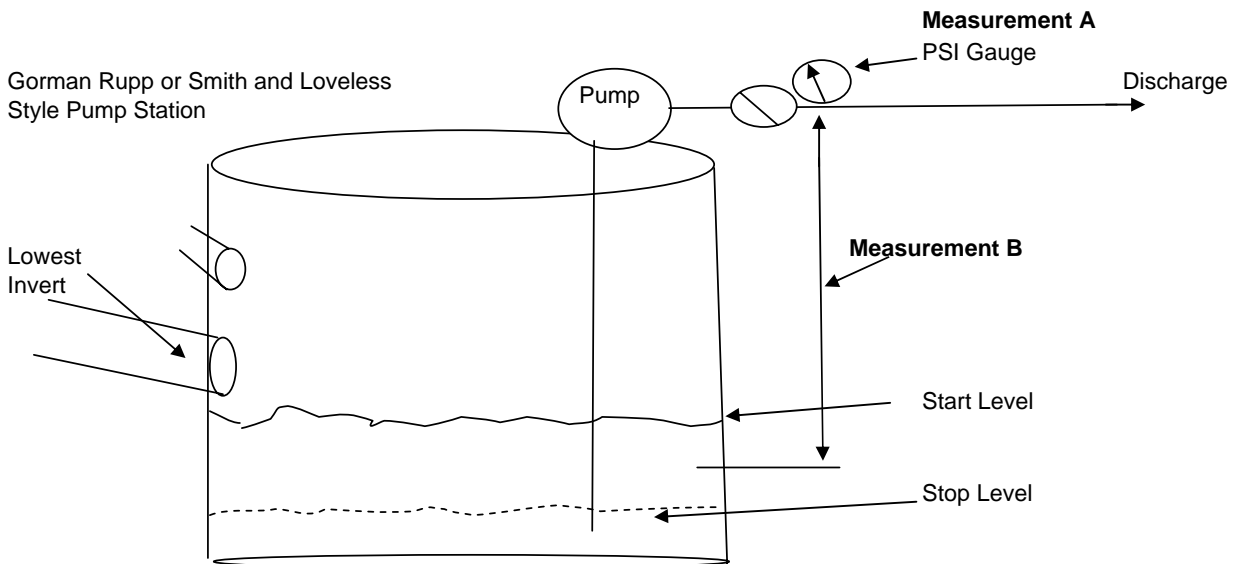
### Total Dynamic Head

<b>1 Pump</b>	<b>14.5925</b>	ft
With pumps 1&2 running	-5.158	ft
With pumps 2&3 running	-5.158	ft
With pumps 1&3 running	-5.158	ft

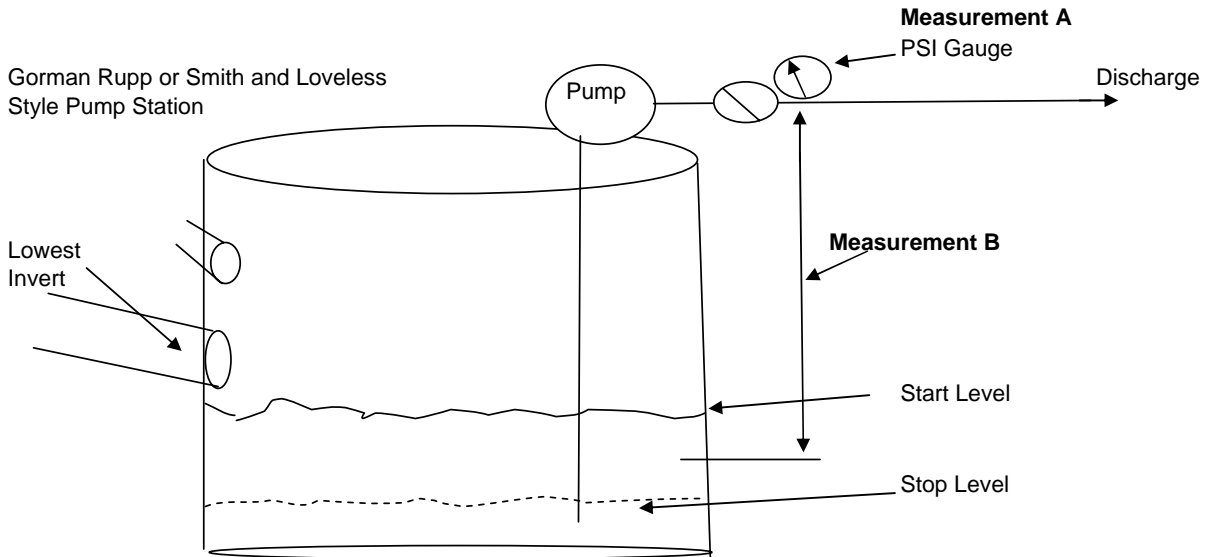
<b>1 Pump</b>	12.7281	ft
With pumps 1&2 running	-8.9859	ft
With pumps 2&3 running	-8.9859	ft
With pumps 1&3 running	-8.9859	ft

Gorman Rupp or Smith and Loveless  
Style Pump Station

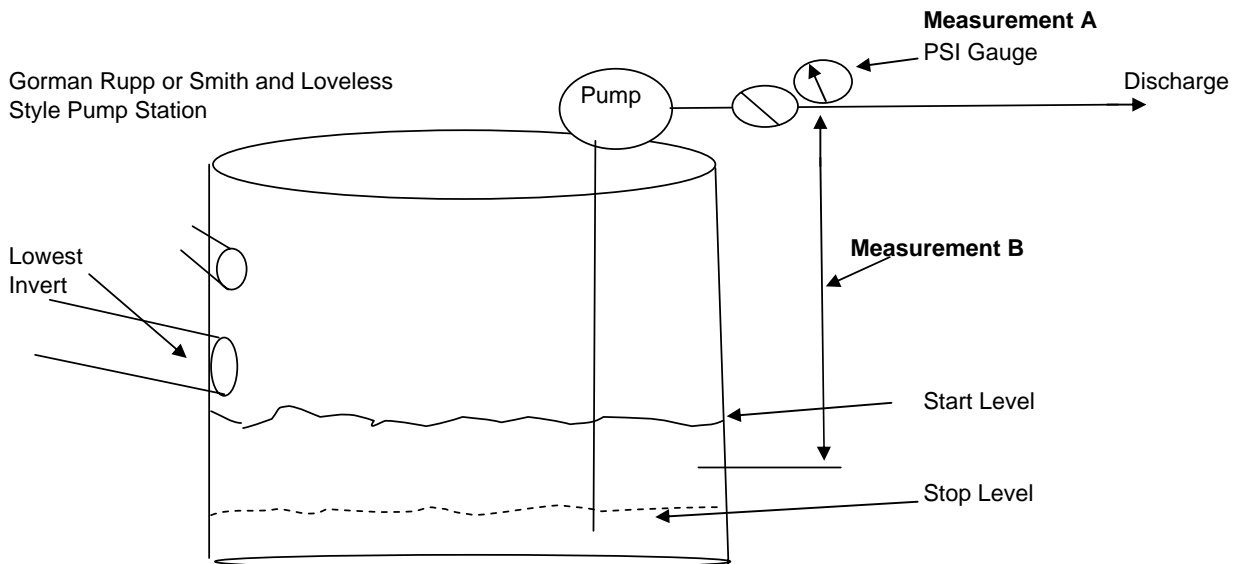
### Total Dynamic Head

<b>1 Pump</b>	<b>47.8455</b>	ft
With pumps 1&2 running	-5.4	ft
With pumps 2&3 running	-5.4	ft
With pumps 1&3 running	-5.4	ft

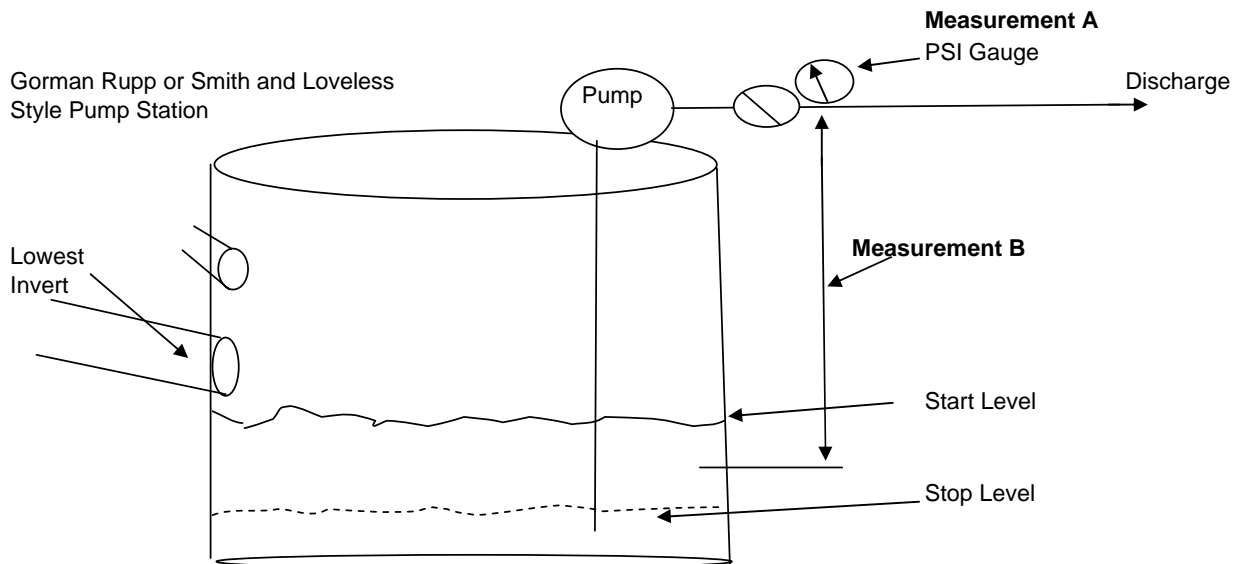
### Total Dynamic Head

<b>1 Pump</b>	<b>18.48035</b>	ft
With pumps 1&2 running	-3.661	ft
With pumps 2&3 running	-3.661	ft
With pumps 1&3 running	-3.661	ft

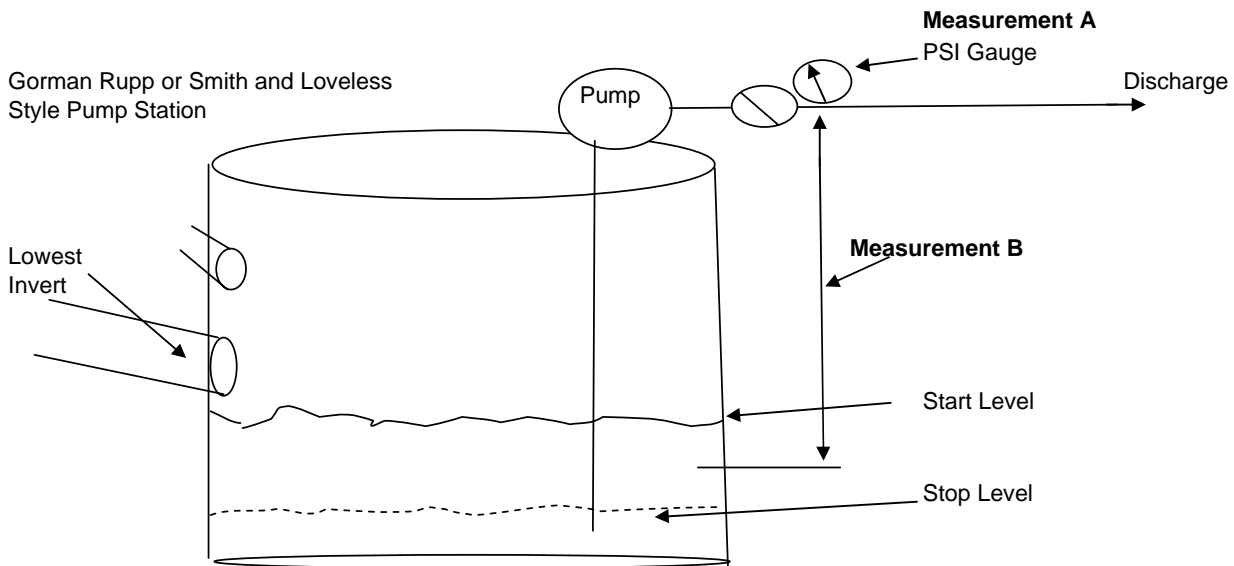
### Total Dynamic Head

<b>1 Pump</b>	<b>47.501</b>	ft
With pumps 1&2 running	4.304	ft
With pumps 2&3 running	4.304	ft
With pumps 1&3 running	4.304	ft

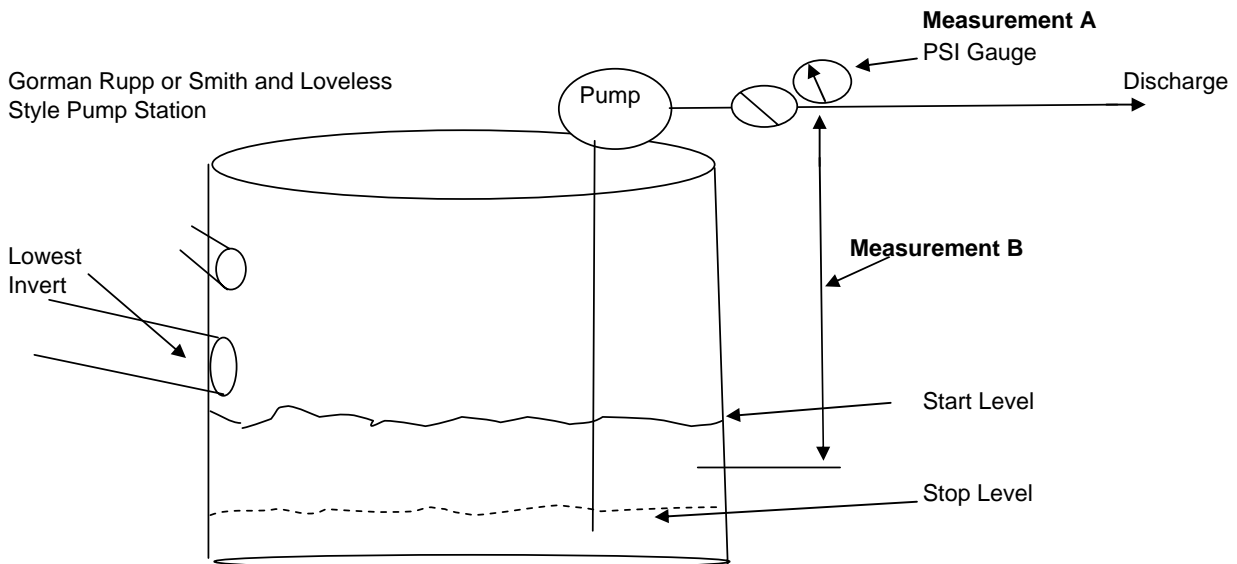
### Total Dynamic Head

<b>1 Pump</b>	<b>22.0245</b>	ft
With pumps 1&2 running	9.666	ft
With pumps 2&3 running	9.666	ft
With pumps 1&3 running	9.666	ft

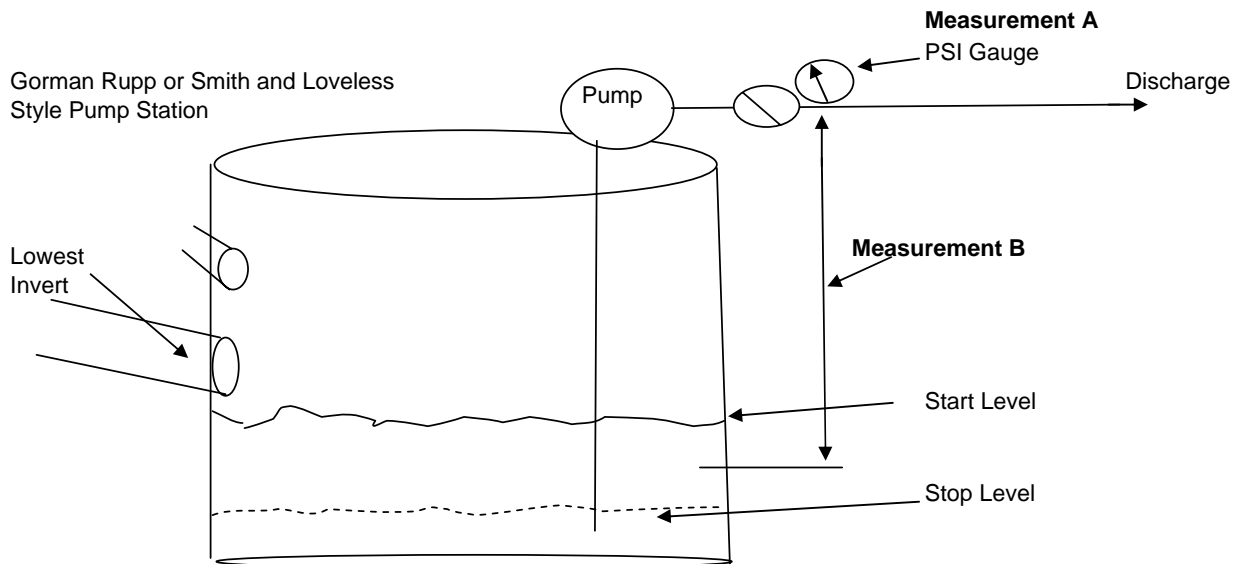
### Total Dynamic Head

<b>1 Pump</b>	44.928	ft
With pumps 1&2 running	1.5	ft
With pumps 2&3 running	1.5	ft
With pumps 1&3 running	1.5	ft

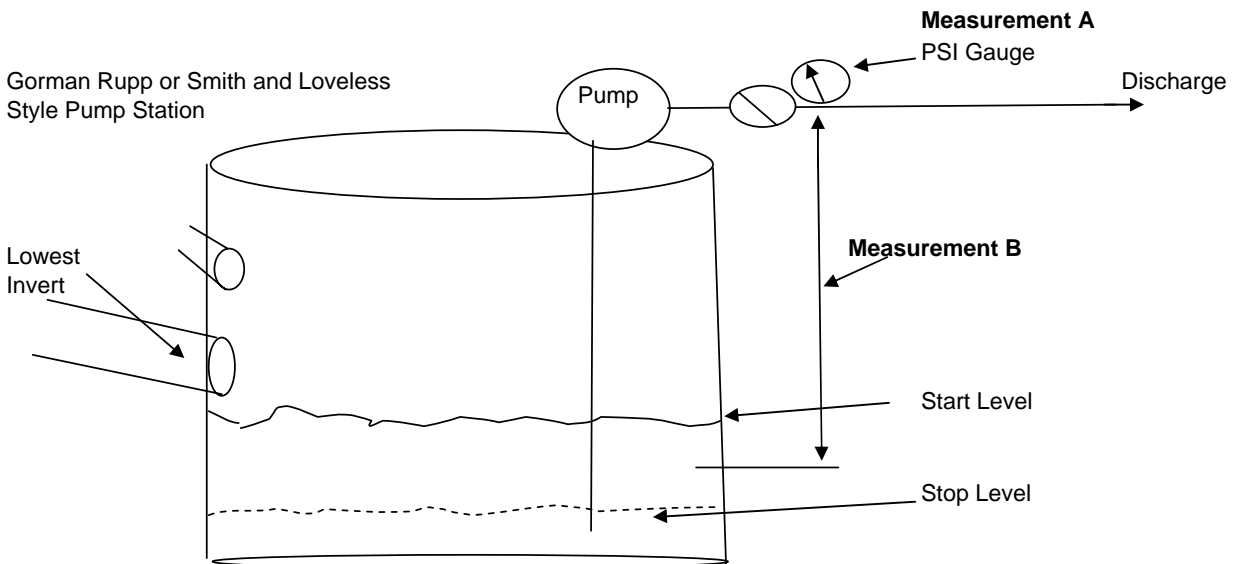
### Total Dynamic Head

<b>1 Pump</b>	<b>26.583</b>	ft
With pumps 1&2 running	5.1	ft
With pumps 2&3 running	5.1	ft
With pumps 1&3 running	5.1	ft

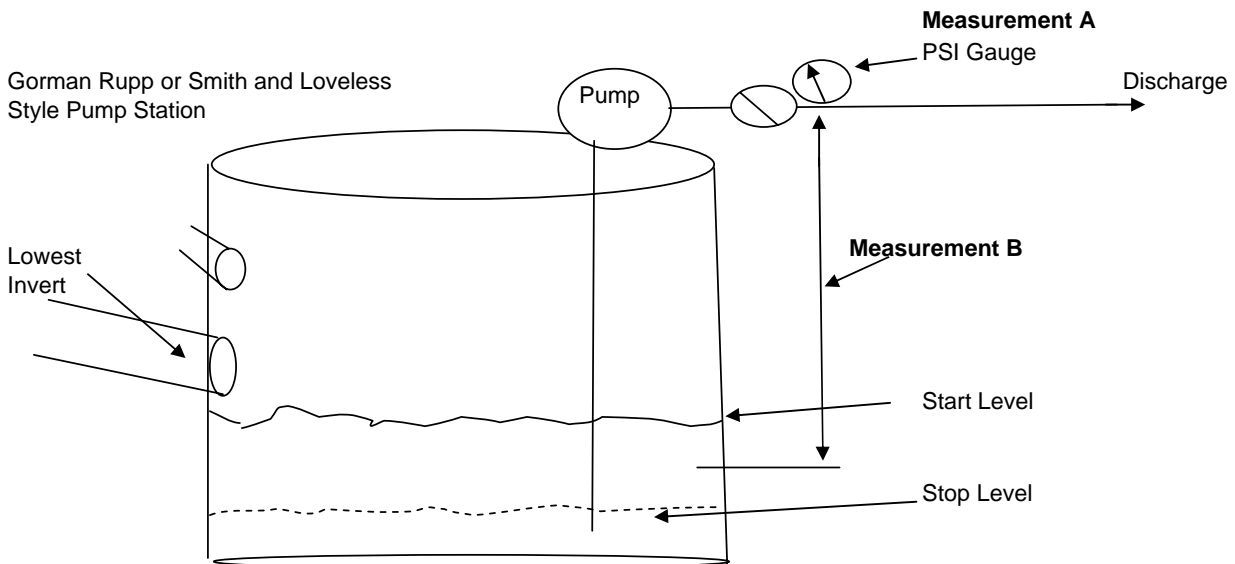
### Total Dynamic Head

**1 Pump**     70.917 ft  
 With pumps 1&2 running                       -0.693 ft  
 With pumps 2&3 running                       -0.693 ft  
 With pumps 1&3 running                       -0.693 ft

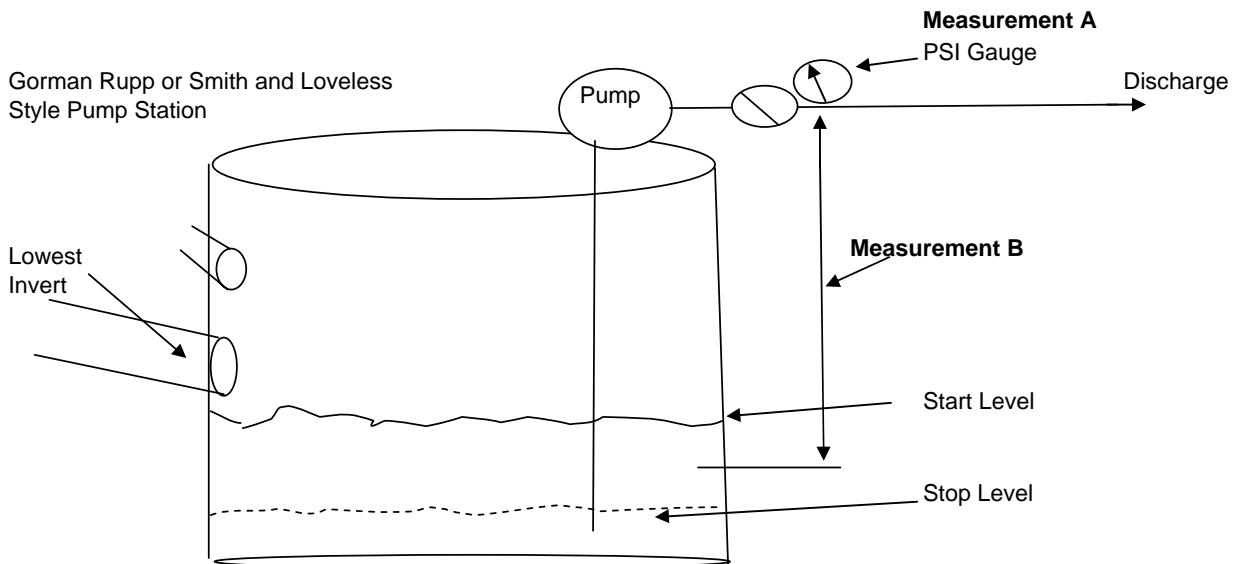
### Total Dynamic Head

<b>1 Pump</b>	16.5165	ft
With pumps 1&2 running	-24.1395	ft
With pumps 2&3 running	-24.1395	ft
With pumps 1&3 running	-24.1395	ft

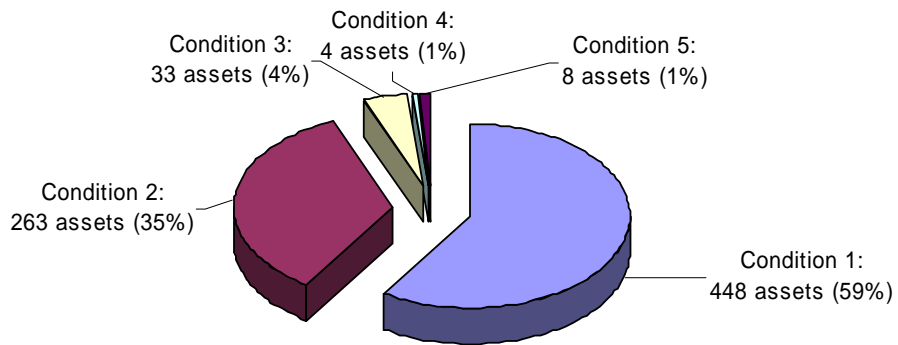
**EXHIBIT E-1**  
Condition Rating Summary (All Assets)

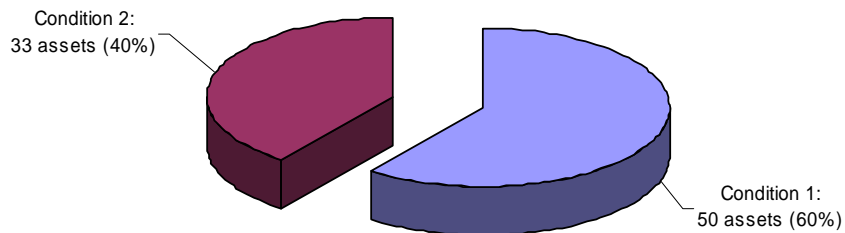
**EXHIBIT E-2**  
Booster Station Asset Condition Distribution

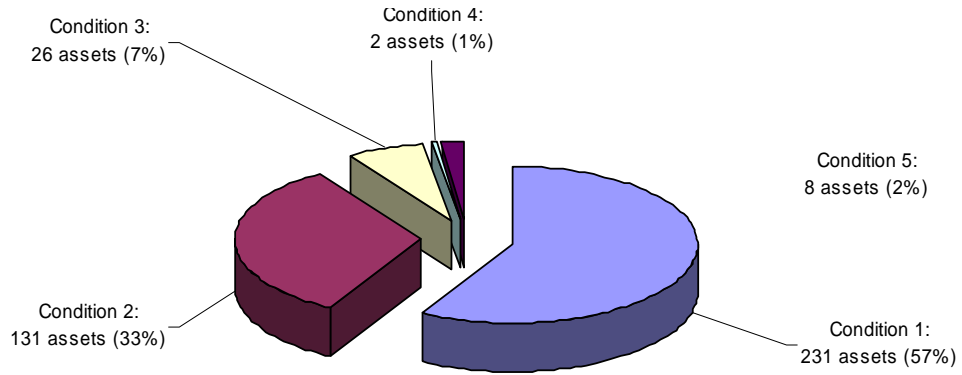
**EXHIBIT E-3**  
Lift Station Asset Condition Distribution

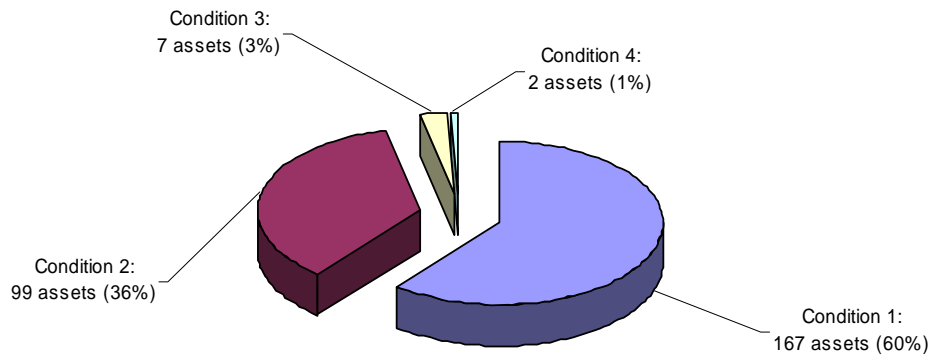
**EXHIBIT E-4**  
Vine Street Asset Condition Distribution
